# **The Blackburn Point Bridge Project Development and Environment (PD&E) Study**

Alternatives Public Meeting

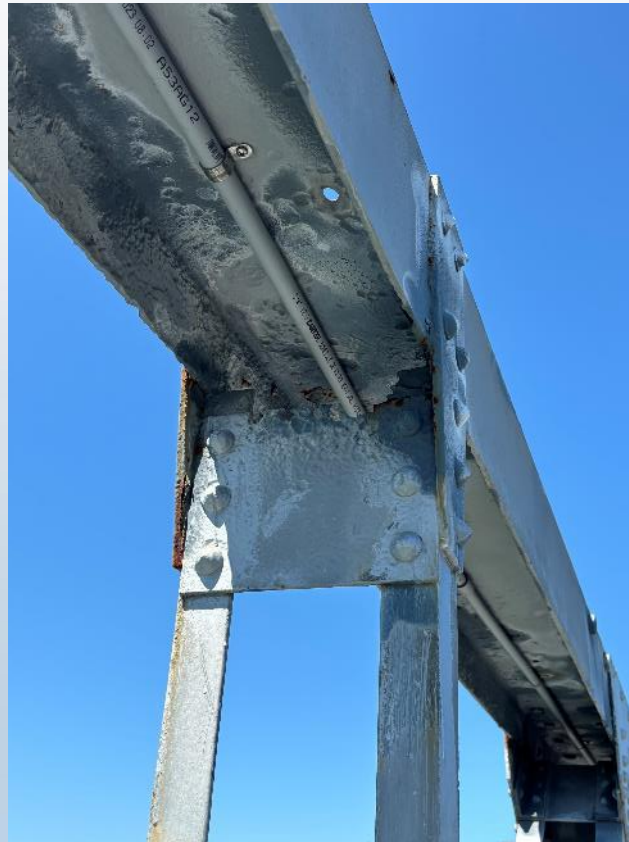
Photographs representative of existing conditions of the swing bridge's main upper truss members

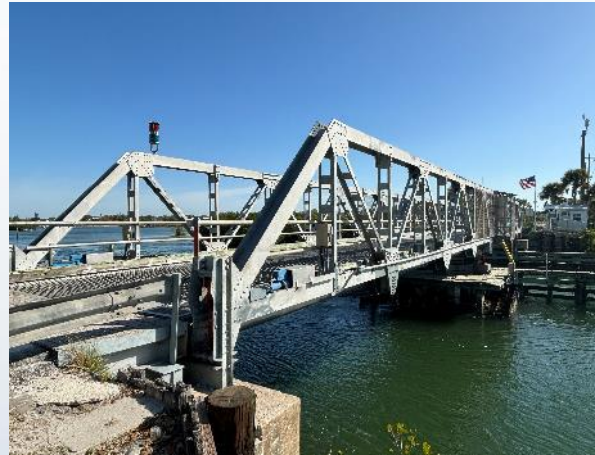
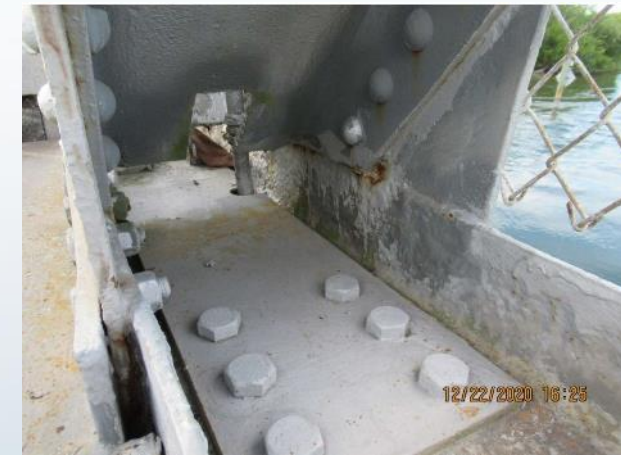
Prior Major Repairs:

1981 – Major Repairs  
(hit by barge)

1987 – Major Repairs

1995 – Major Repairs

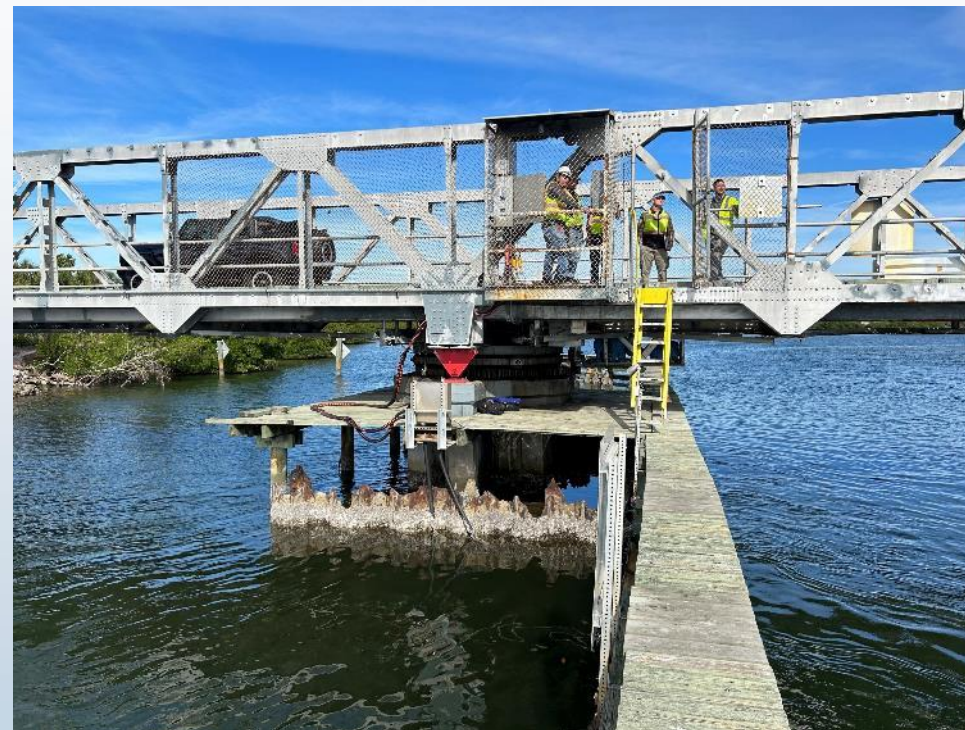
- Existing swing bridge and abutments are not capable of sustaining a direct vessel collision
- The existing bridge low members are within the splash zone, subject to accelerated corrosion due to saltwater and salt laden air

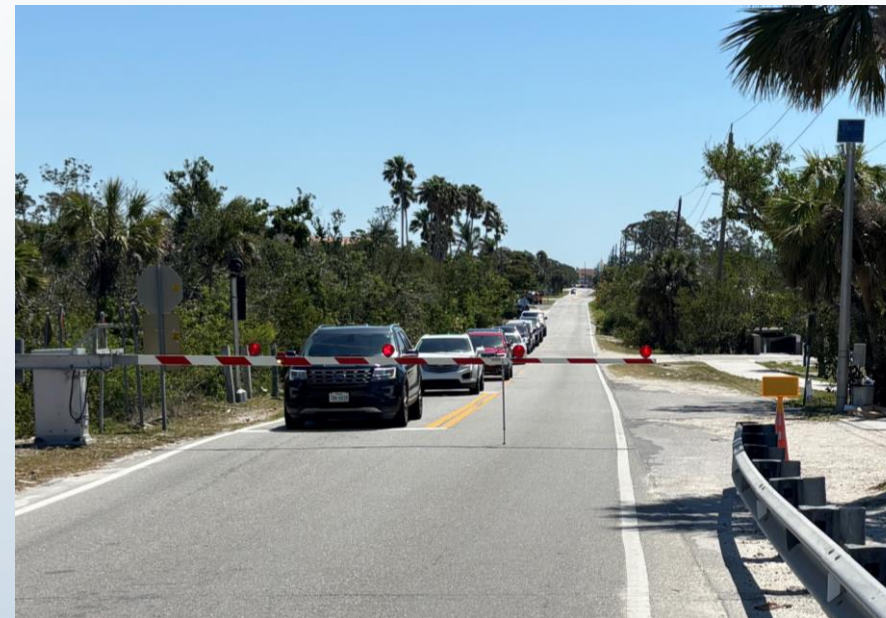
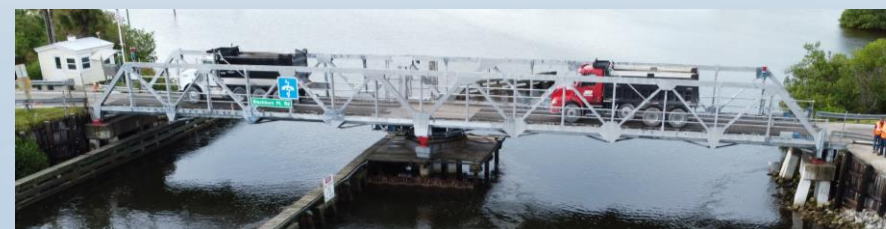
Existing bridge is important for evacuation during a storm event.

Blackburn Point Road between Casey Key and US 41 is a designated emergency evacuation route.

There is insufficient room available to pass a stalled vehicle on the bridge during an emergency.

Proposed improvements will increase bridge width to provide sufficient room for vehicles to pass a stalled vehicle on the bridge.

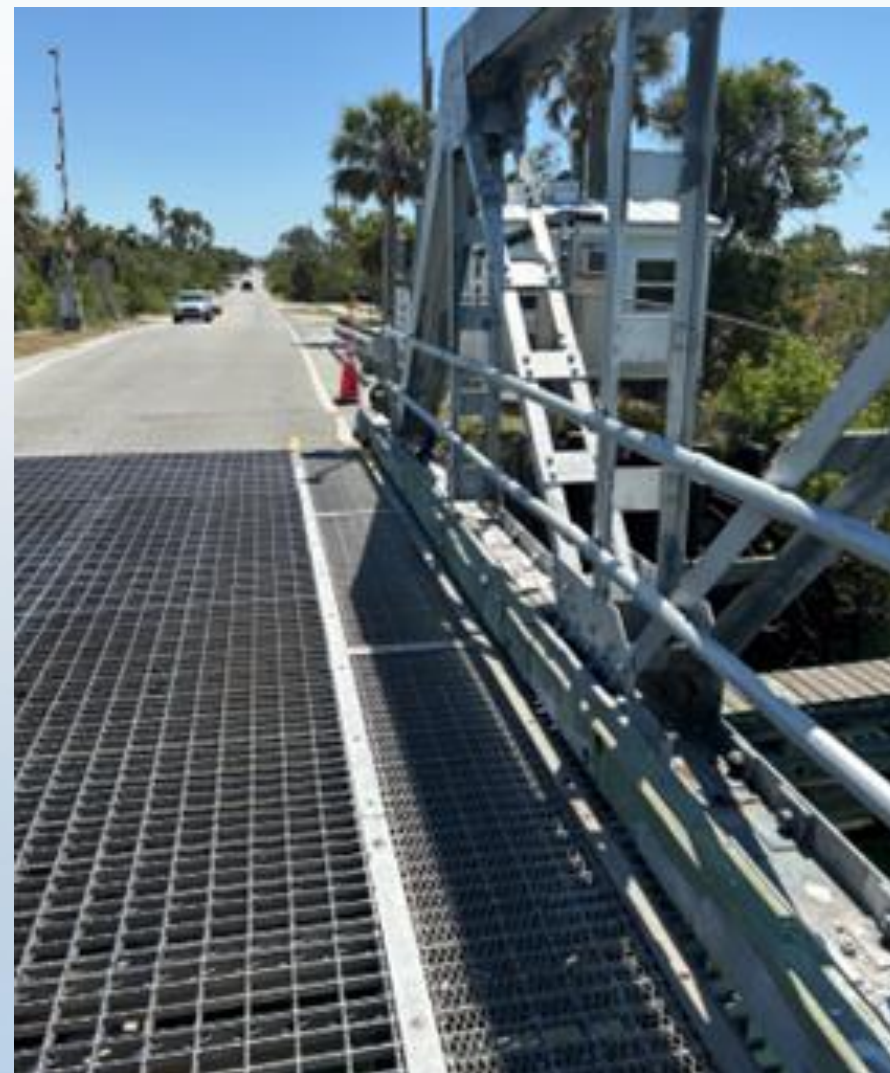
Existing bridge railings do not meet current standards for pedestrians or bicycles.

Existing bridge railings do not meet current geometric and crash testing safety standards for vehicles.

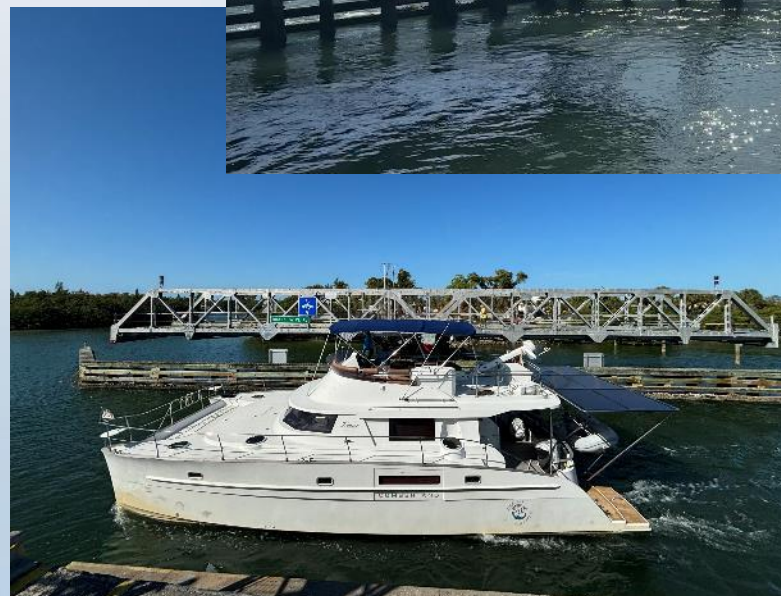
- Horizontal – 51 feet
- Vertical – 9.3 feet

- Horizontal – 90 feet
- Vertical – 21 feet

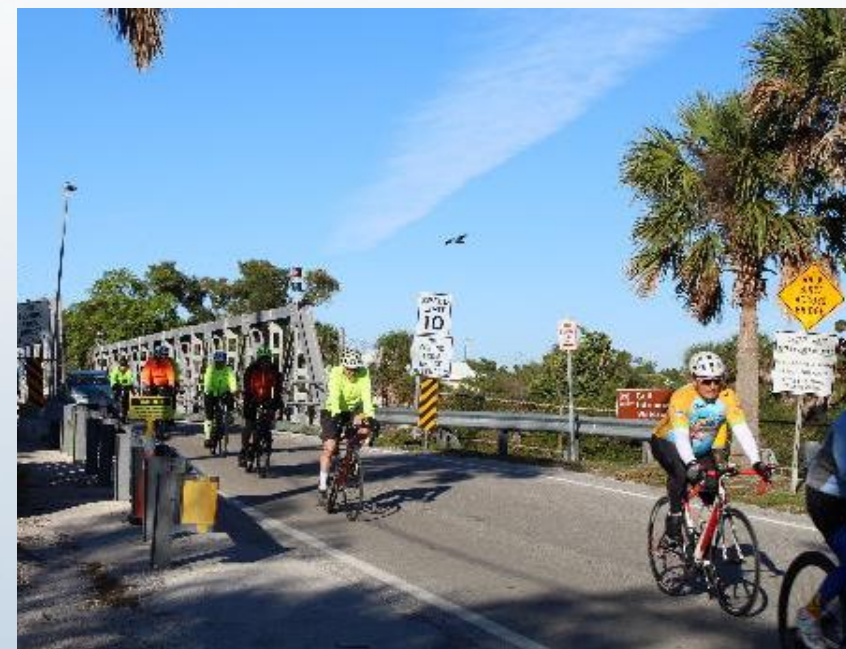
There are no sidewalks on the bridge to meet current accessibility requirements established by the Americans with Disabilities Act (ADA).

There are no bicycle lanes on the bridge. The bridge has an open grid metal deck which is problematic for bicyclists. An existing warning sign at each end of the bridge states "Walk Bikes Across Bridge".

The proposed improvements for this project will provide sidewalks, bicycle lanes, and a solid bridge deck for enhanced safety.

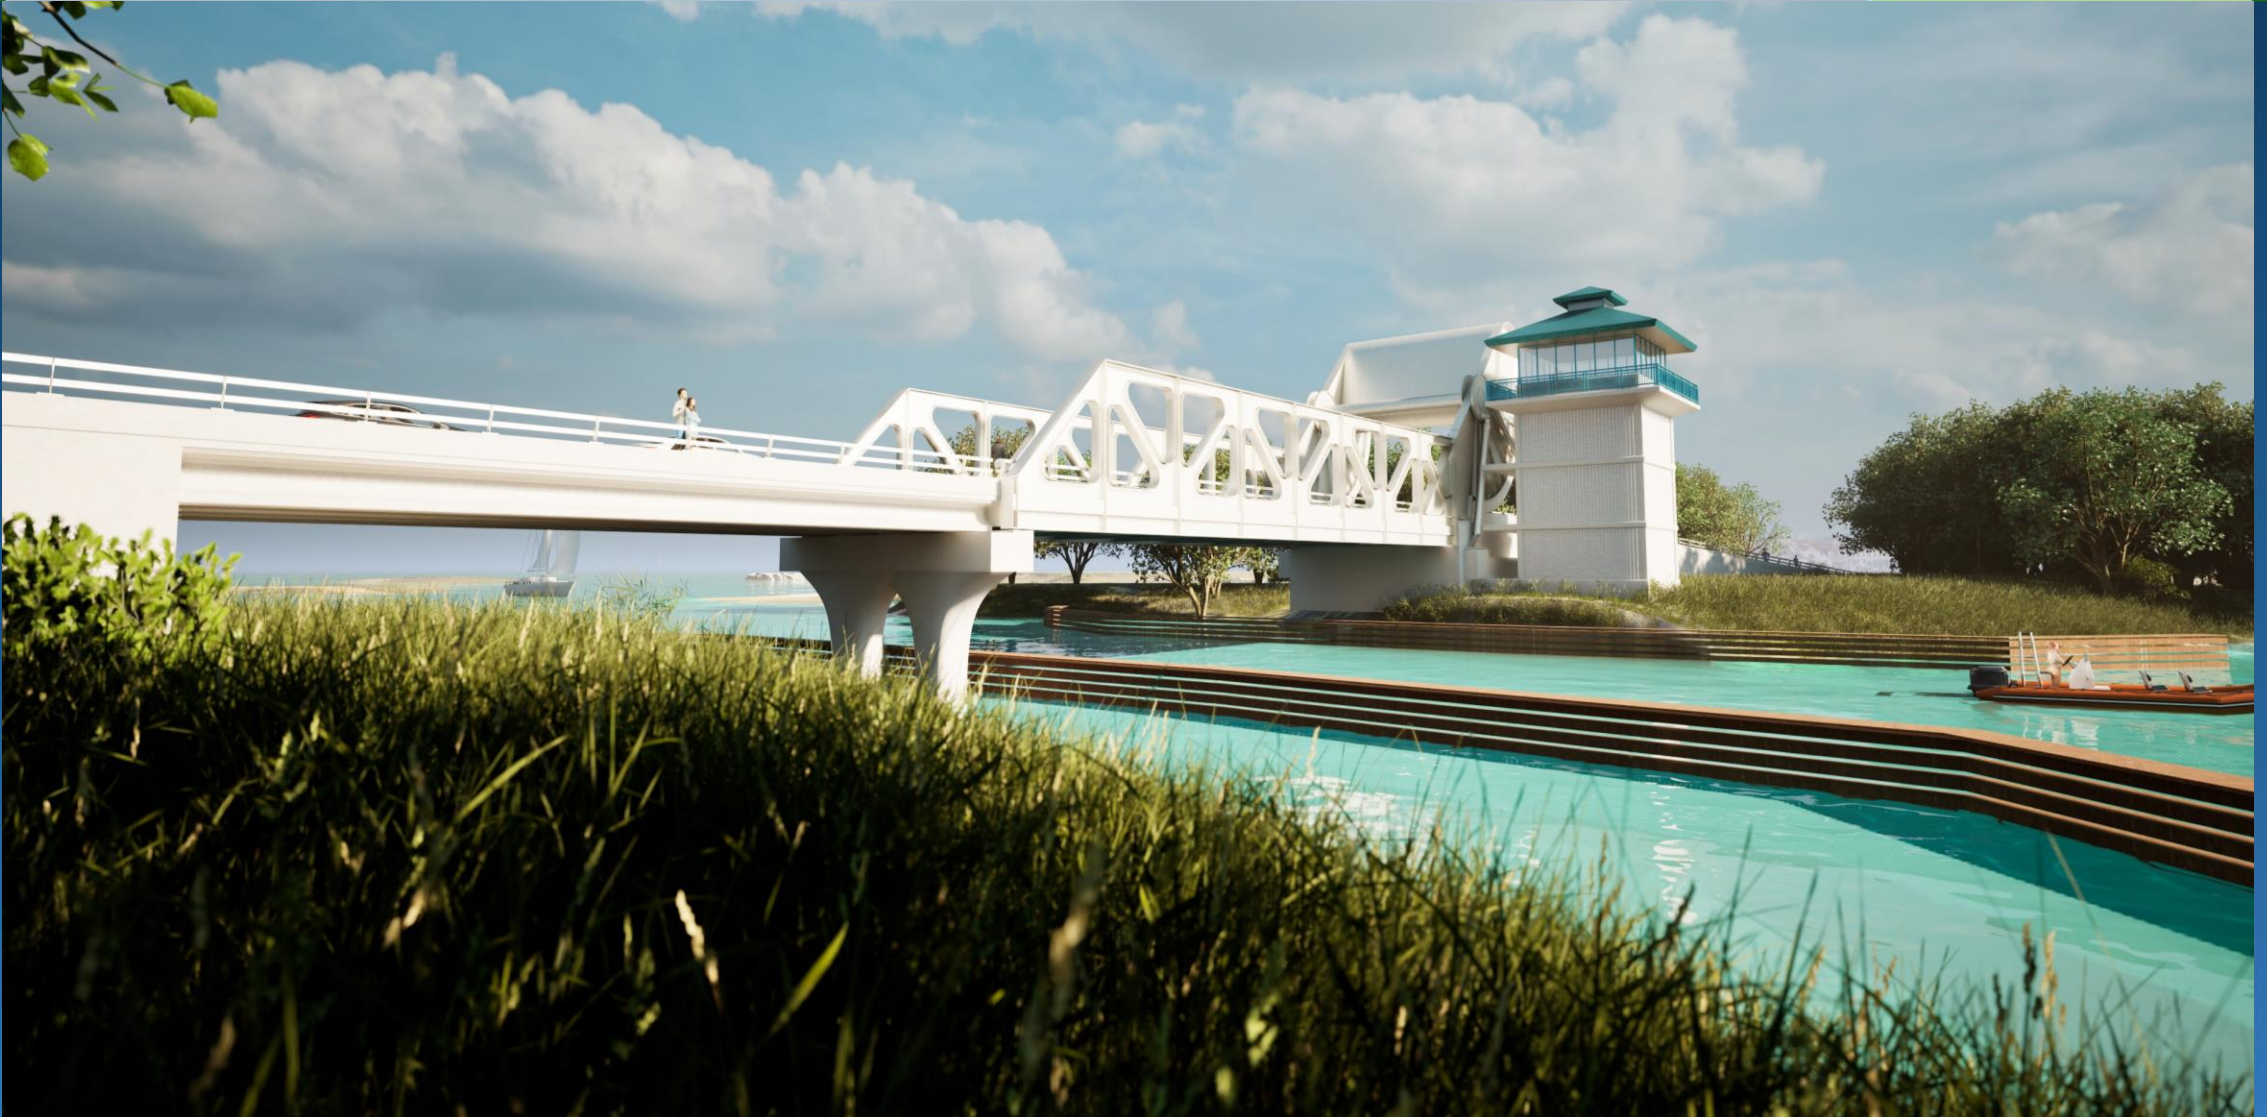
# Rendering – Bascule Span

North alignment

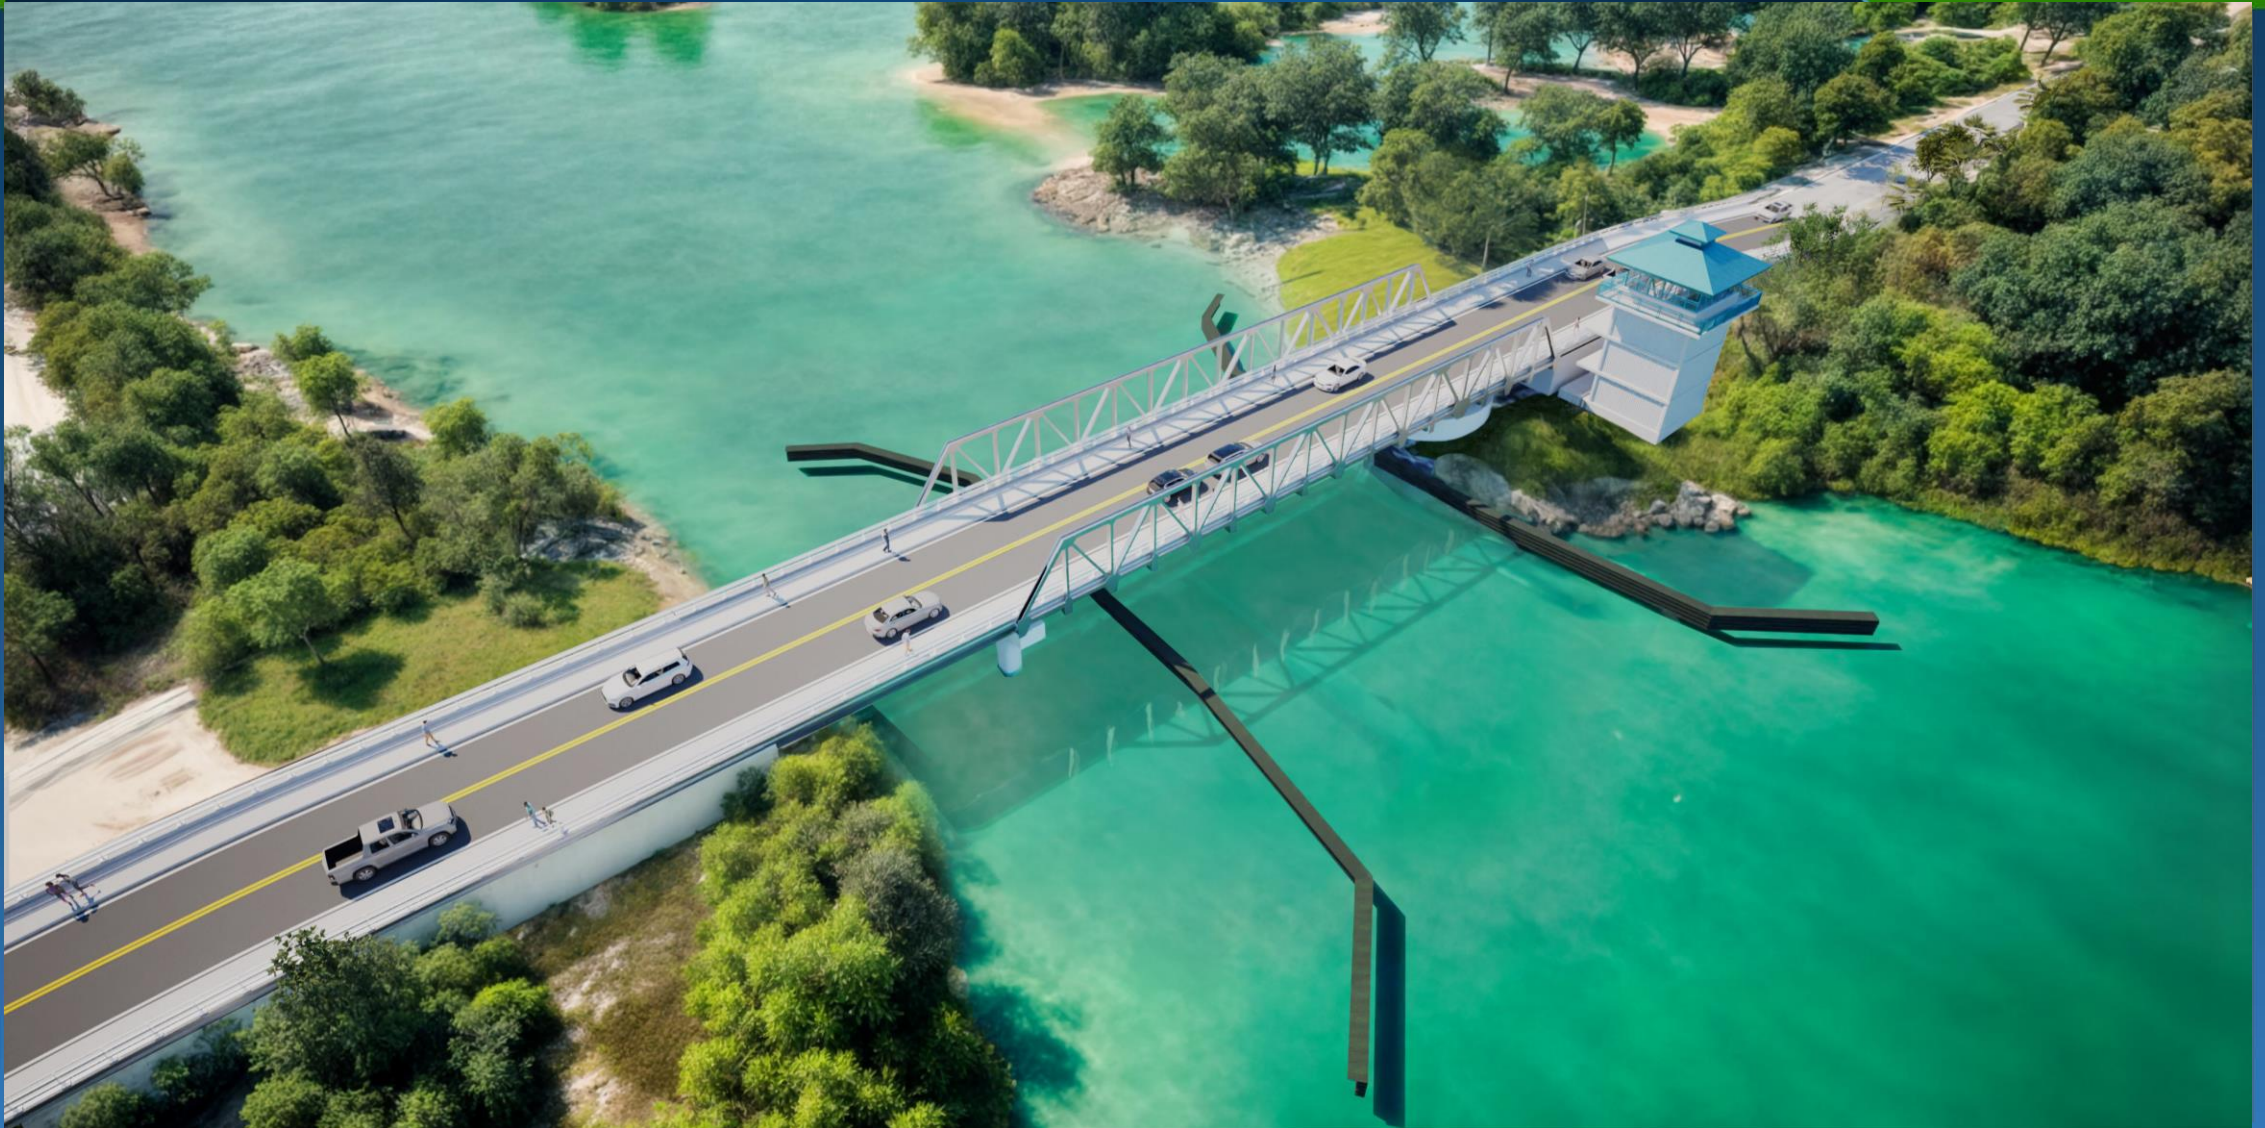
# Rendering – Swing Span (East Pivot)

Bob-tailed configuration (long span over channel, shorter back span) reduces movable span length

Pivot east of channel,  
north alignment

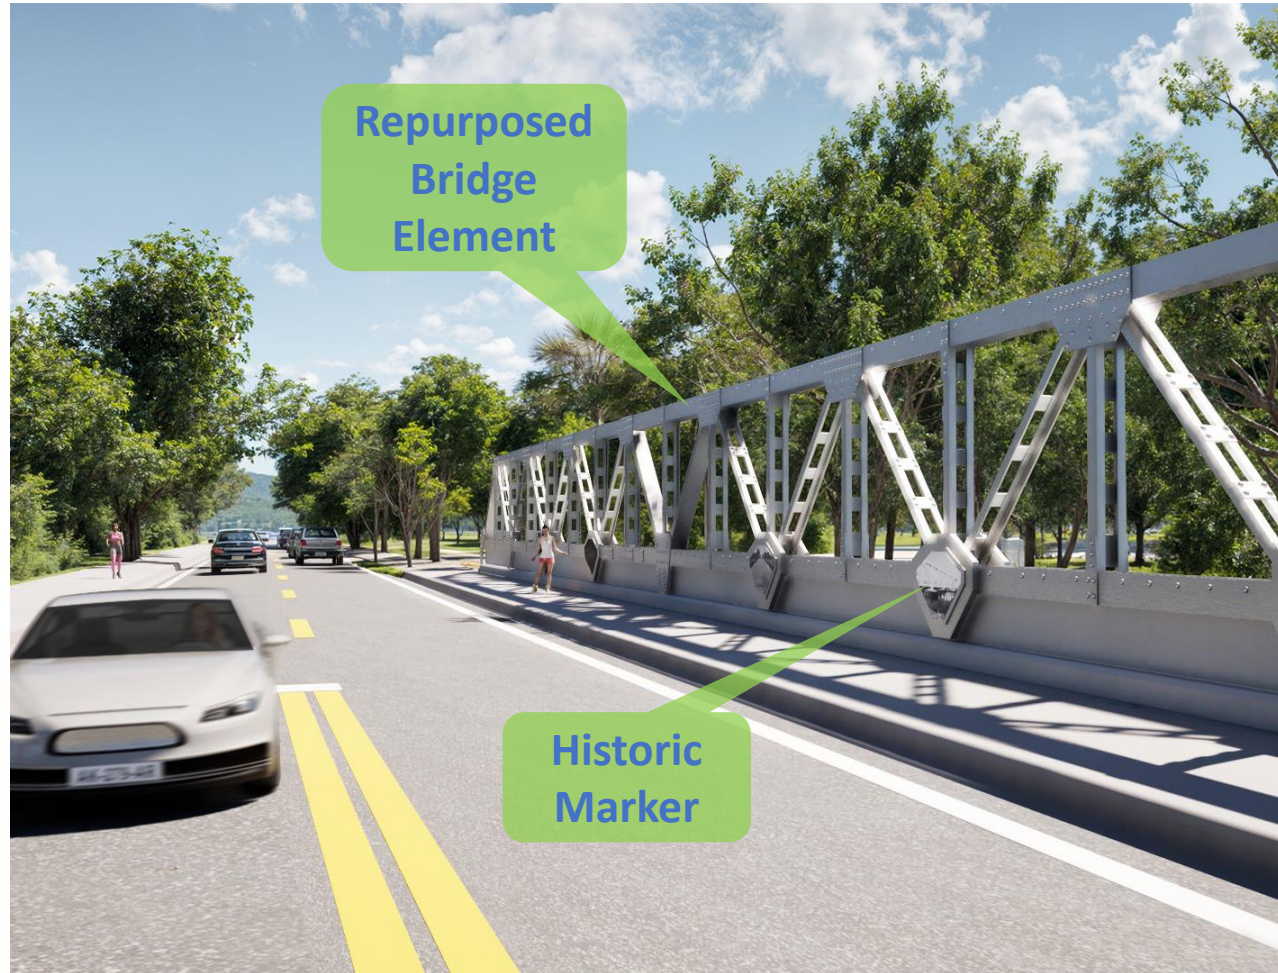
View from Blackburn Point Road

## Potential mitigation measures
