TO THE ALTERNATIVES PUBLIC MEETING FOR THE BLACKBURN POINT BRIDGE REPLACEMENT STUDY

Purpose and Need: The purpose of the project is to review alternatives to replace the Blackburn Point Bridge (Bridge No. 170064) on Blackburn Point Road (County Road (CR) 789) over the Gulf Intracoastal Waterway in Osprey, Sarasota County, Florida. The need for the project is based on the following criteria:

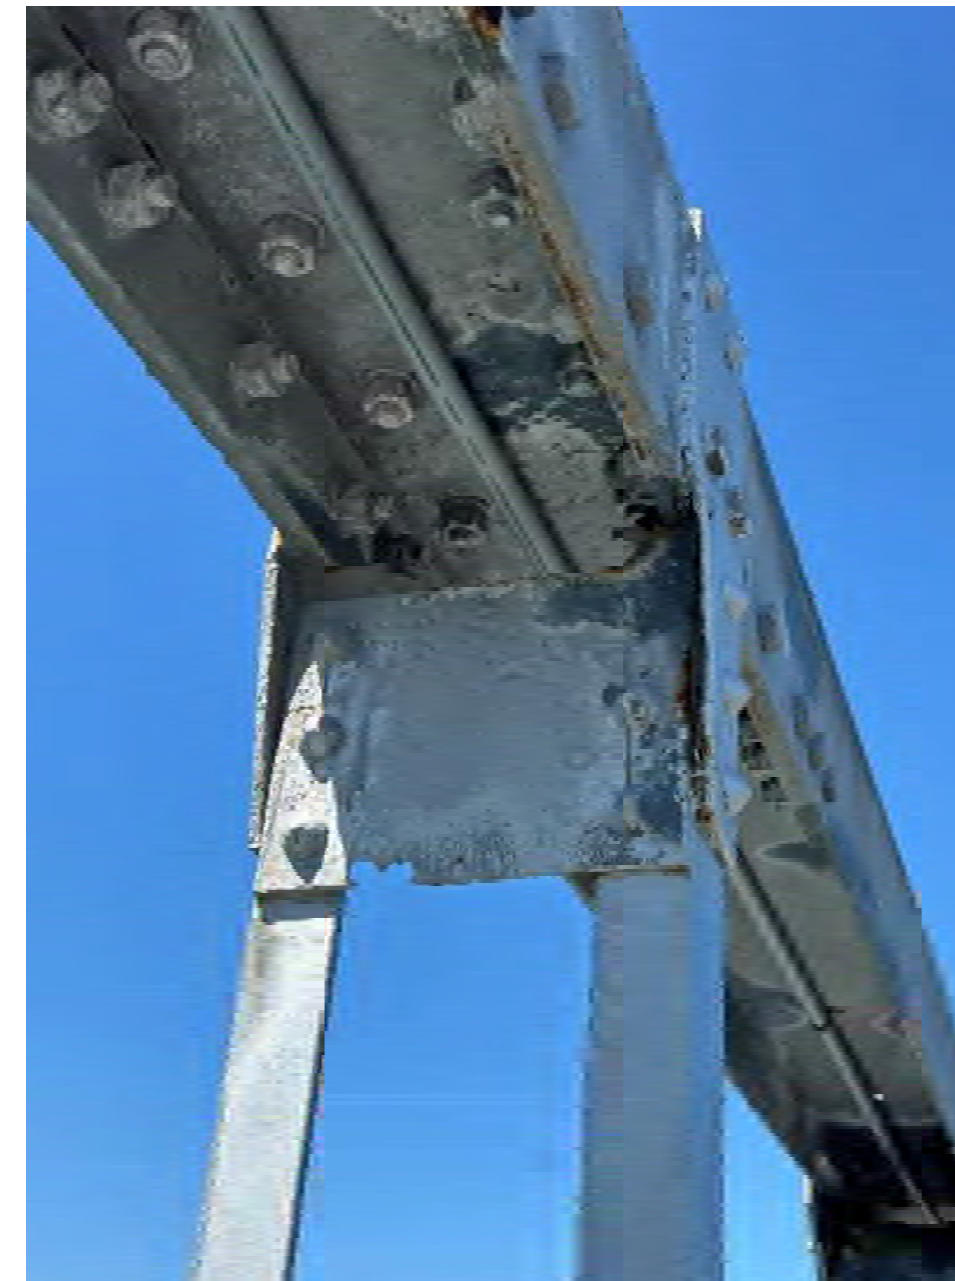
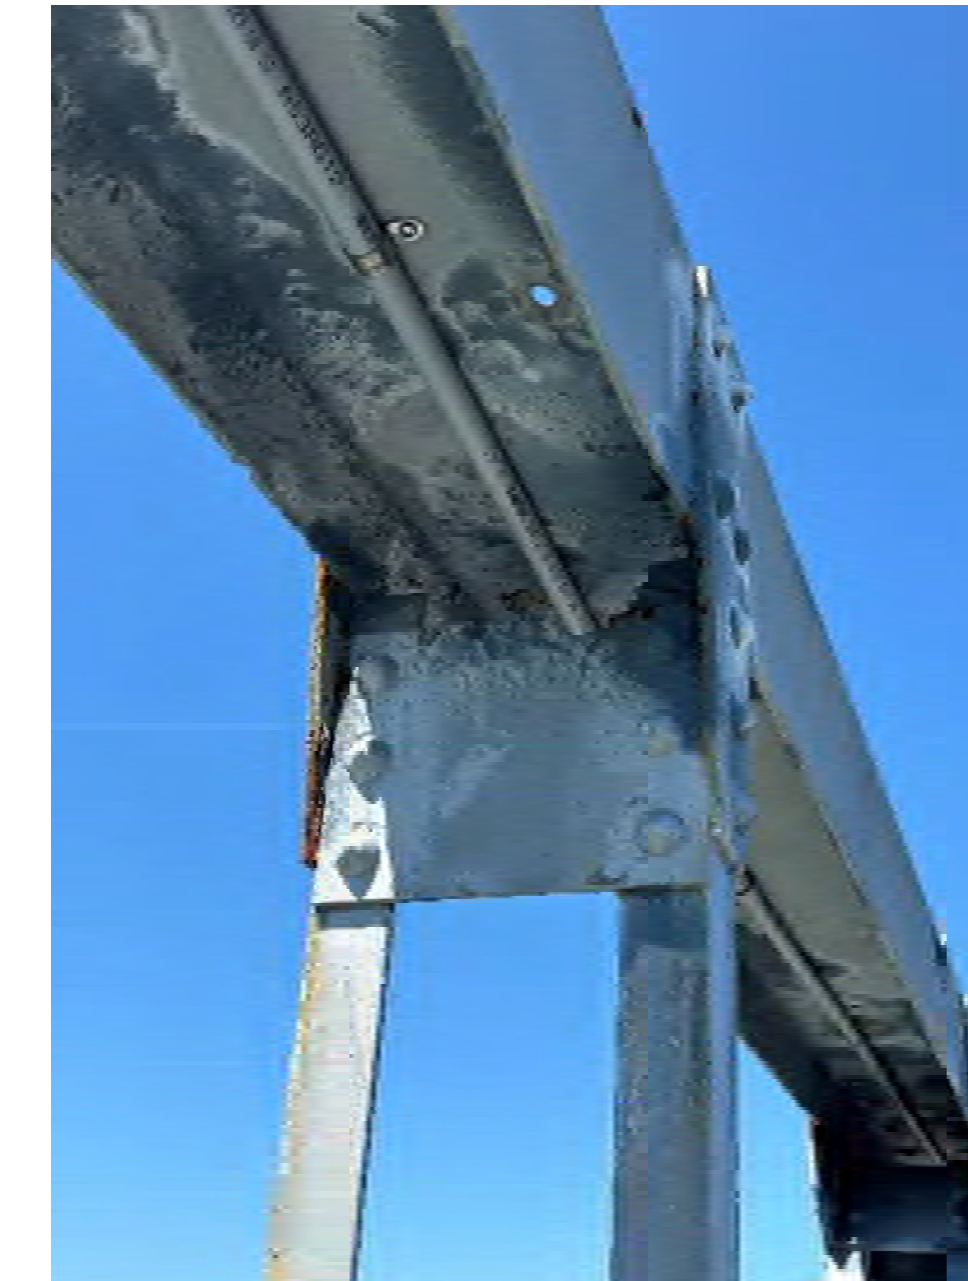
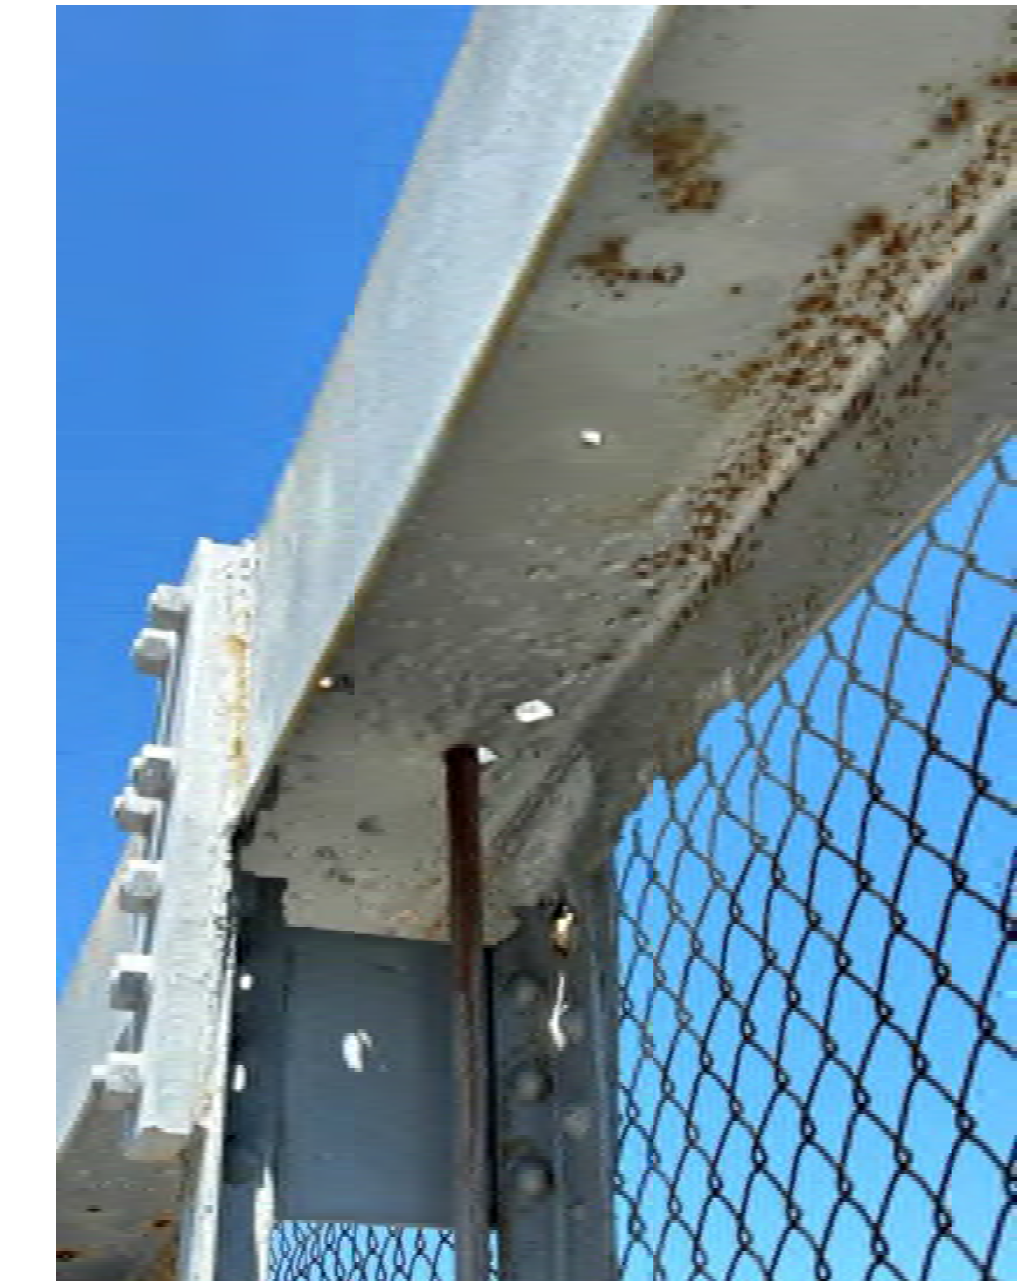
Photographs representative of existing conditions of the swing bridge's main upper truss members

- Steel truss corrosion
- Piling deterioration
- Fender system deterioration & impact damage

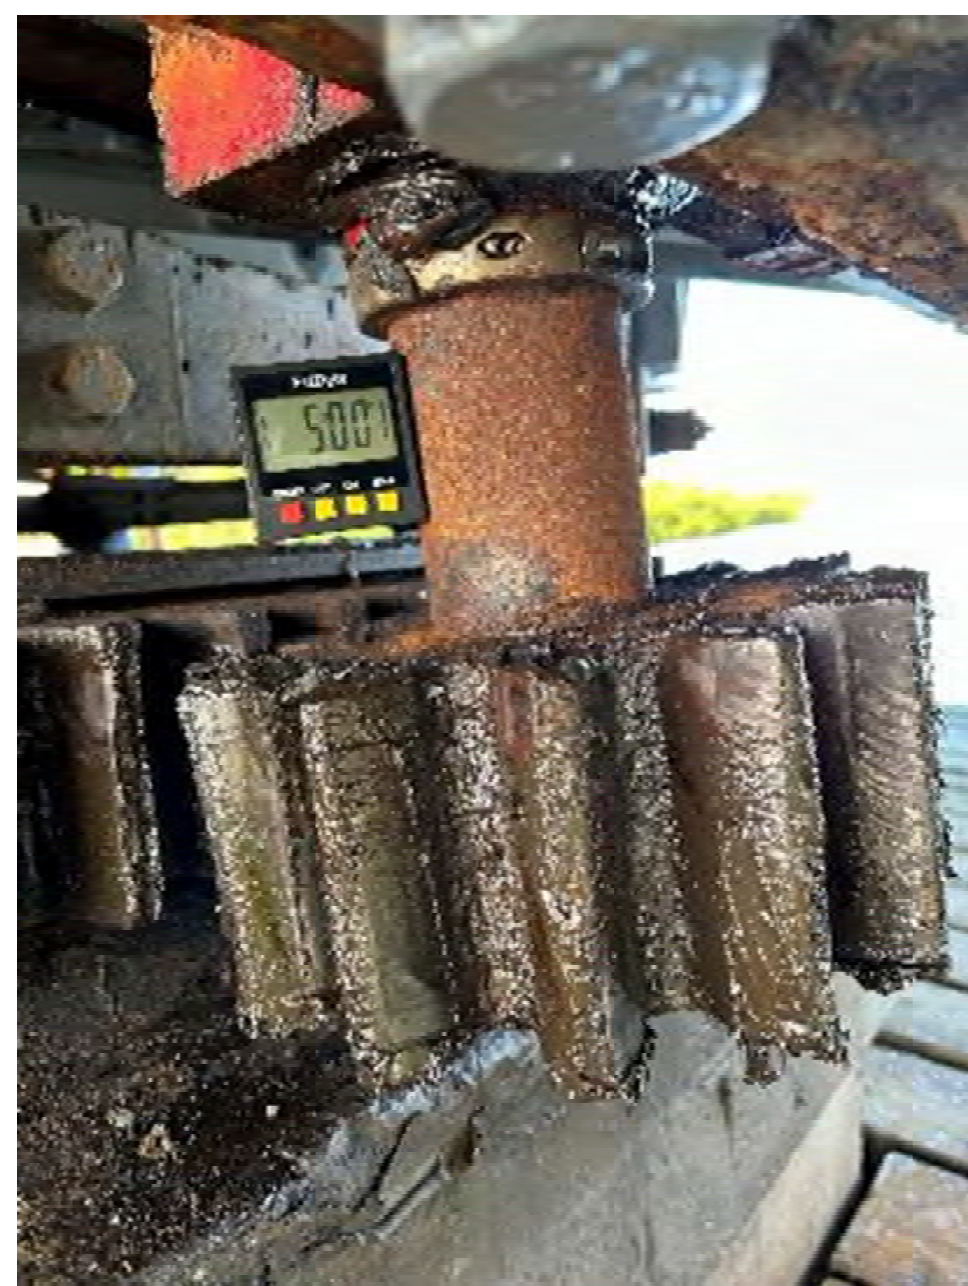
Bent Main Pinion Gear Shaft

- Pinion shaft was replaced three (3) times in the past four (4) years
- Fender system repairs
- Structural repairs

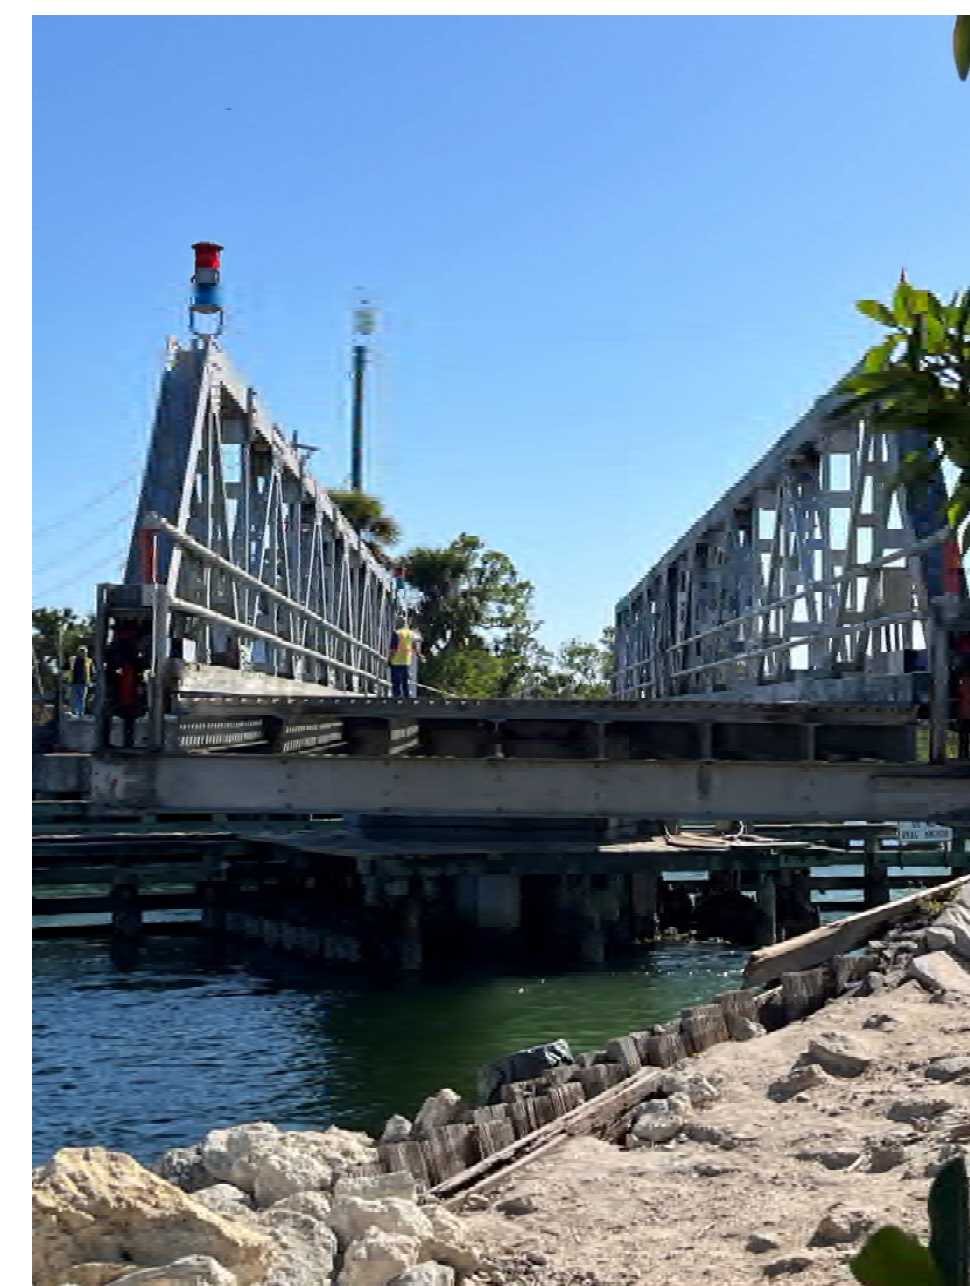
Failing Timber Retaining Wall

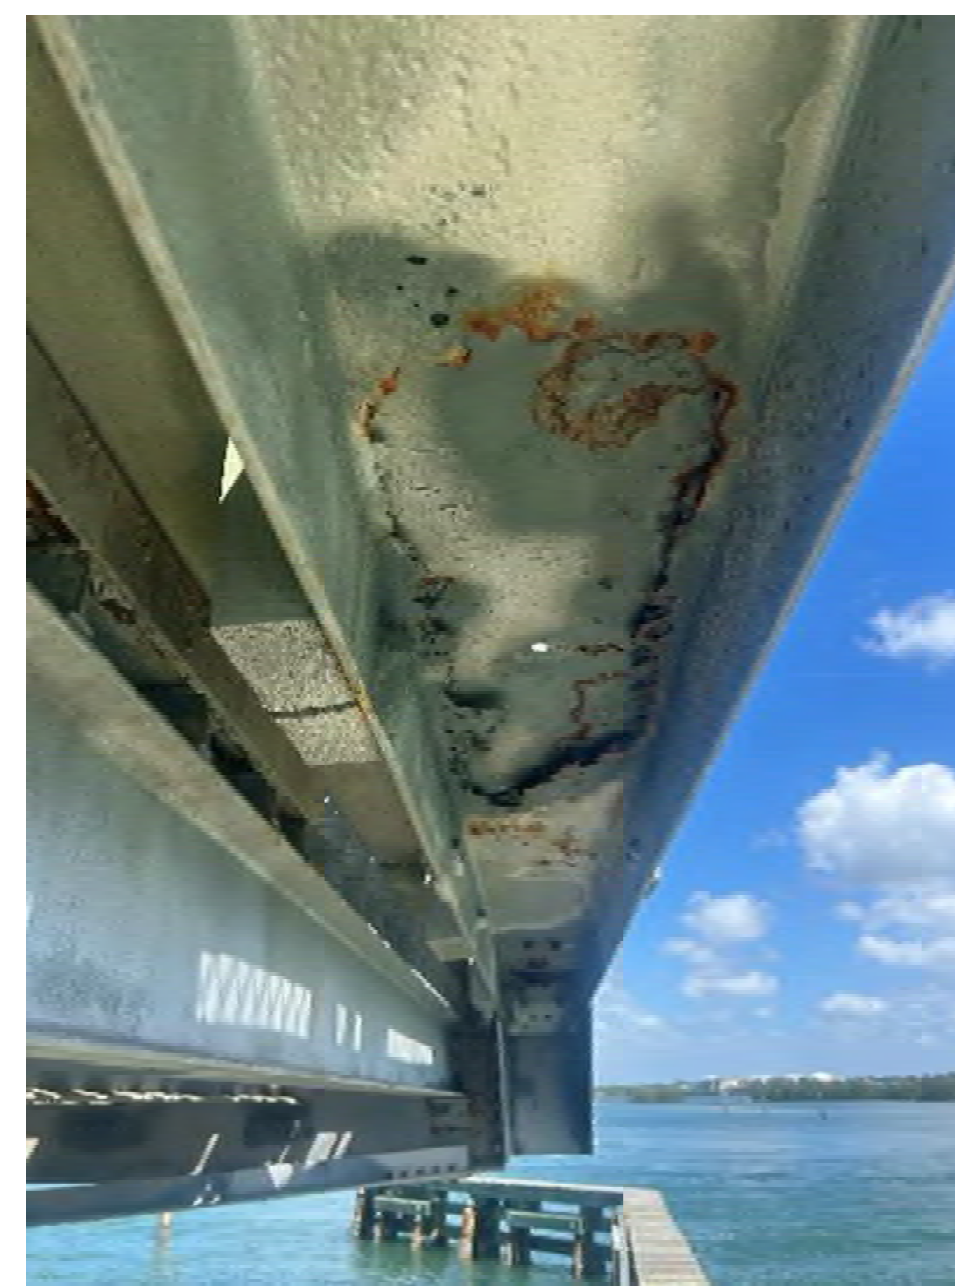
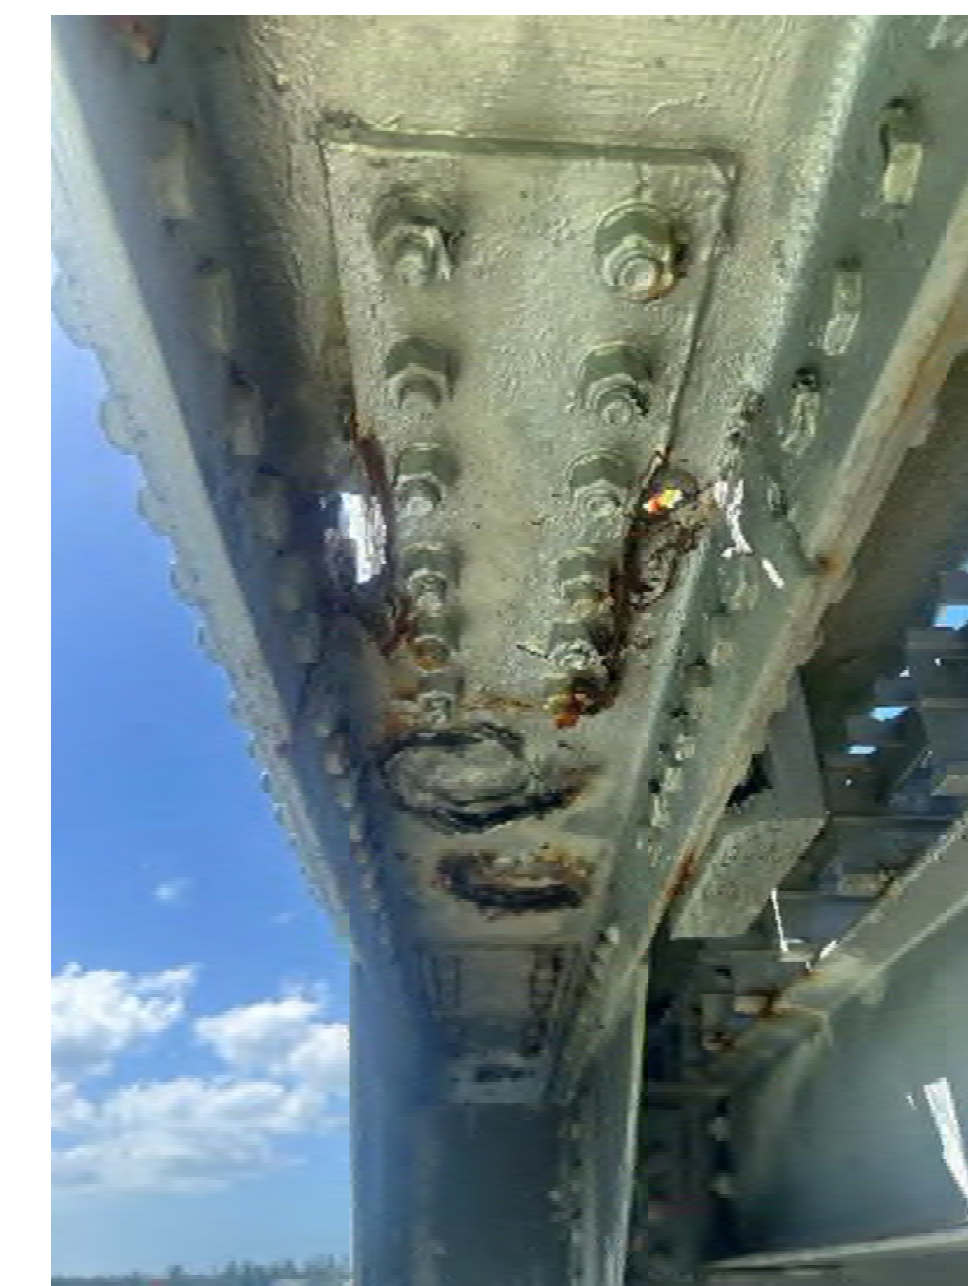
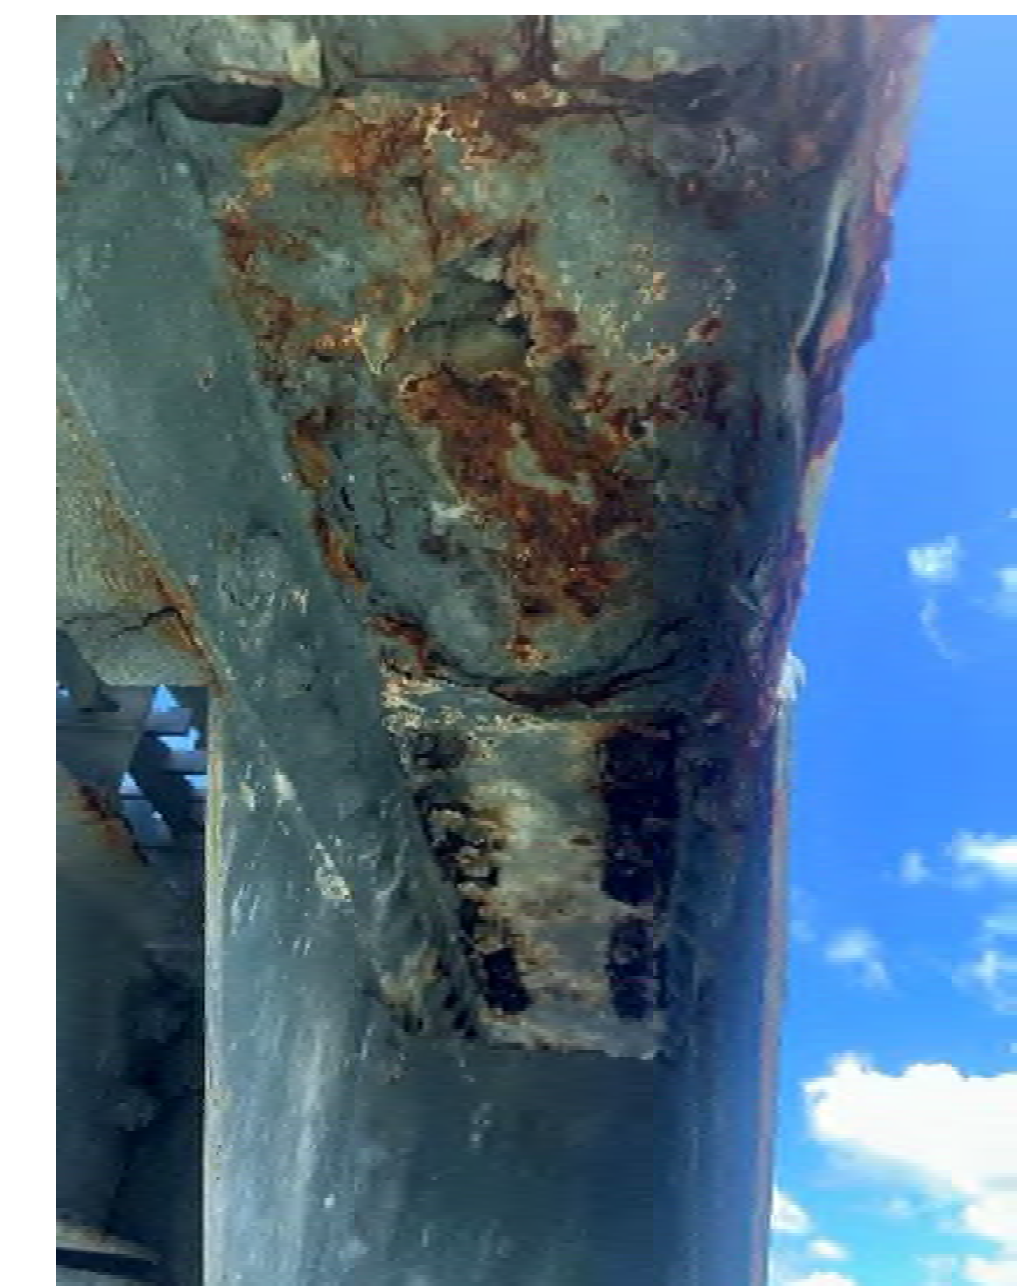
Photographs representative of existing conditions of the swing bridge's main lower truss members

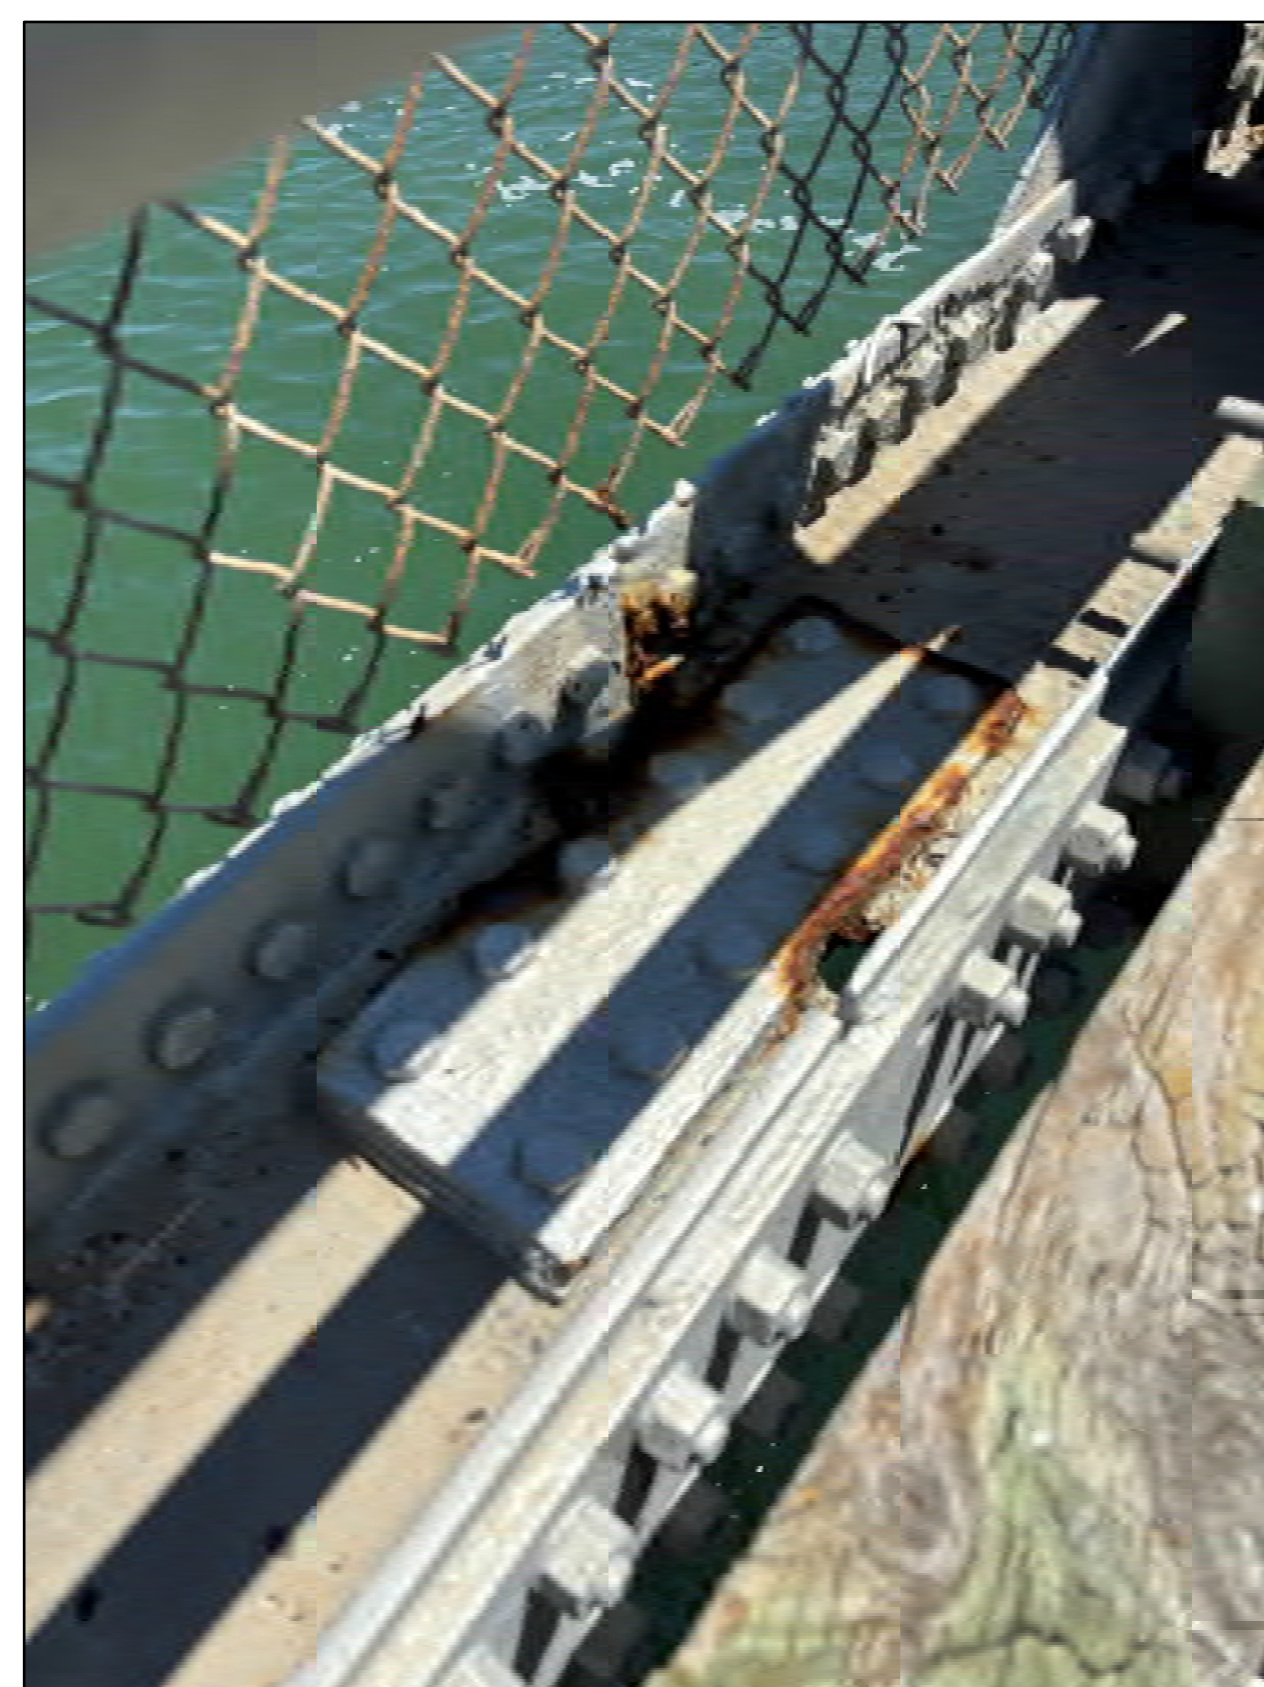
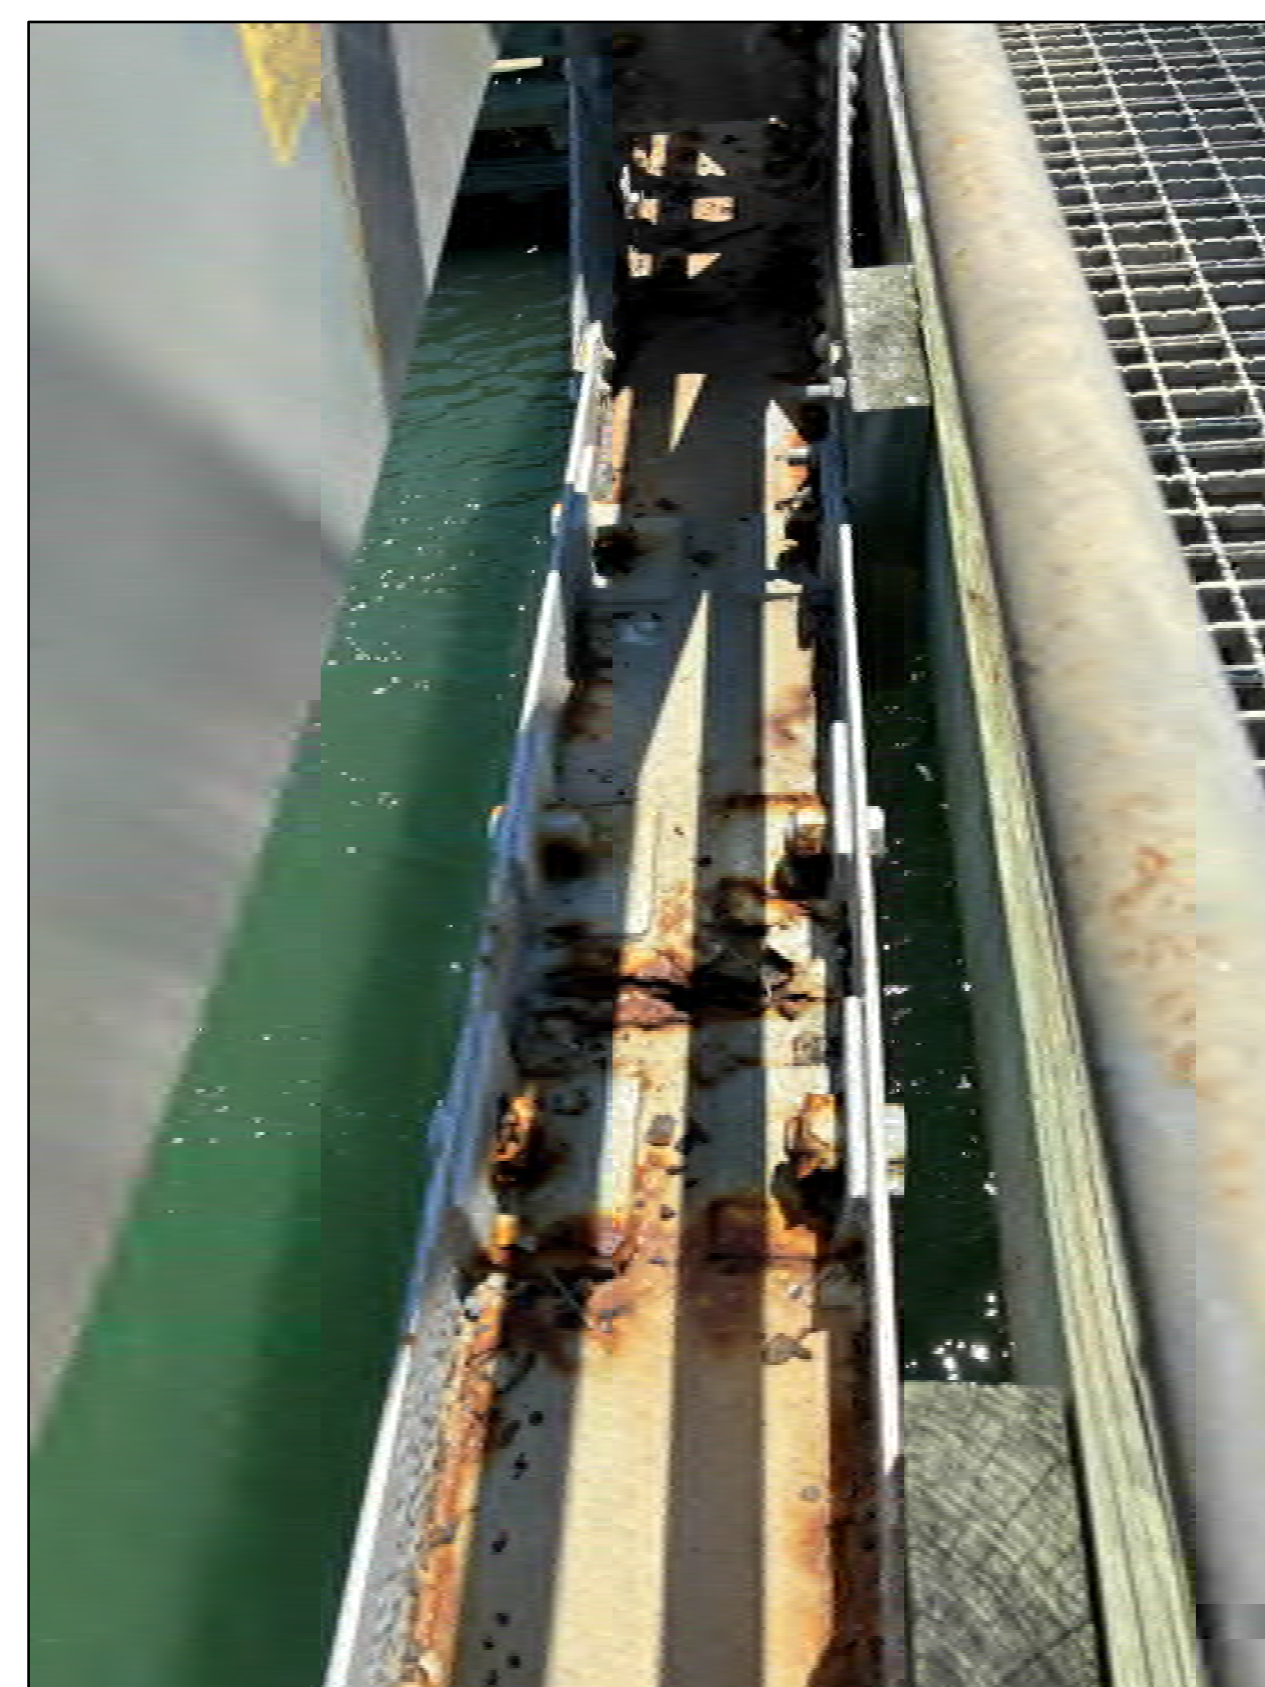
Prior truss repairs exhibiting corrosive section loss

Note: Deteriorated truss members subjected to cyclical tension under truck loading are susceptible to fracture

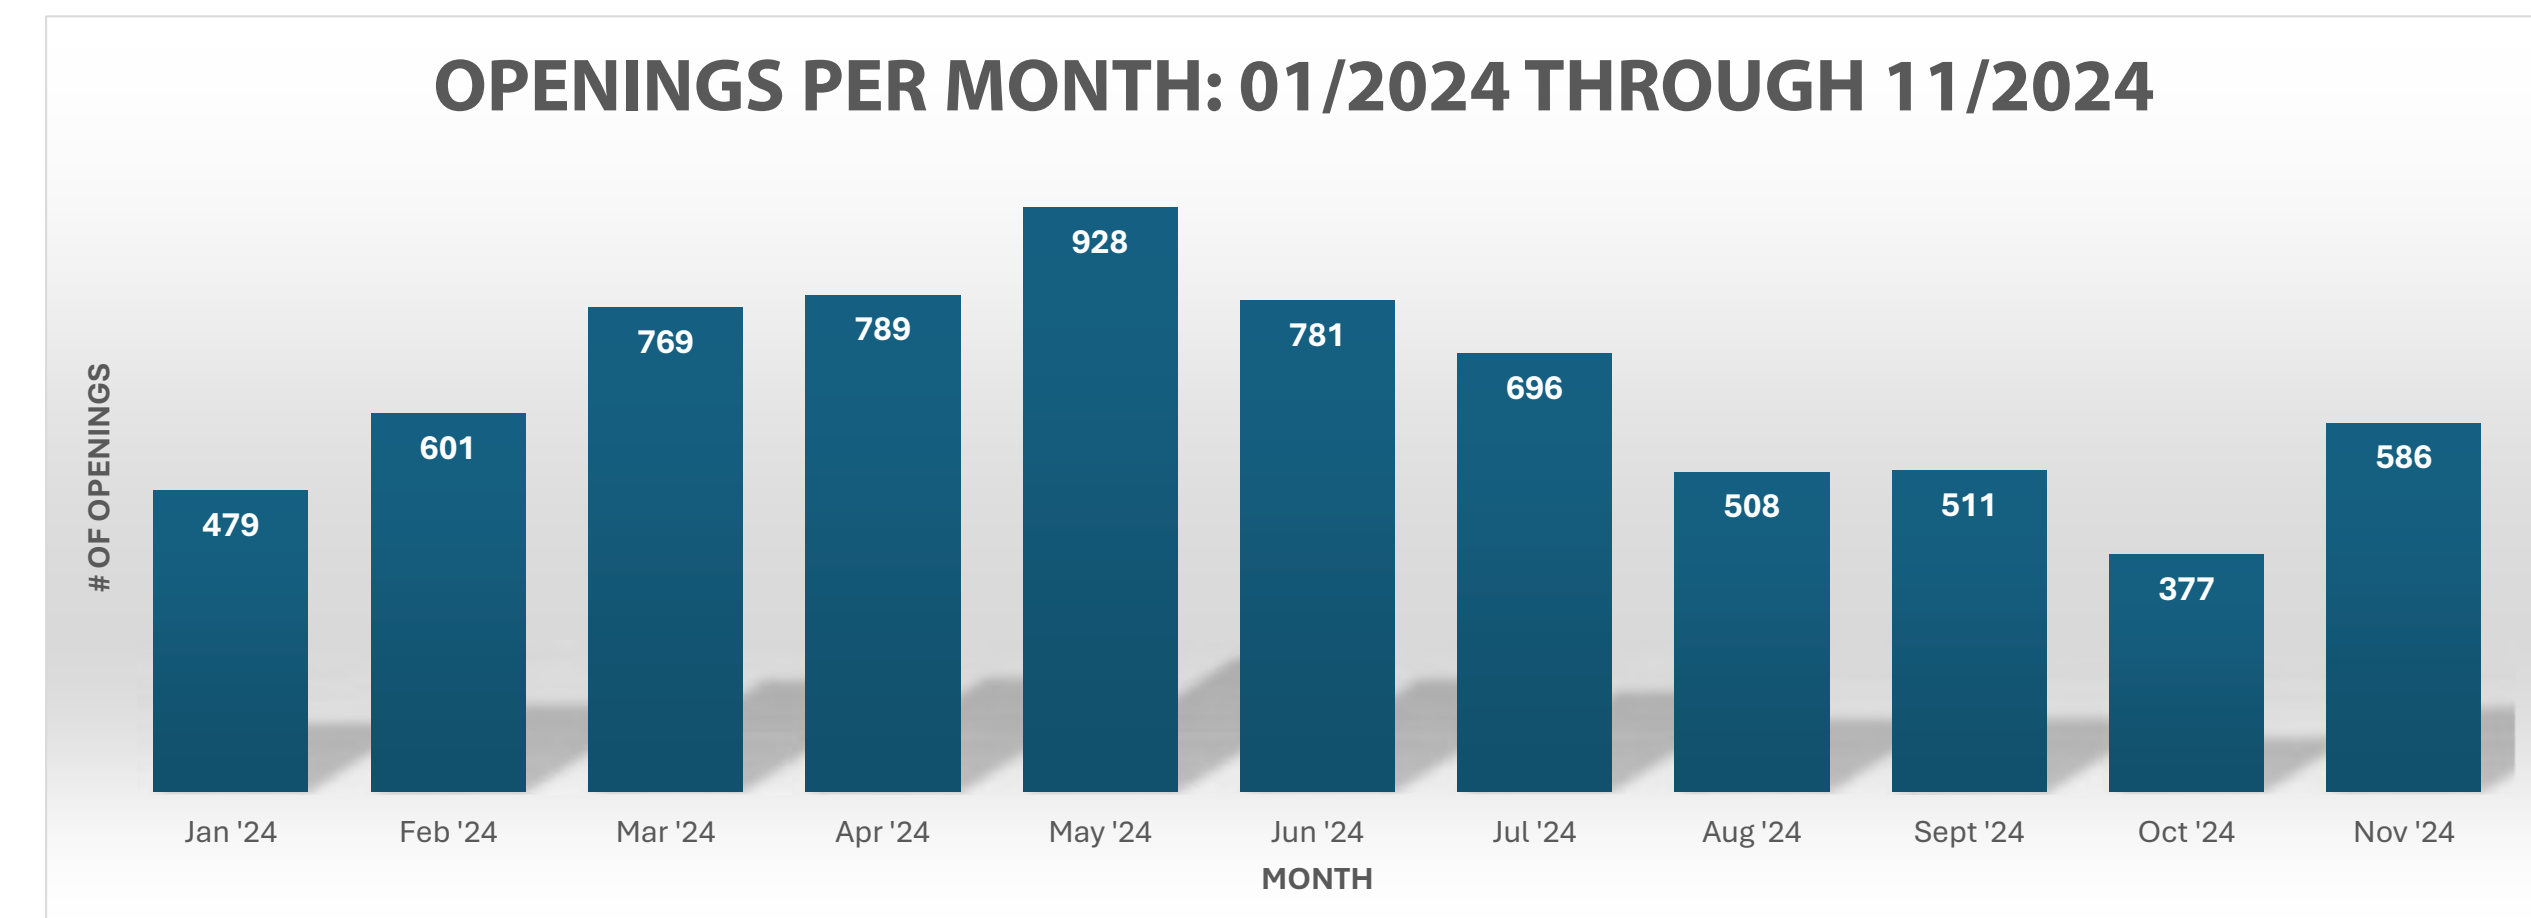
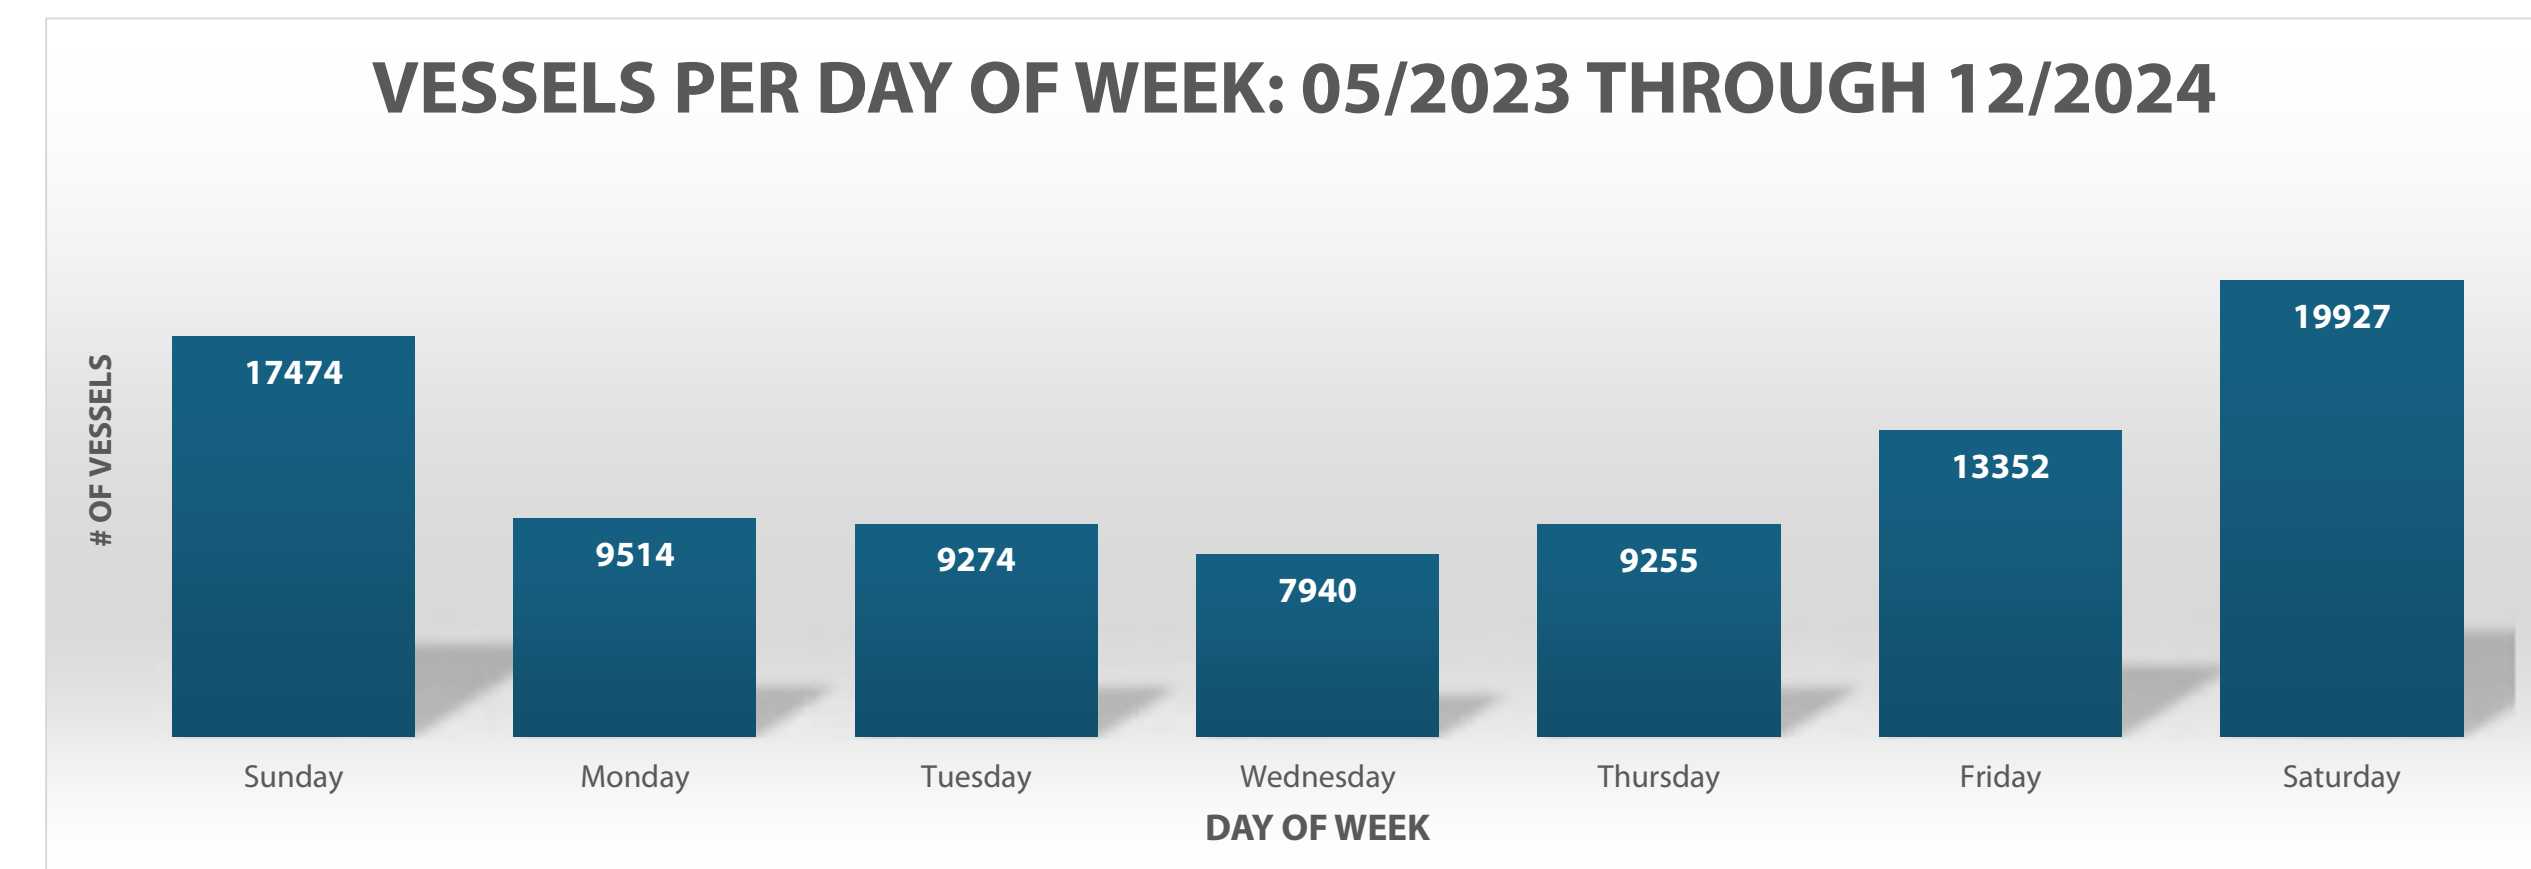
Effect of Increased Vertical Clearance on Bridge Openings

Bridge Clearance	12 Feet	14 Feet	16 Feet	21 Feet
% Reduction in Openings	31%	48%	62%	78%

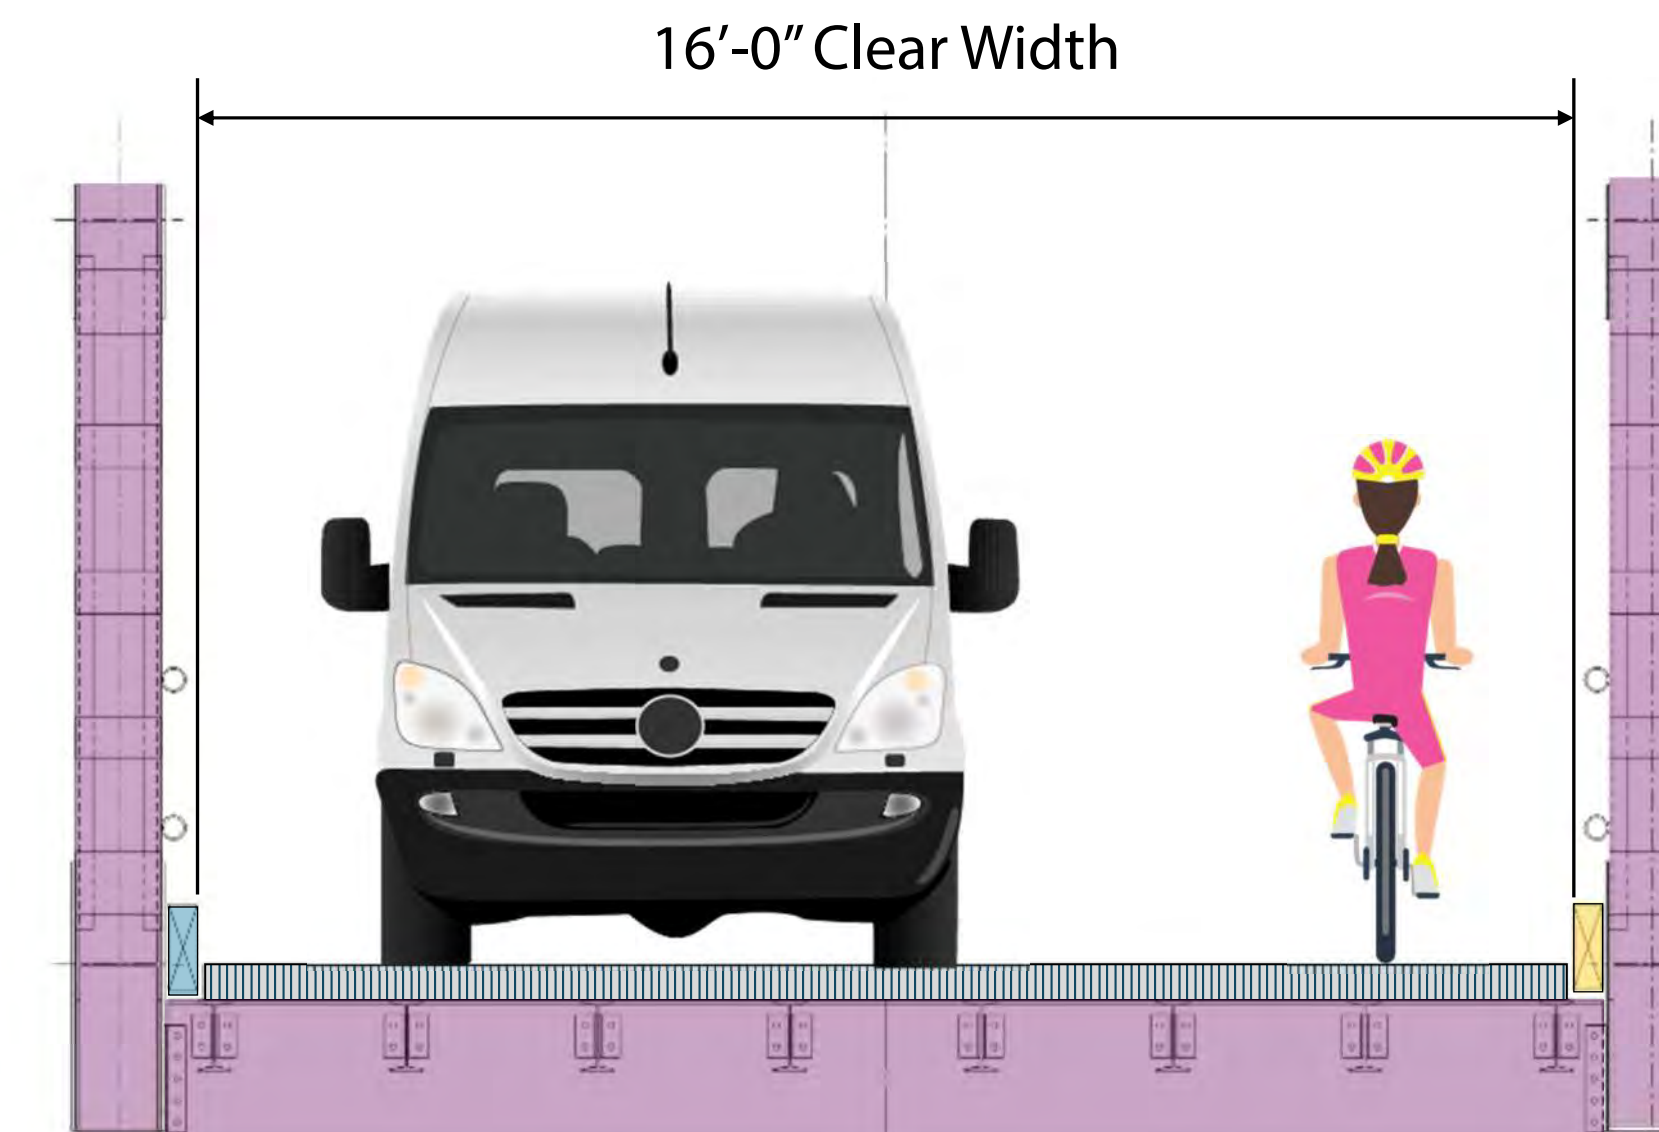
Existing Swing Span Section

Substandard clear roadway width of only one, 16-foot-wide travel lane

The bridge does not feature shoulders, sidewalks or bicycle lanes

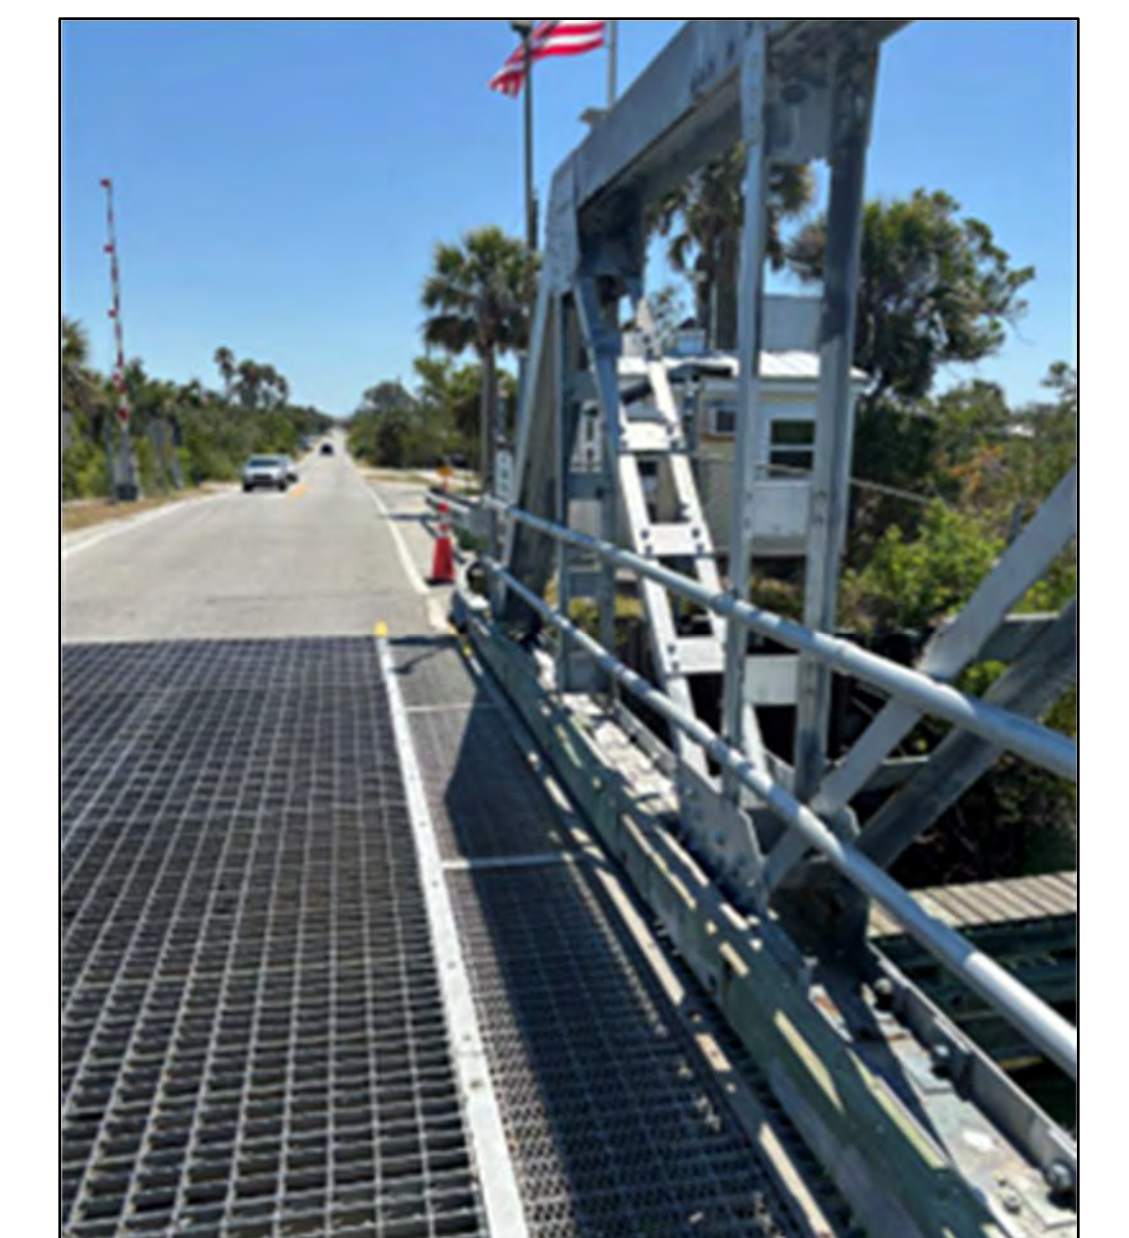
Existing Railing

Existing bridge railings do not meet current standards for pedestrians or bicyclists.

Existing bridge railings do not meet current geometric and crash testing safety standards for vehicles.
