TO THE ALTERNATIVES PUBLIC MEETING FOR THE BLACKBURN POINT BRIDGE REPLACEMENT STUDY

Purpose and Need: The purpose of the project is to review alternatives to replace the Blackburn Point Bridge (Bridge No. 170064) on Blackburn Point Road (County Road (CR) 789) over the Gulf Intracoastal Waterway in Osprey, Sarasota County, Florida. The need for the project is based on the following criteria:

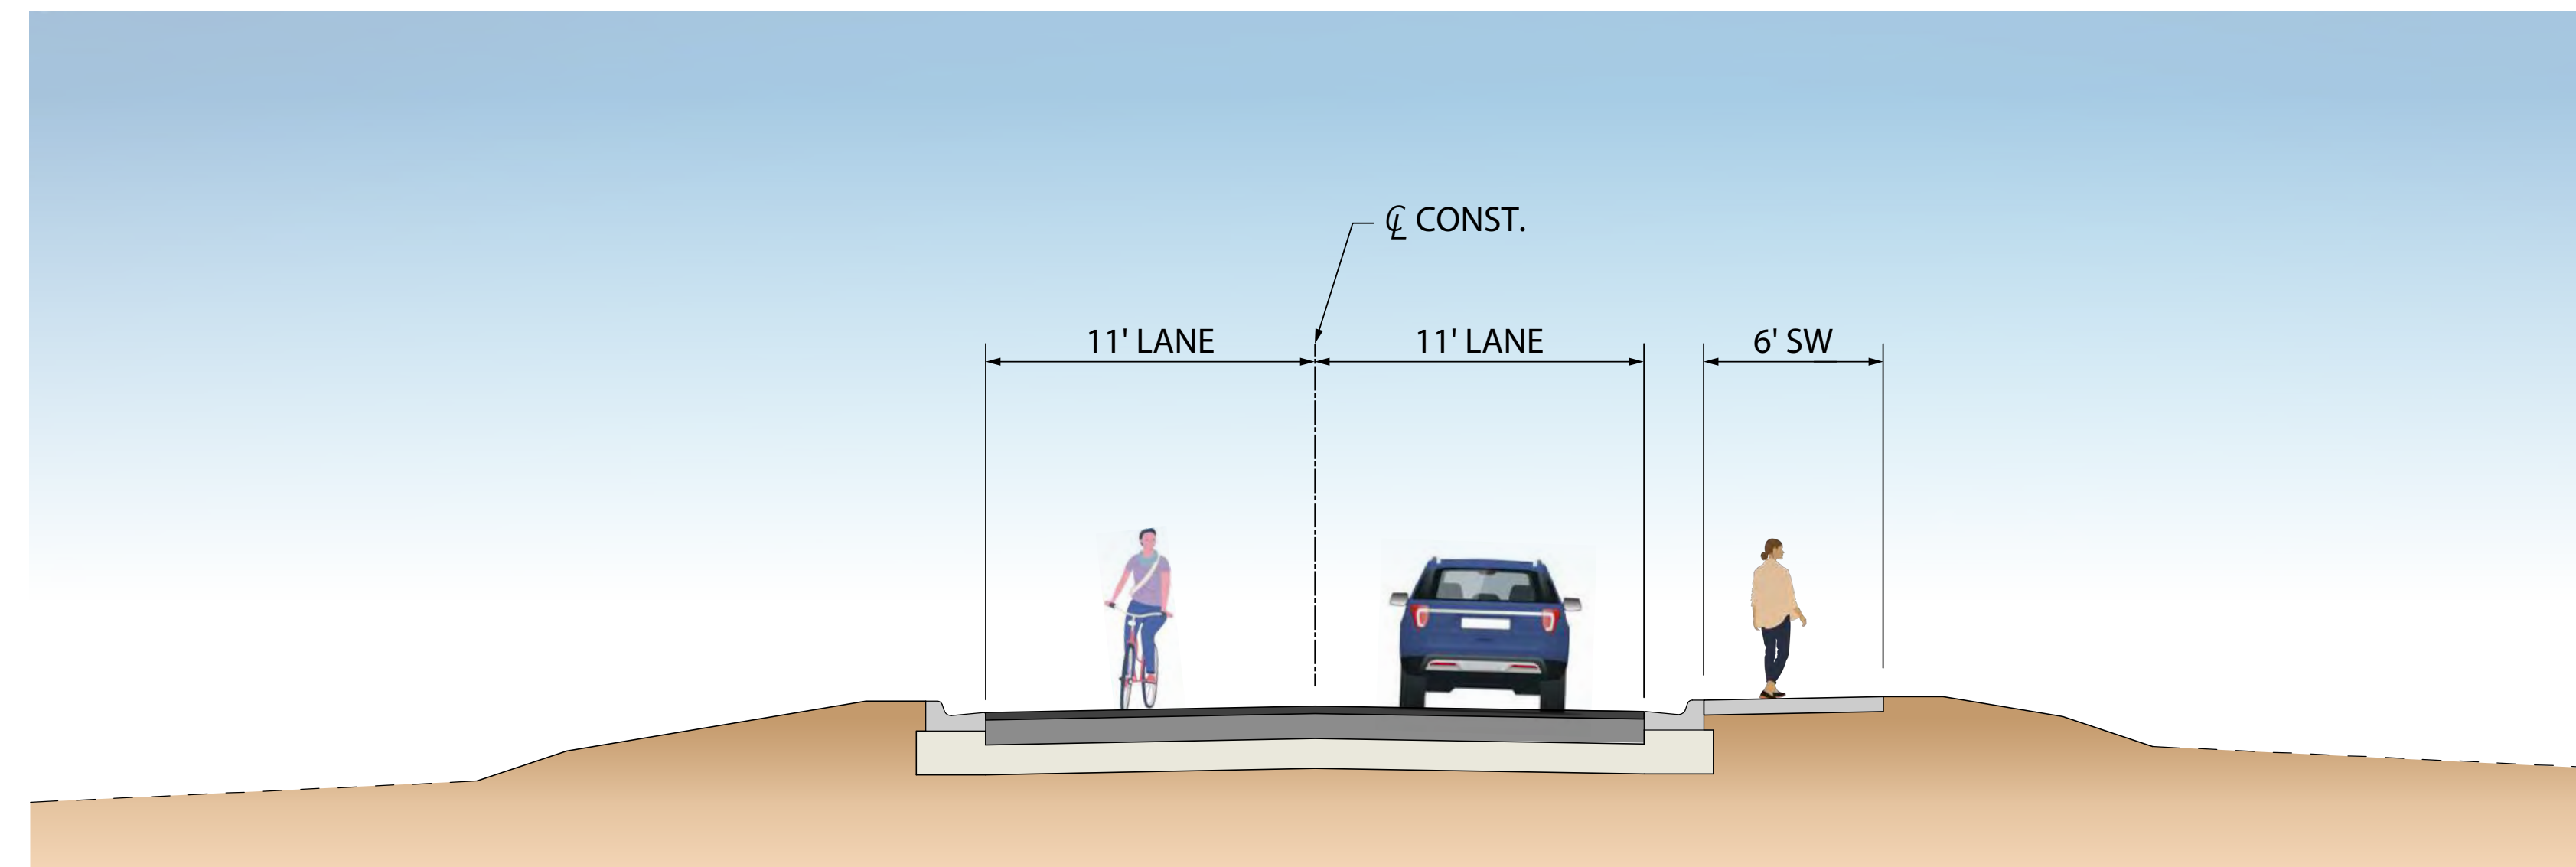
ROADWAY APPROACH

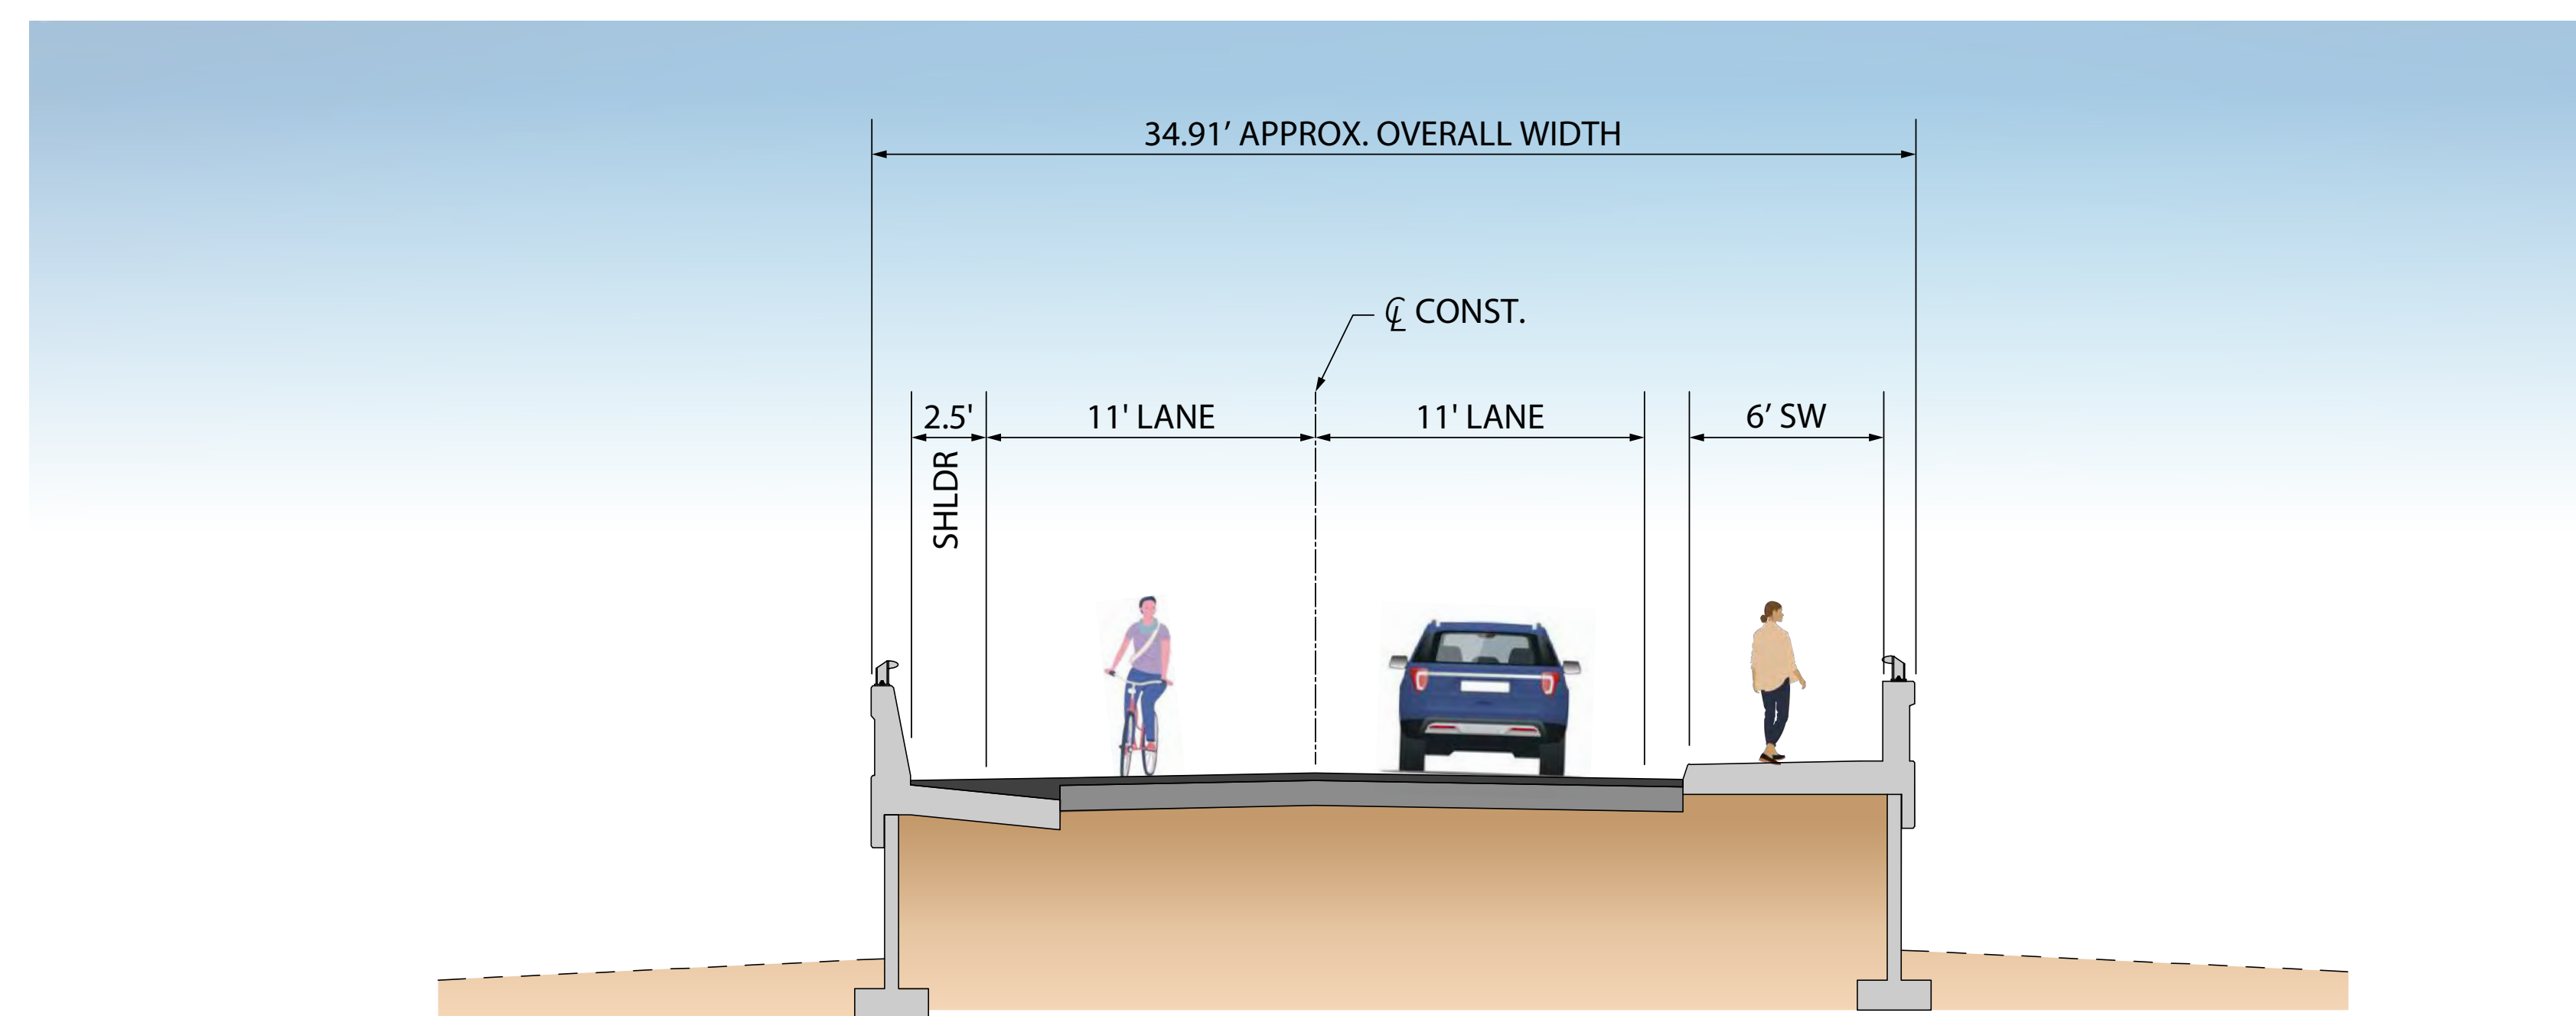
BRIDGE APPROACH

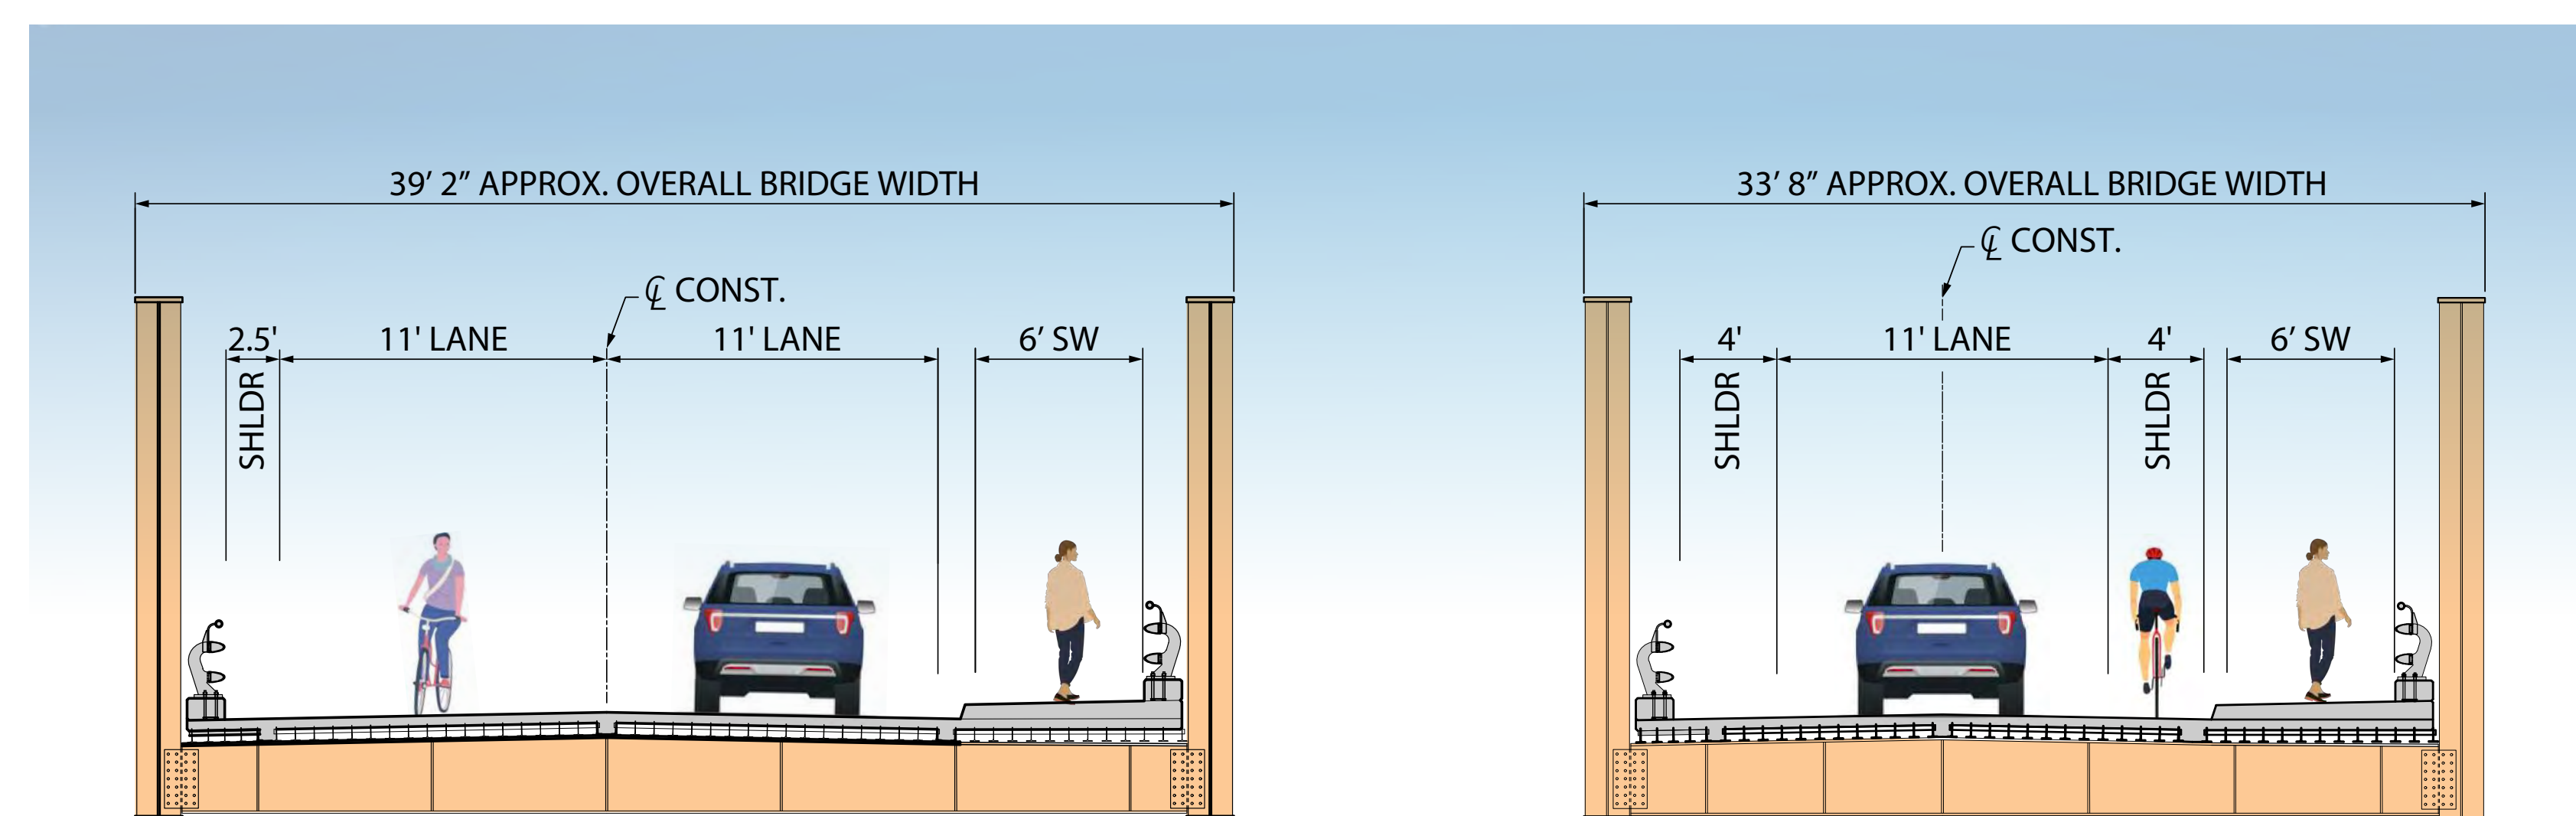
TWO LANE BRIDGE

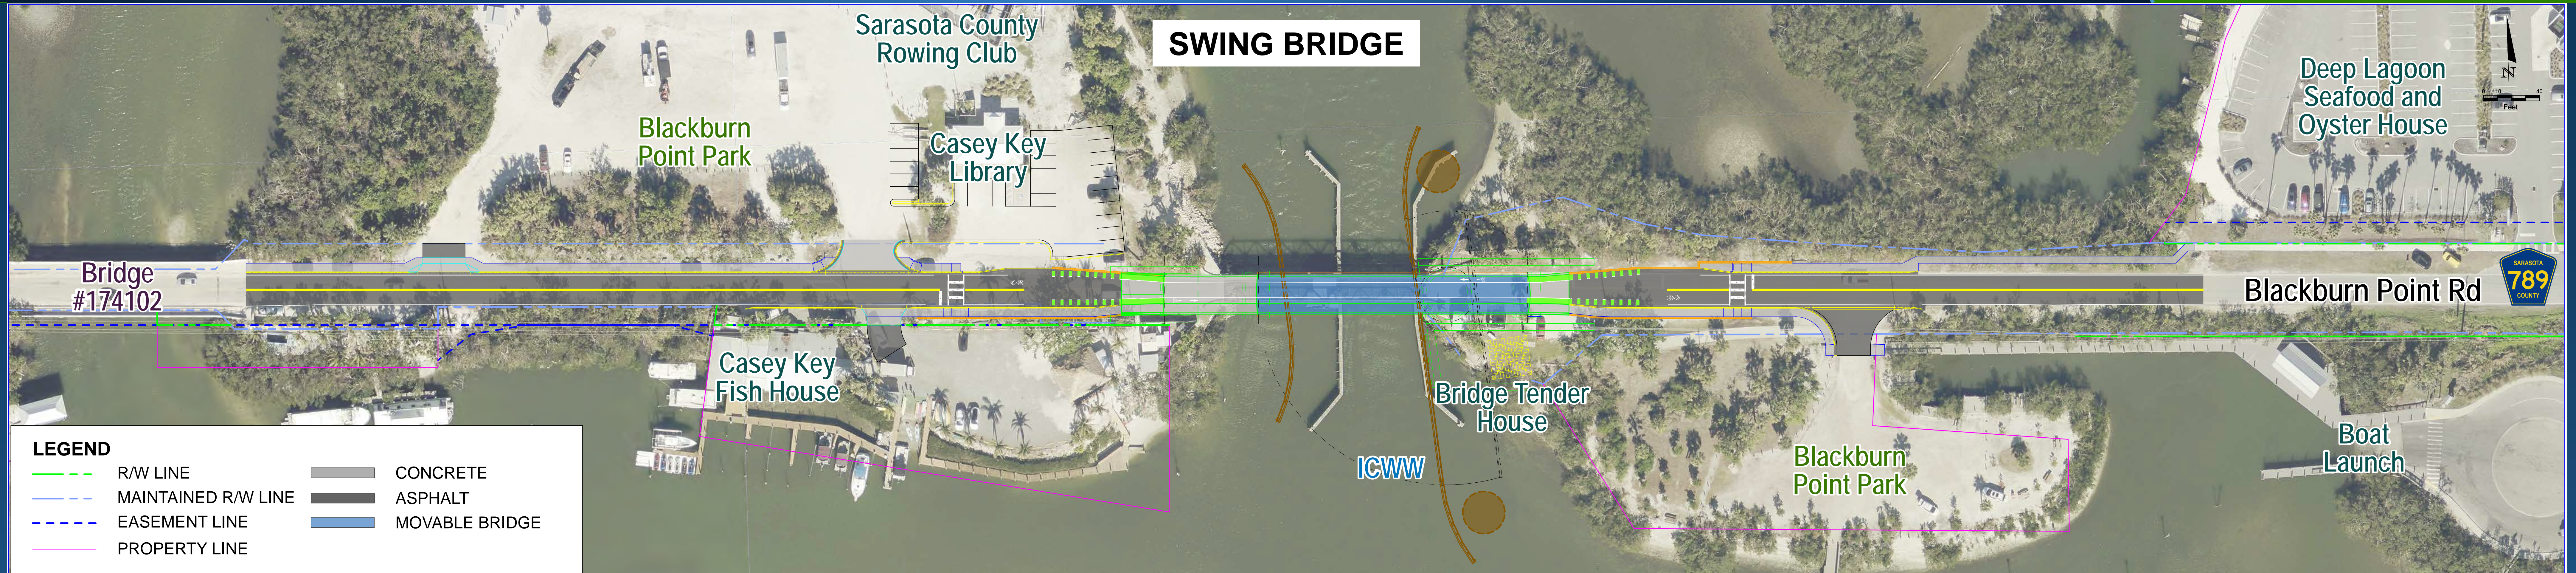
SINGLE-LANE BRIDGE ALTERNATIVES

Profile options are limited by adjacent driveways

- 14 feet vertical clearance on Existing Alignment
- The new roadway is approximately 5'-0" to 5'-6" higher than the existing at bridge ends

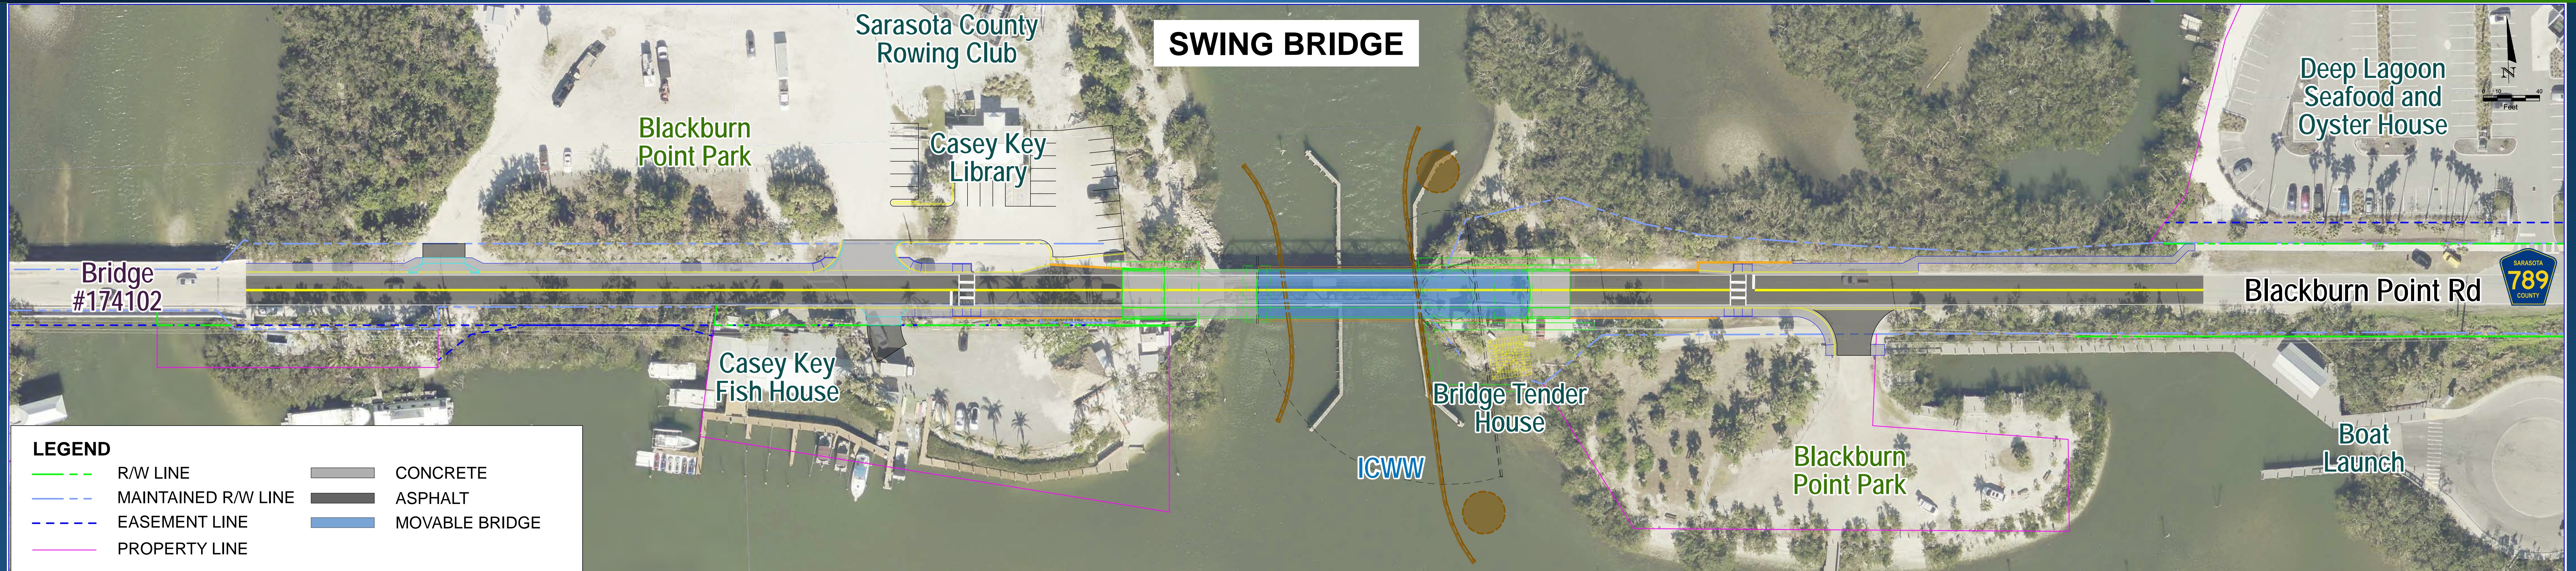
TWO-LANE BRIDGE ALTERNATIVES

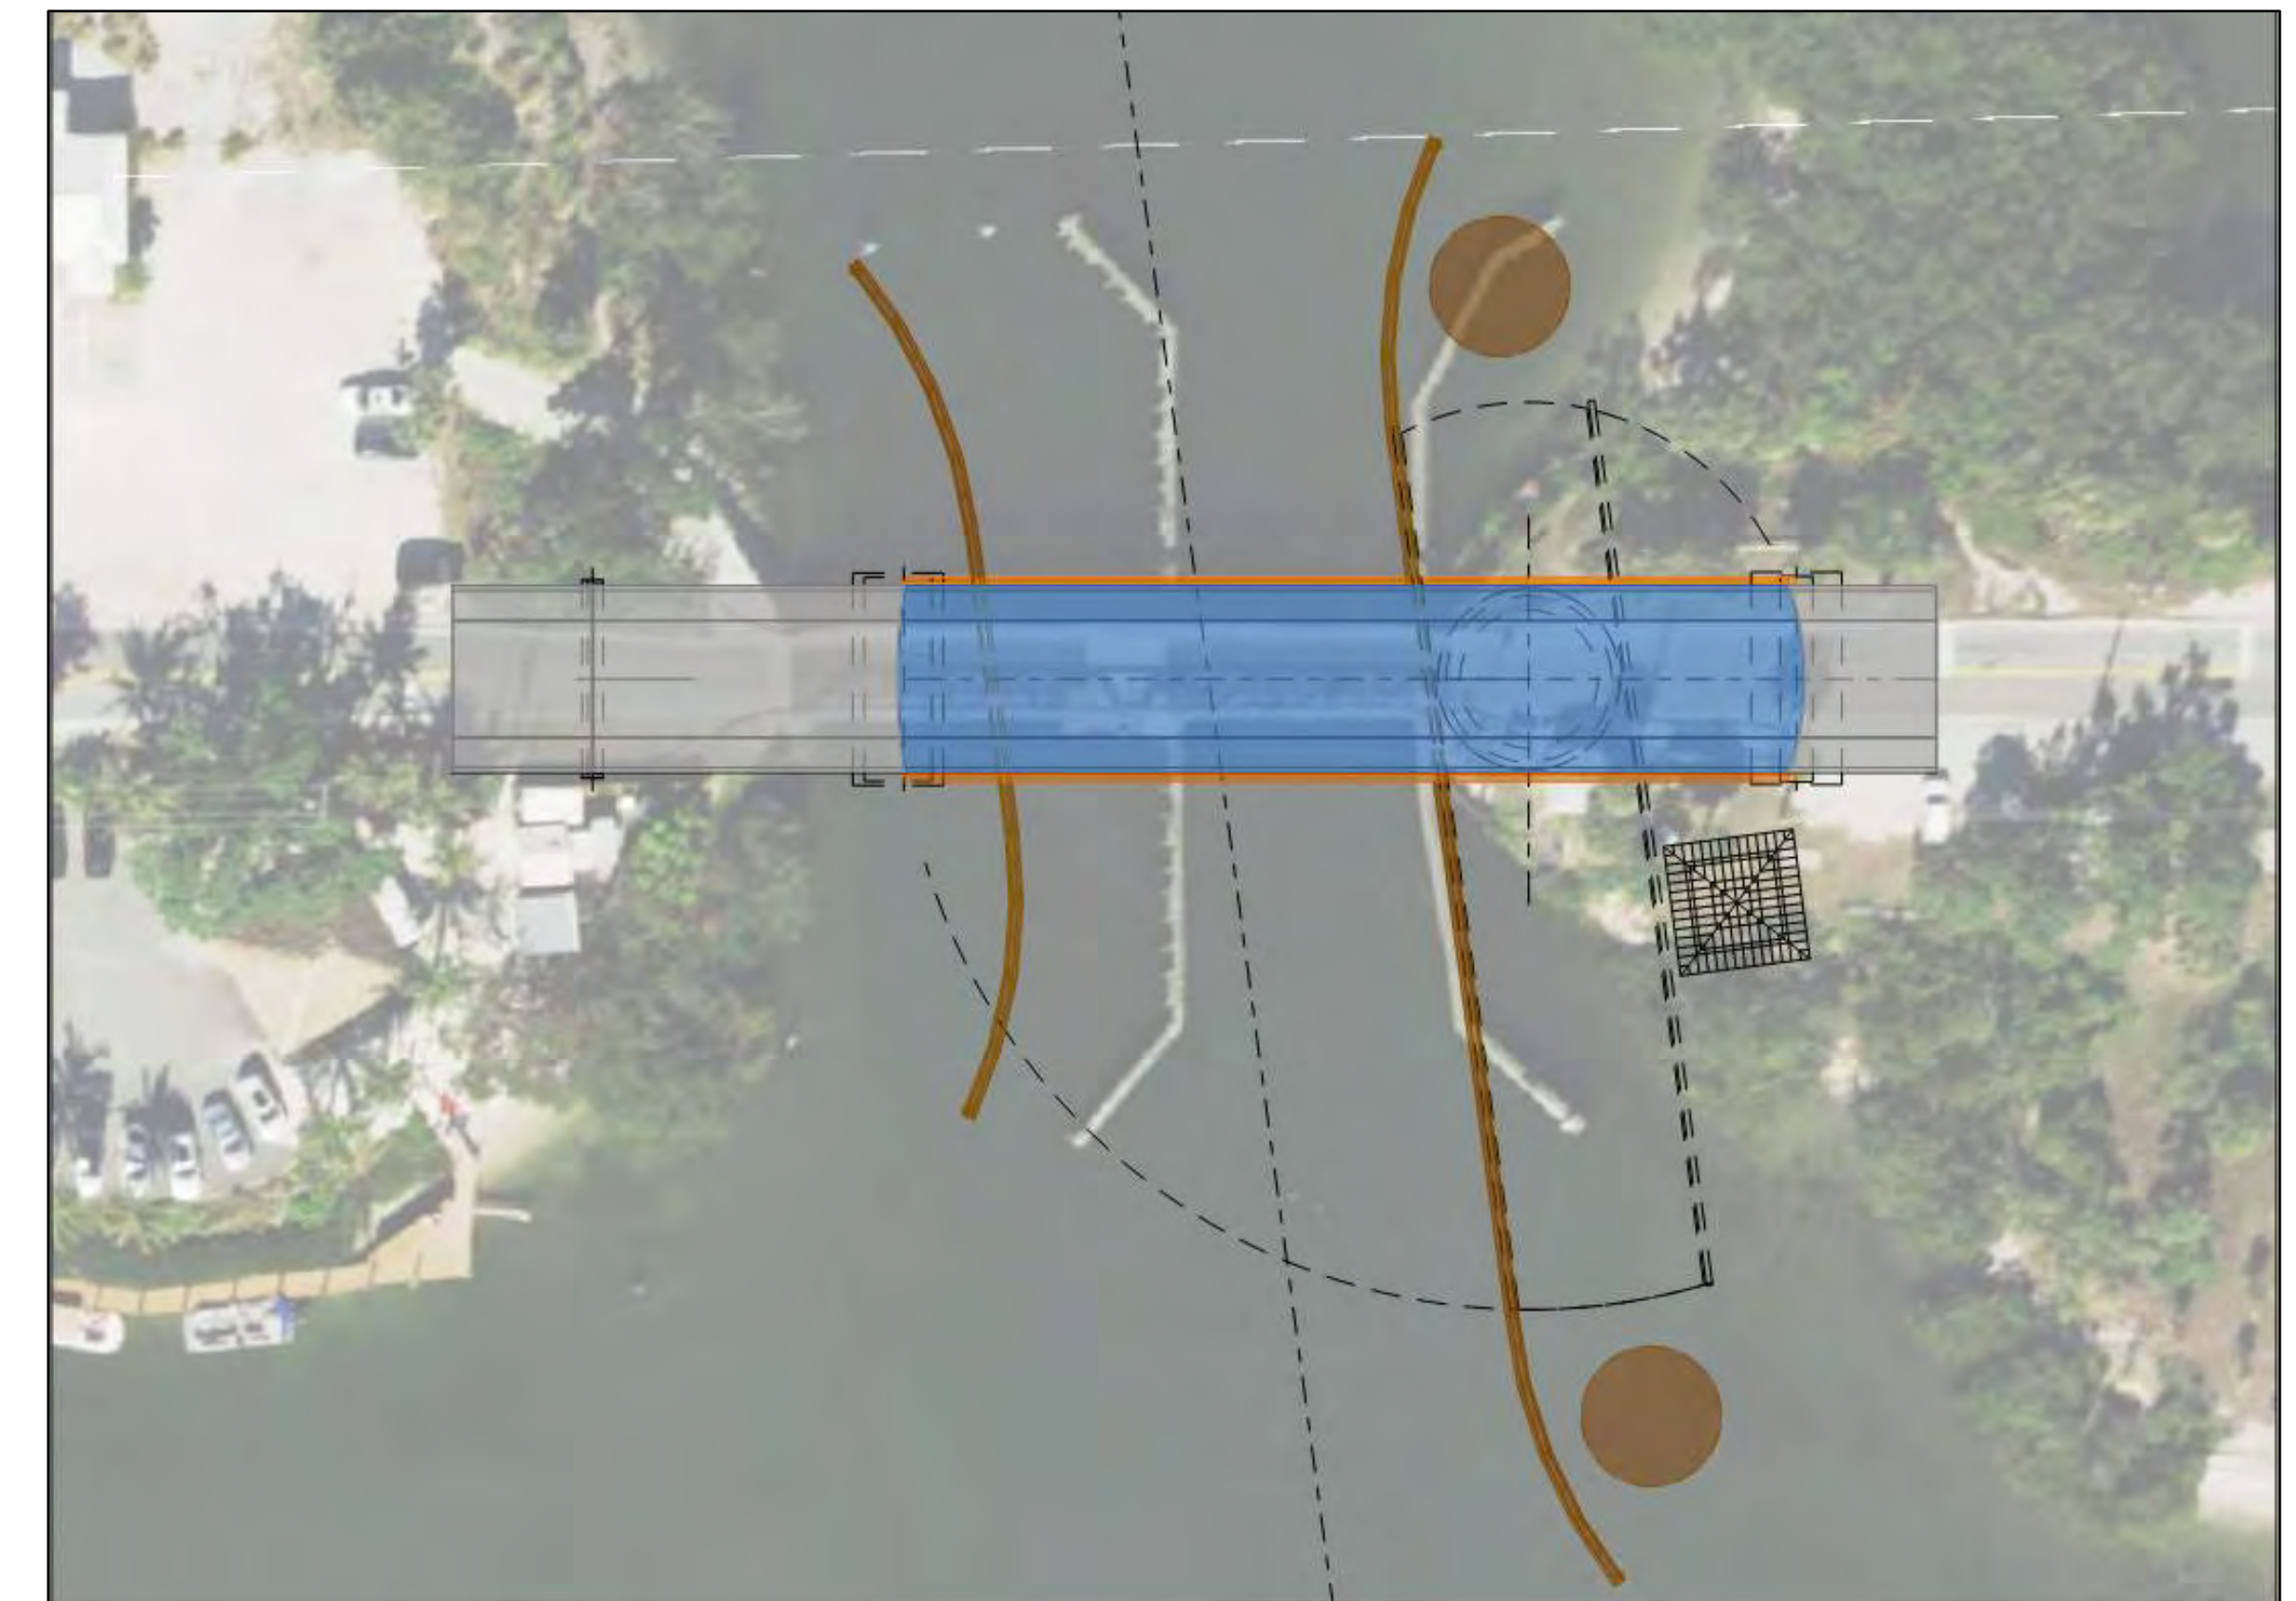
Swing Span on Existing alignment

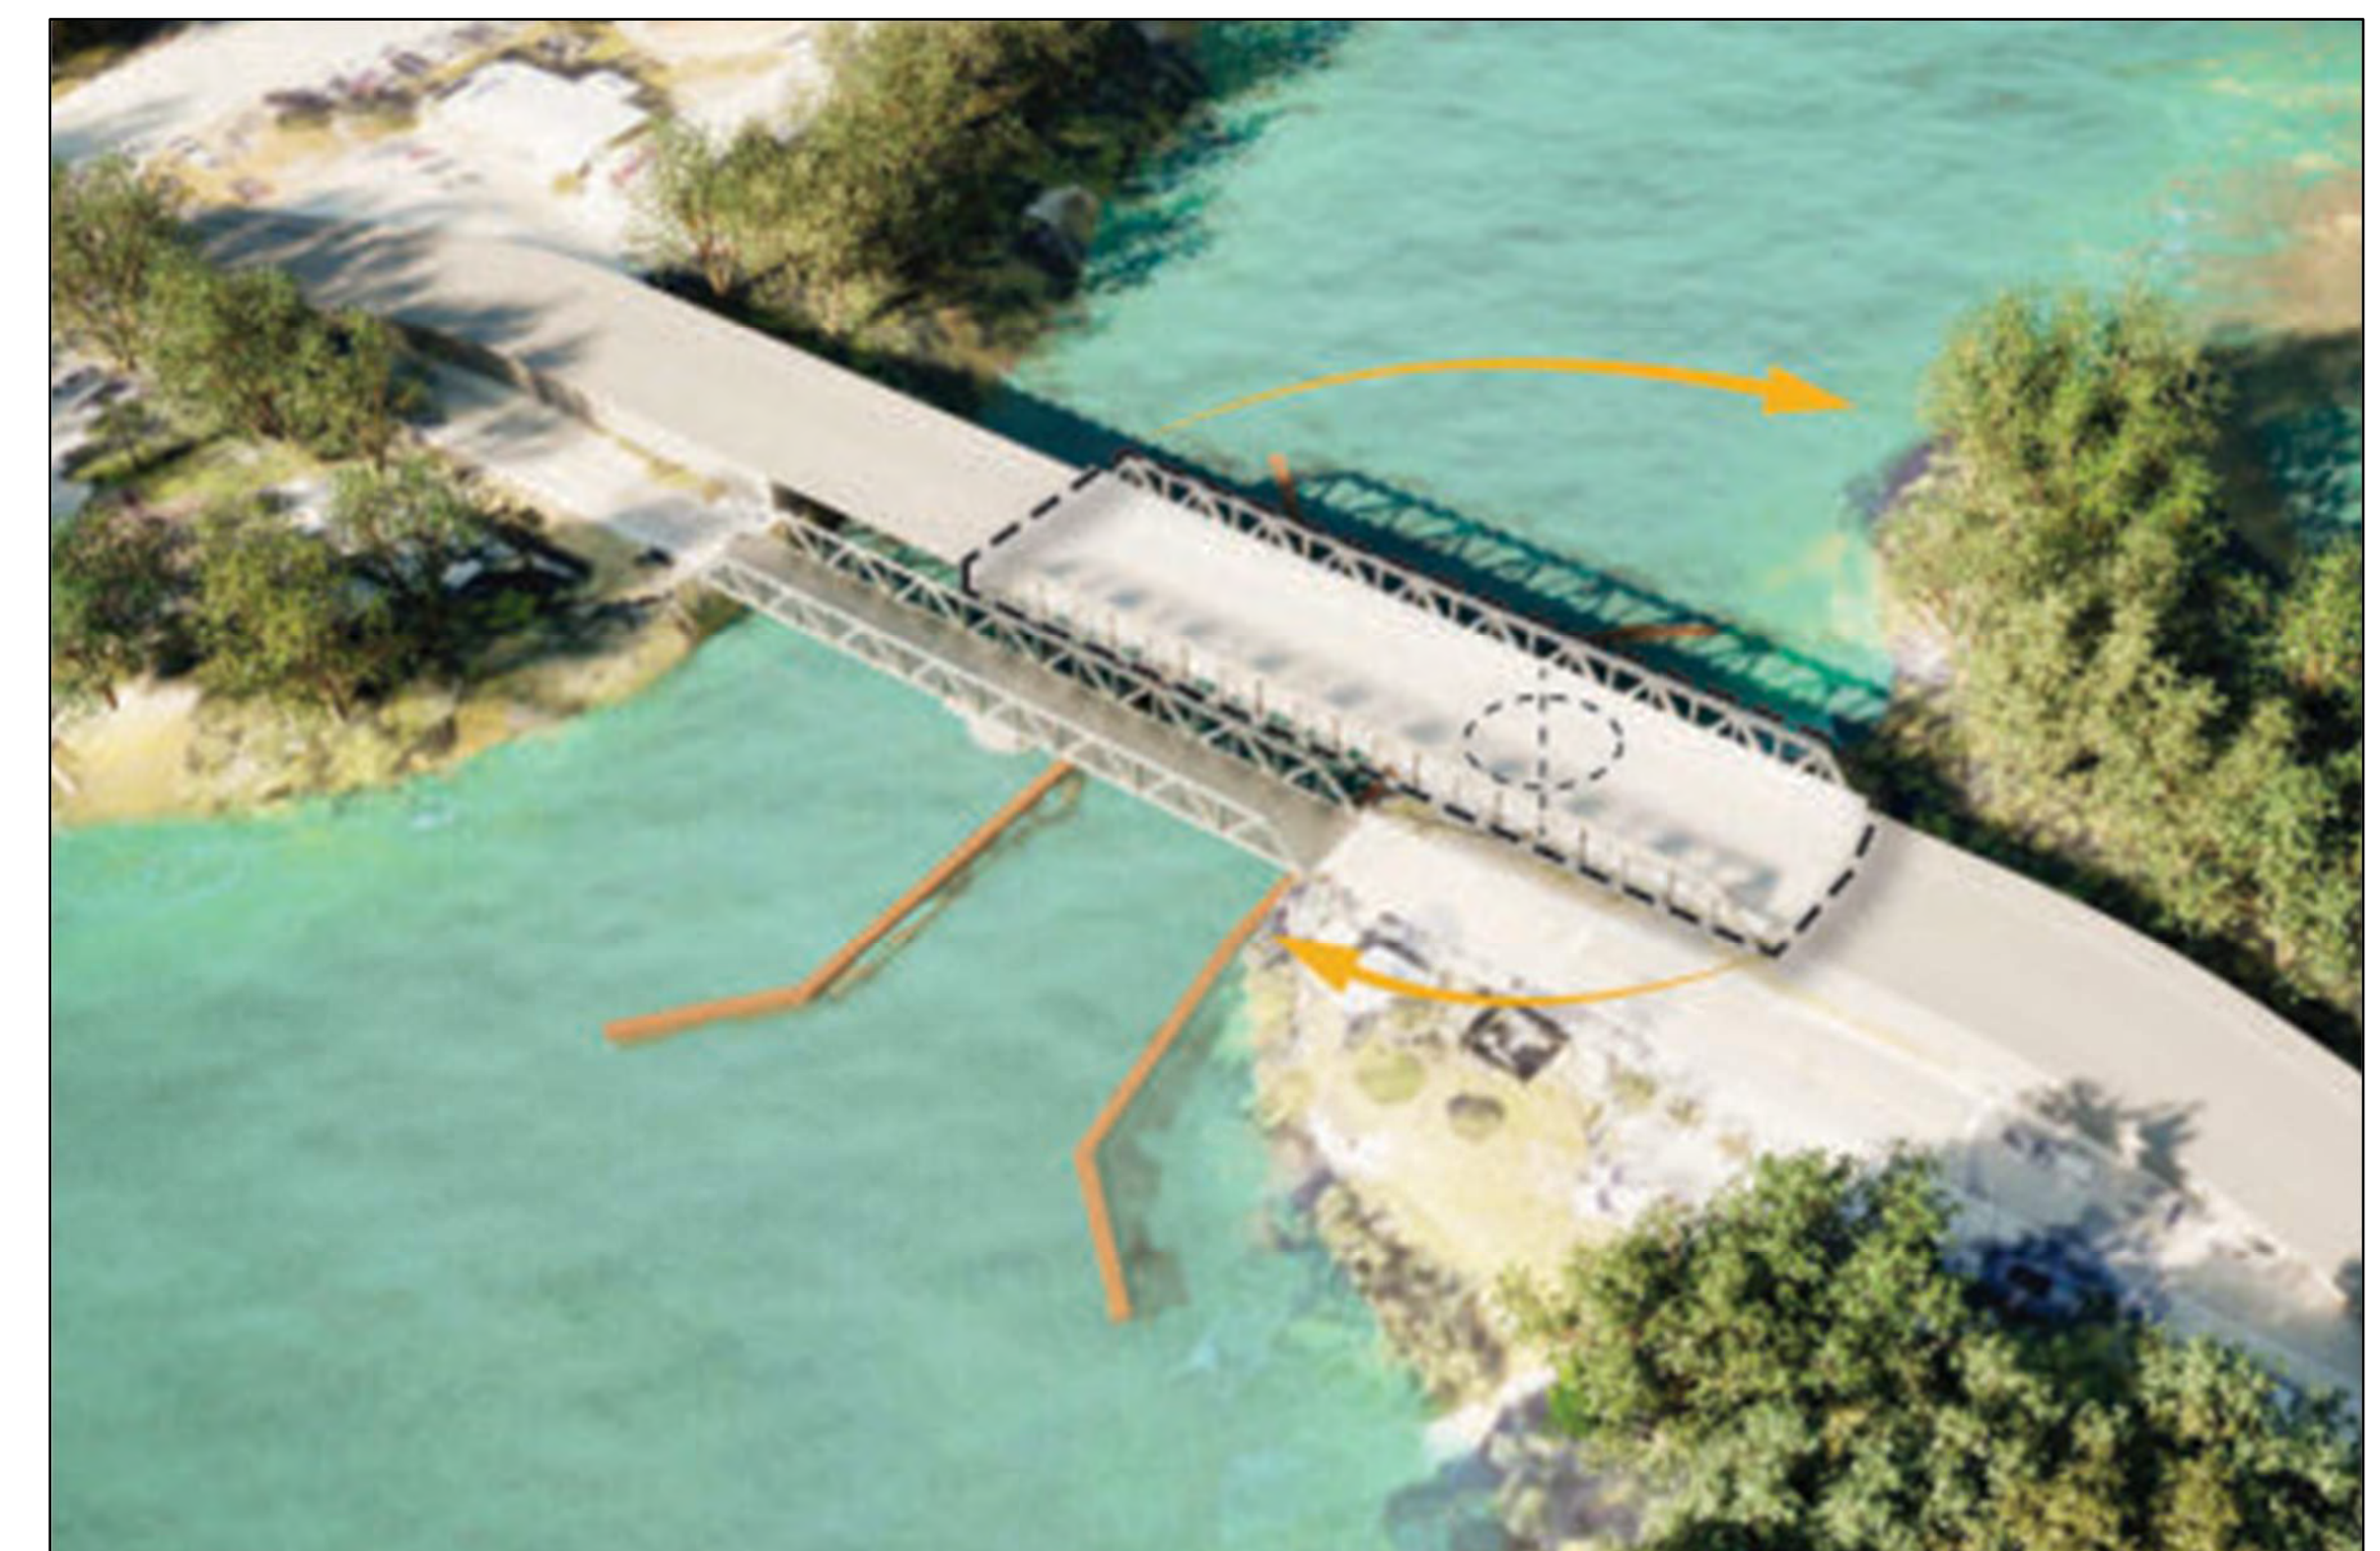
Span Motion Diagram

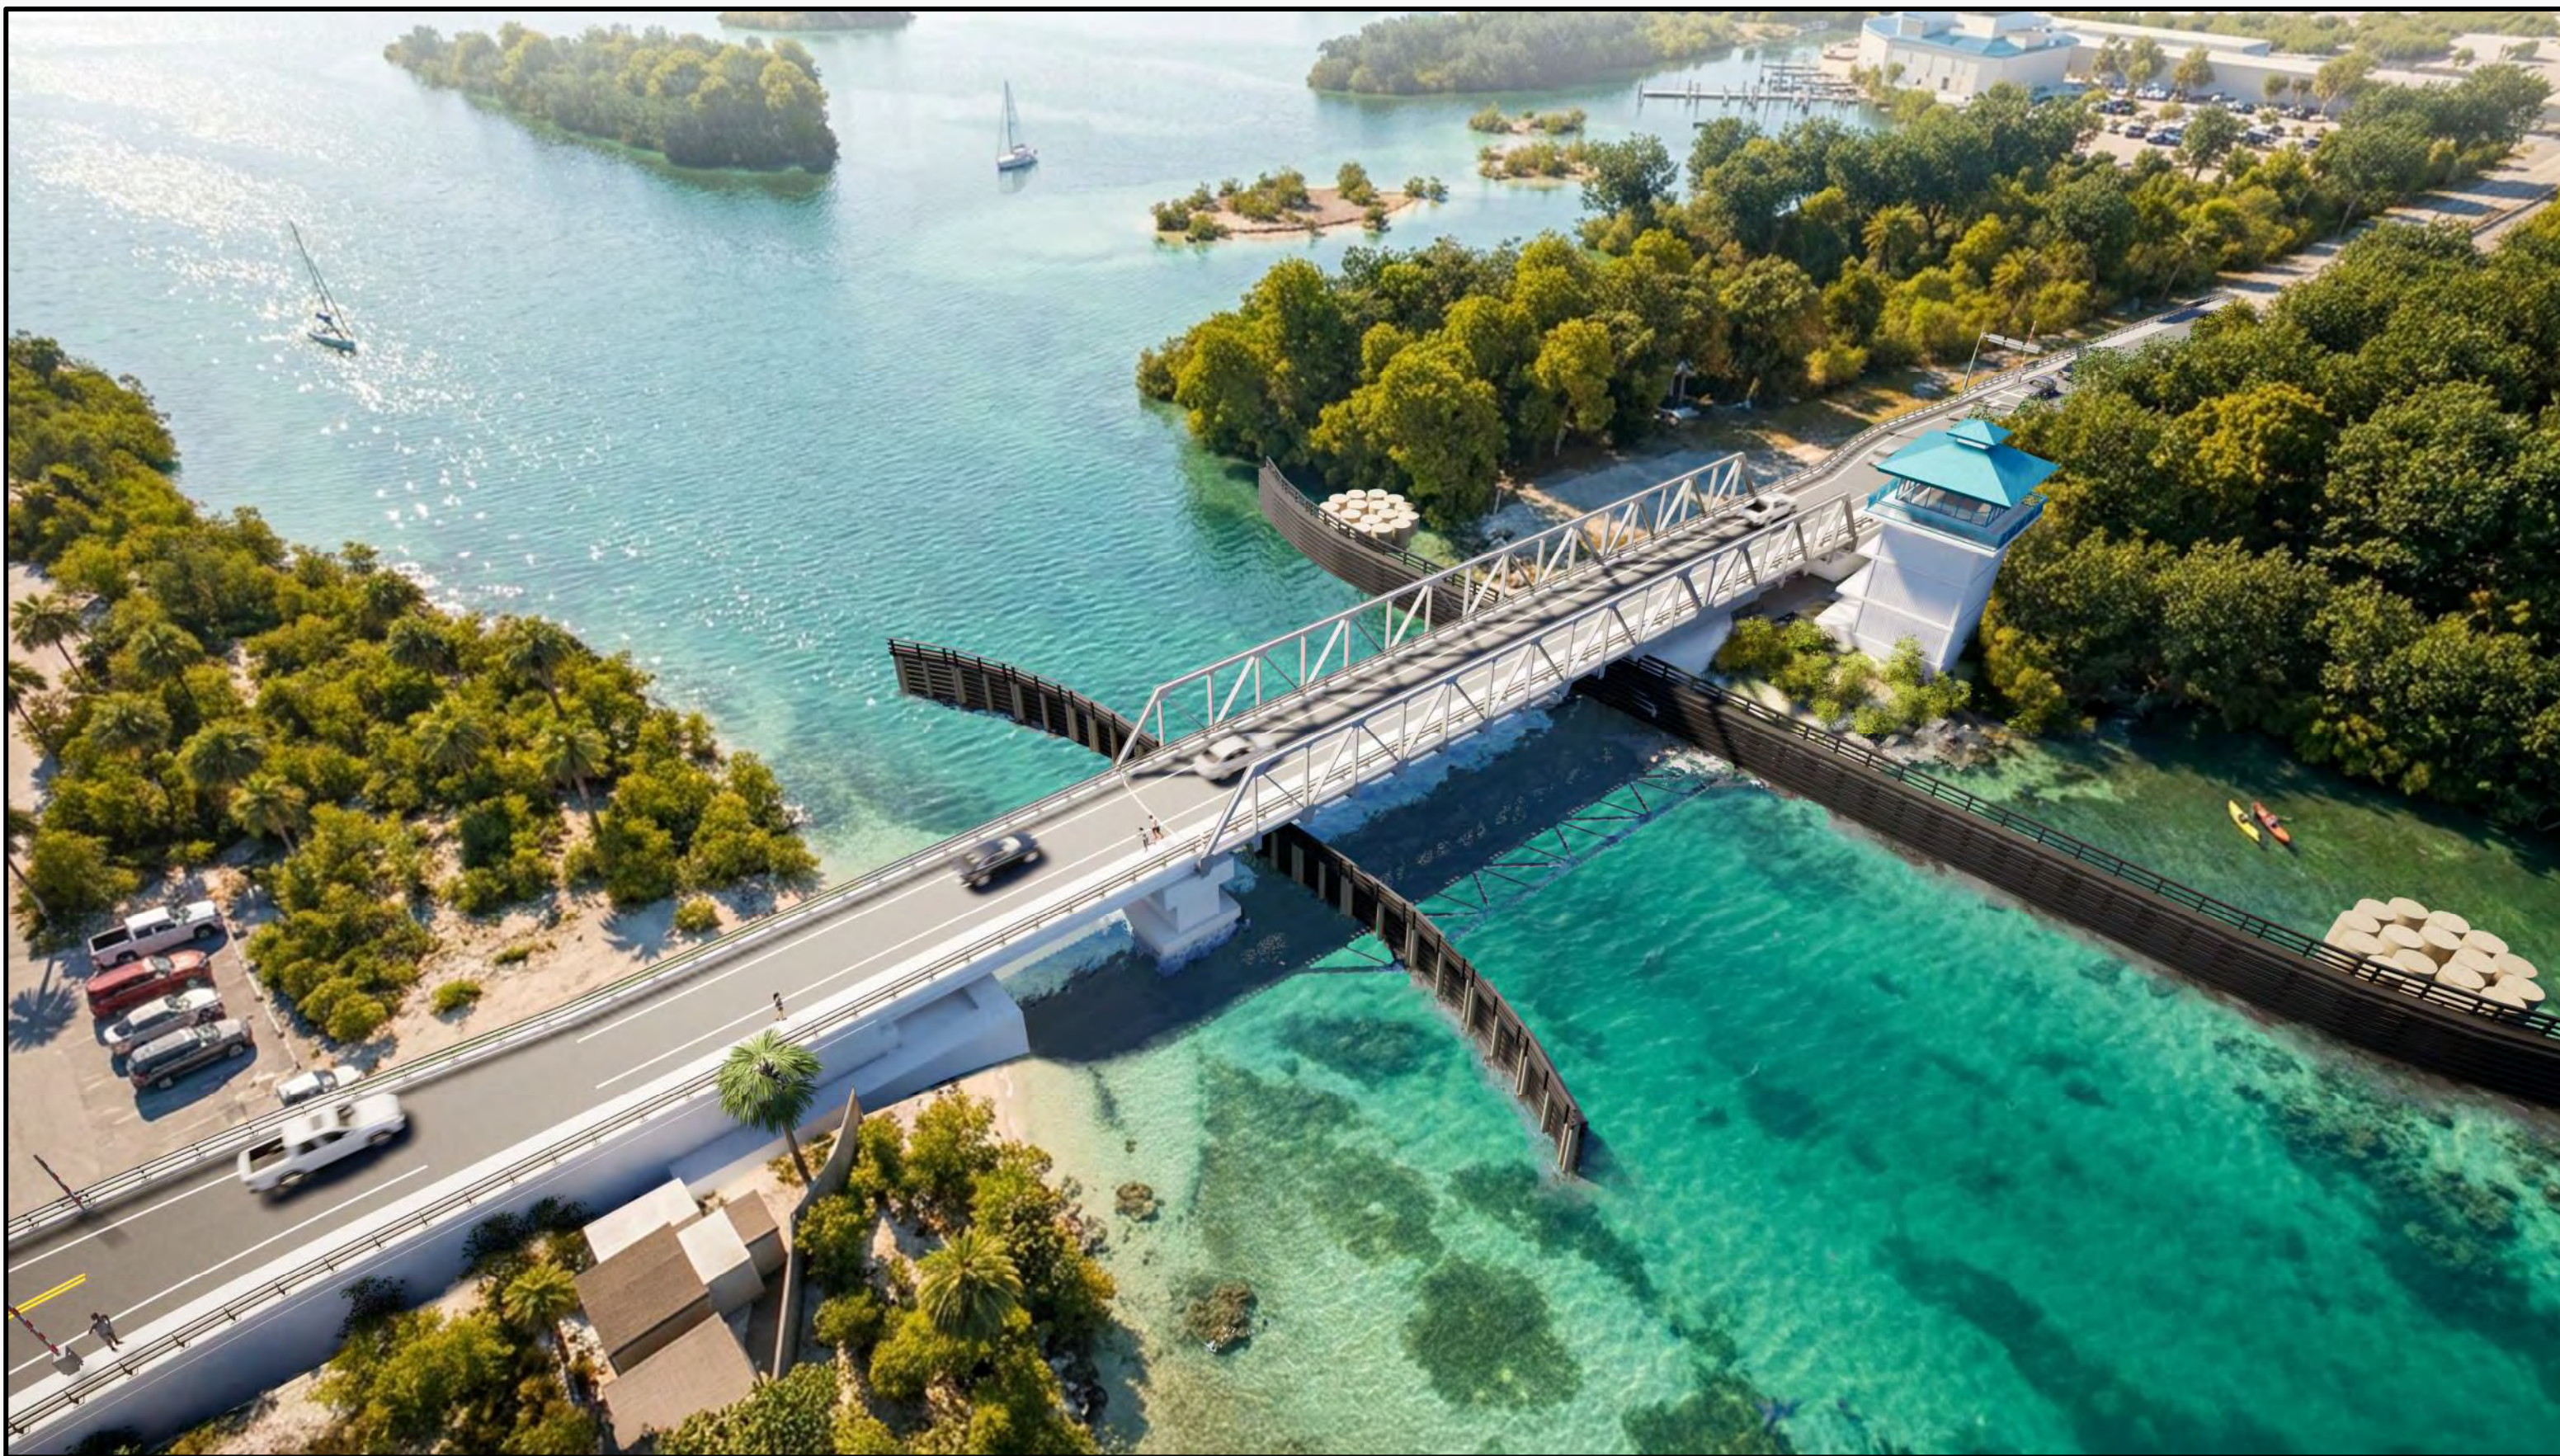
**Single-Lane
Swing Span**

**One sidewalk
on the south
side**
