TO THE ALTERNATIVES PUBLIC MEETING FOR THE BLACKBURN POINT BRIDGE REPLACEMENT STUDY

Purpose and Need: The purpose of the project is to review alternatives to replace the Blackburn Point Bridge (Bridge No. 170064) on Blackburn Point Road (County Road (CR) 789) over the Gulf Intracoastal Waterway in Osprey, Sarasota County, Florida. The need for the project is based on the following criteria:

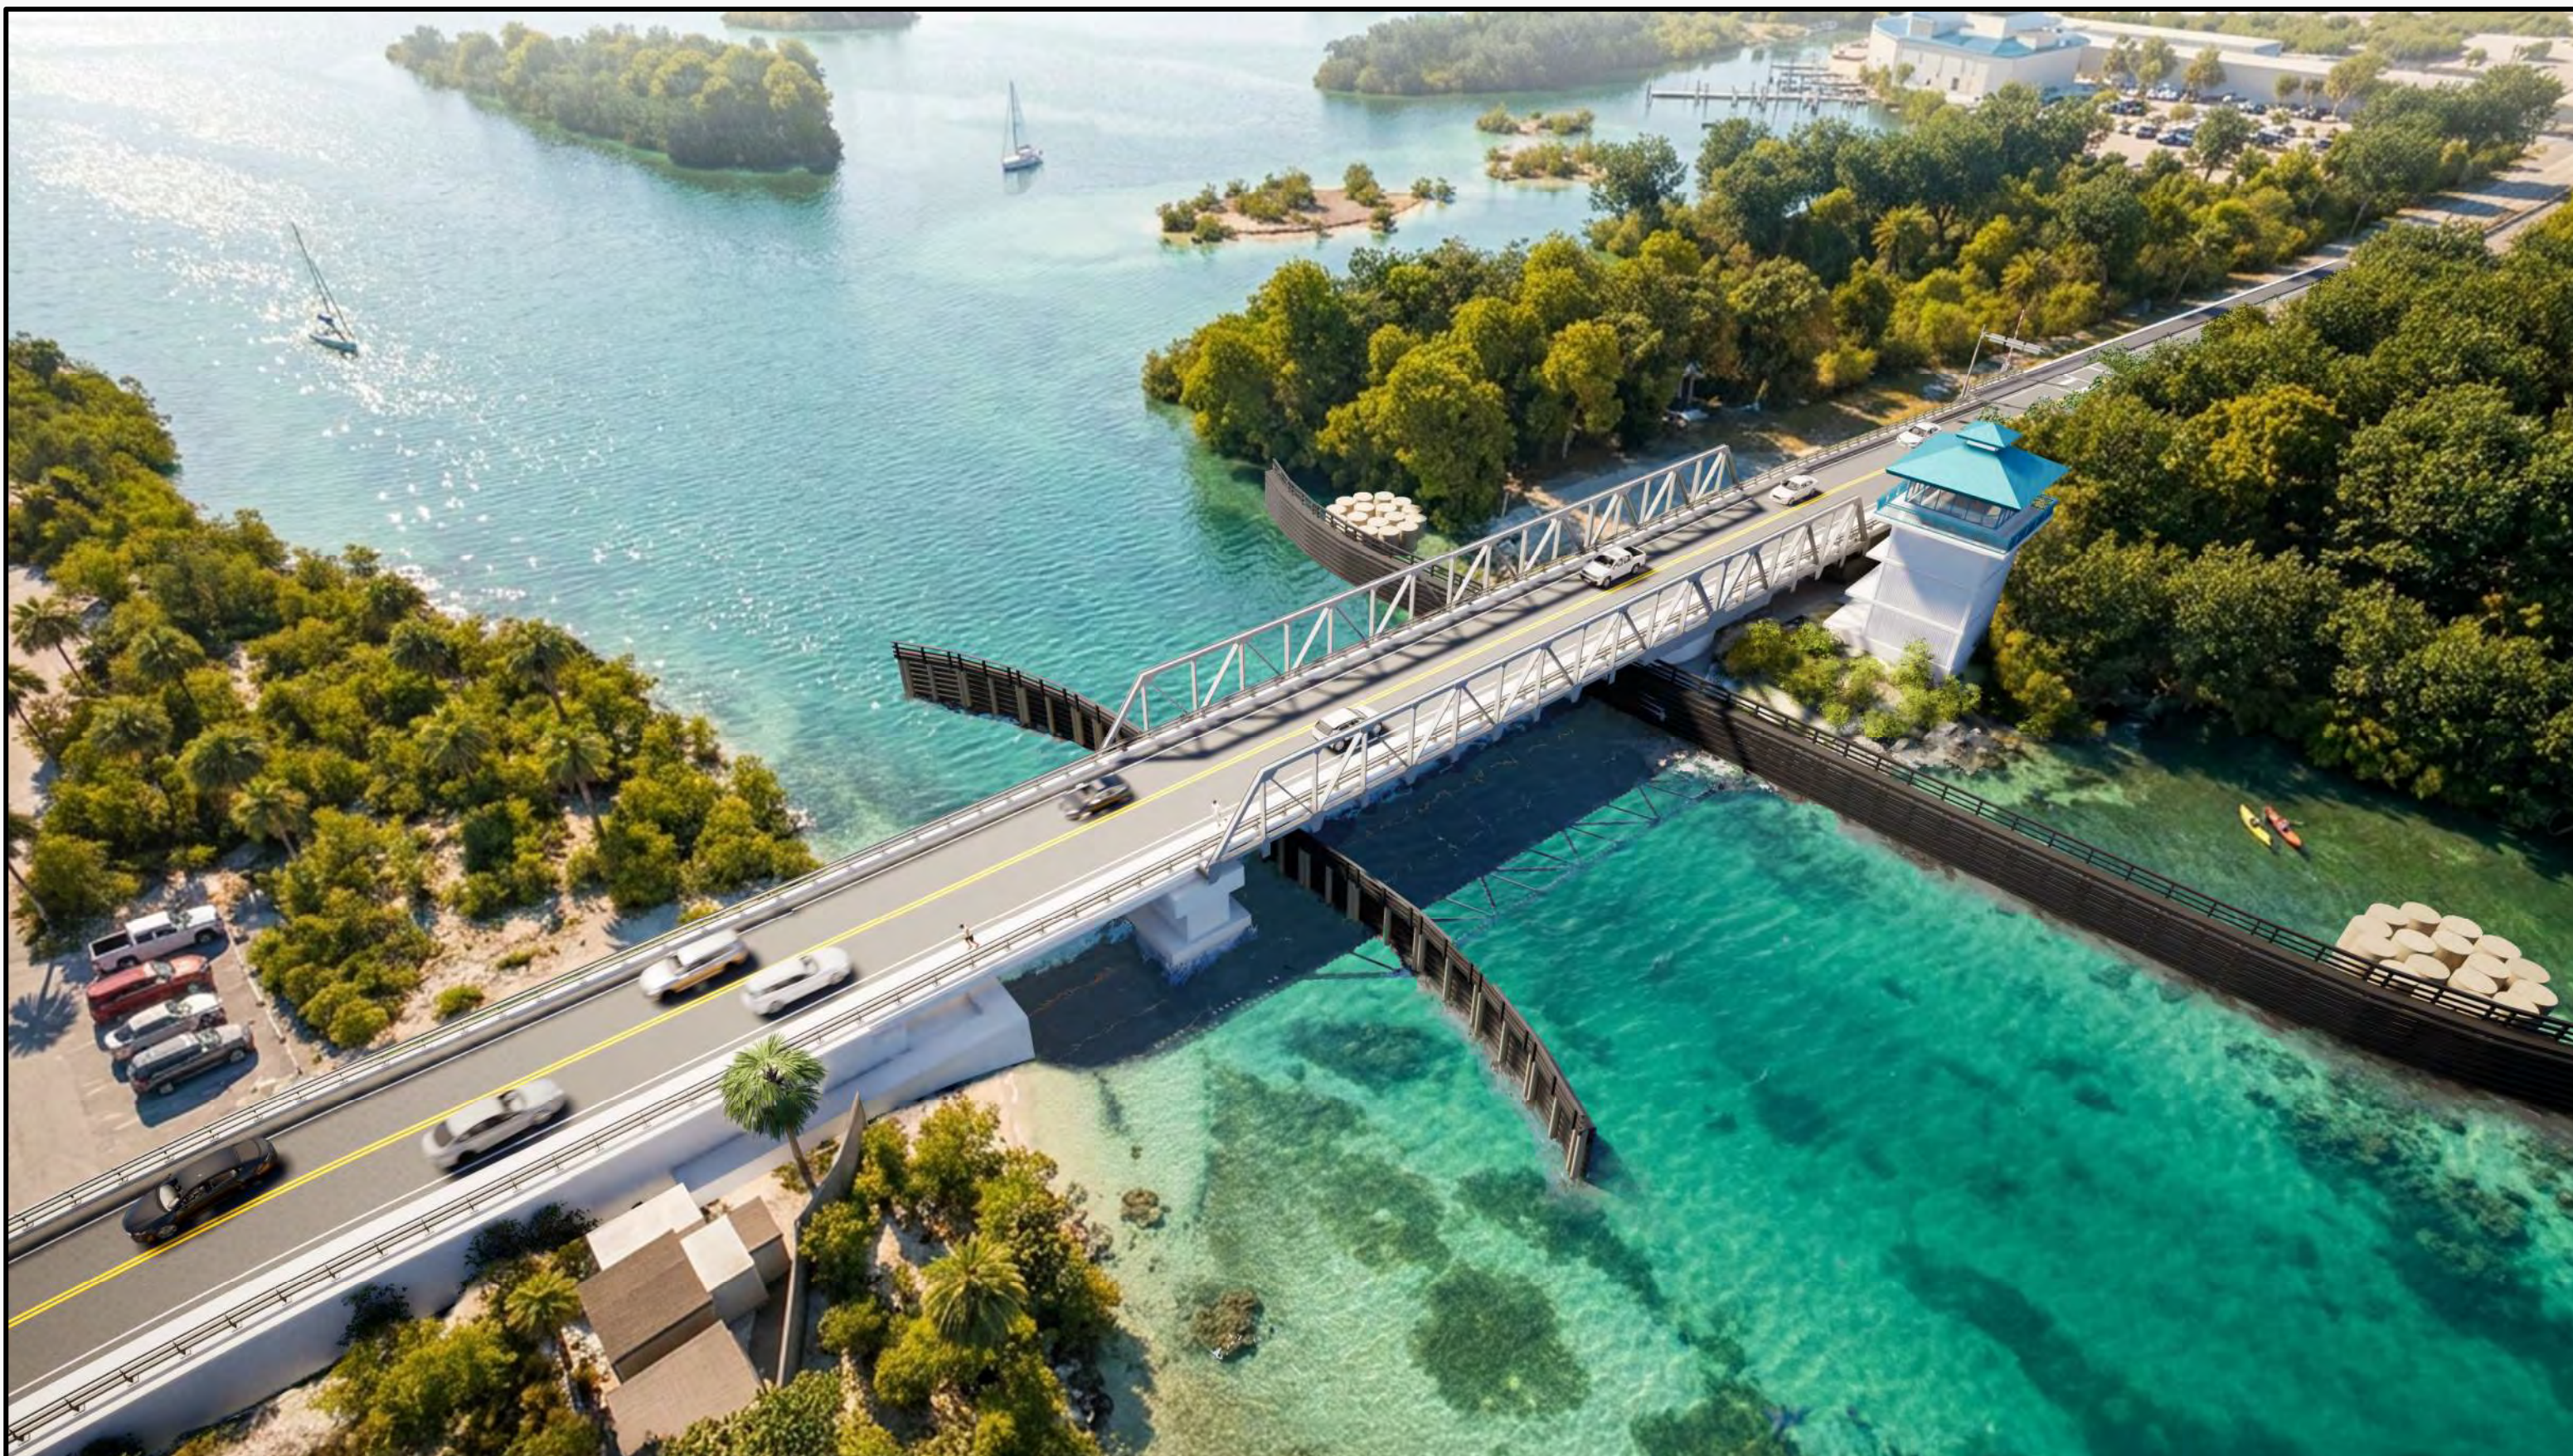
**Two-Lane
Swing Span**

**One sidewalk
on the south
side**

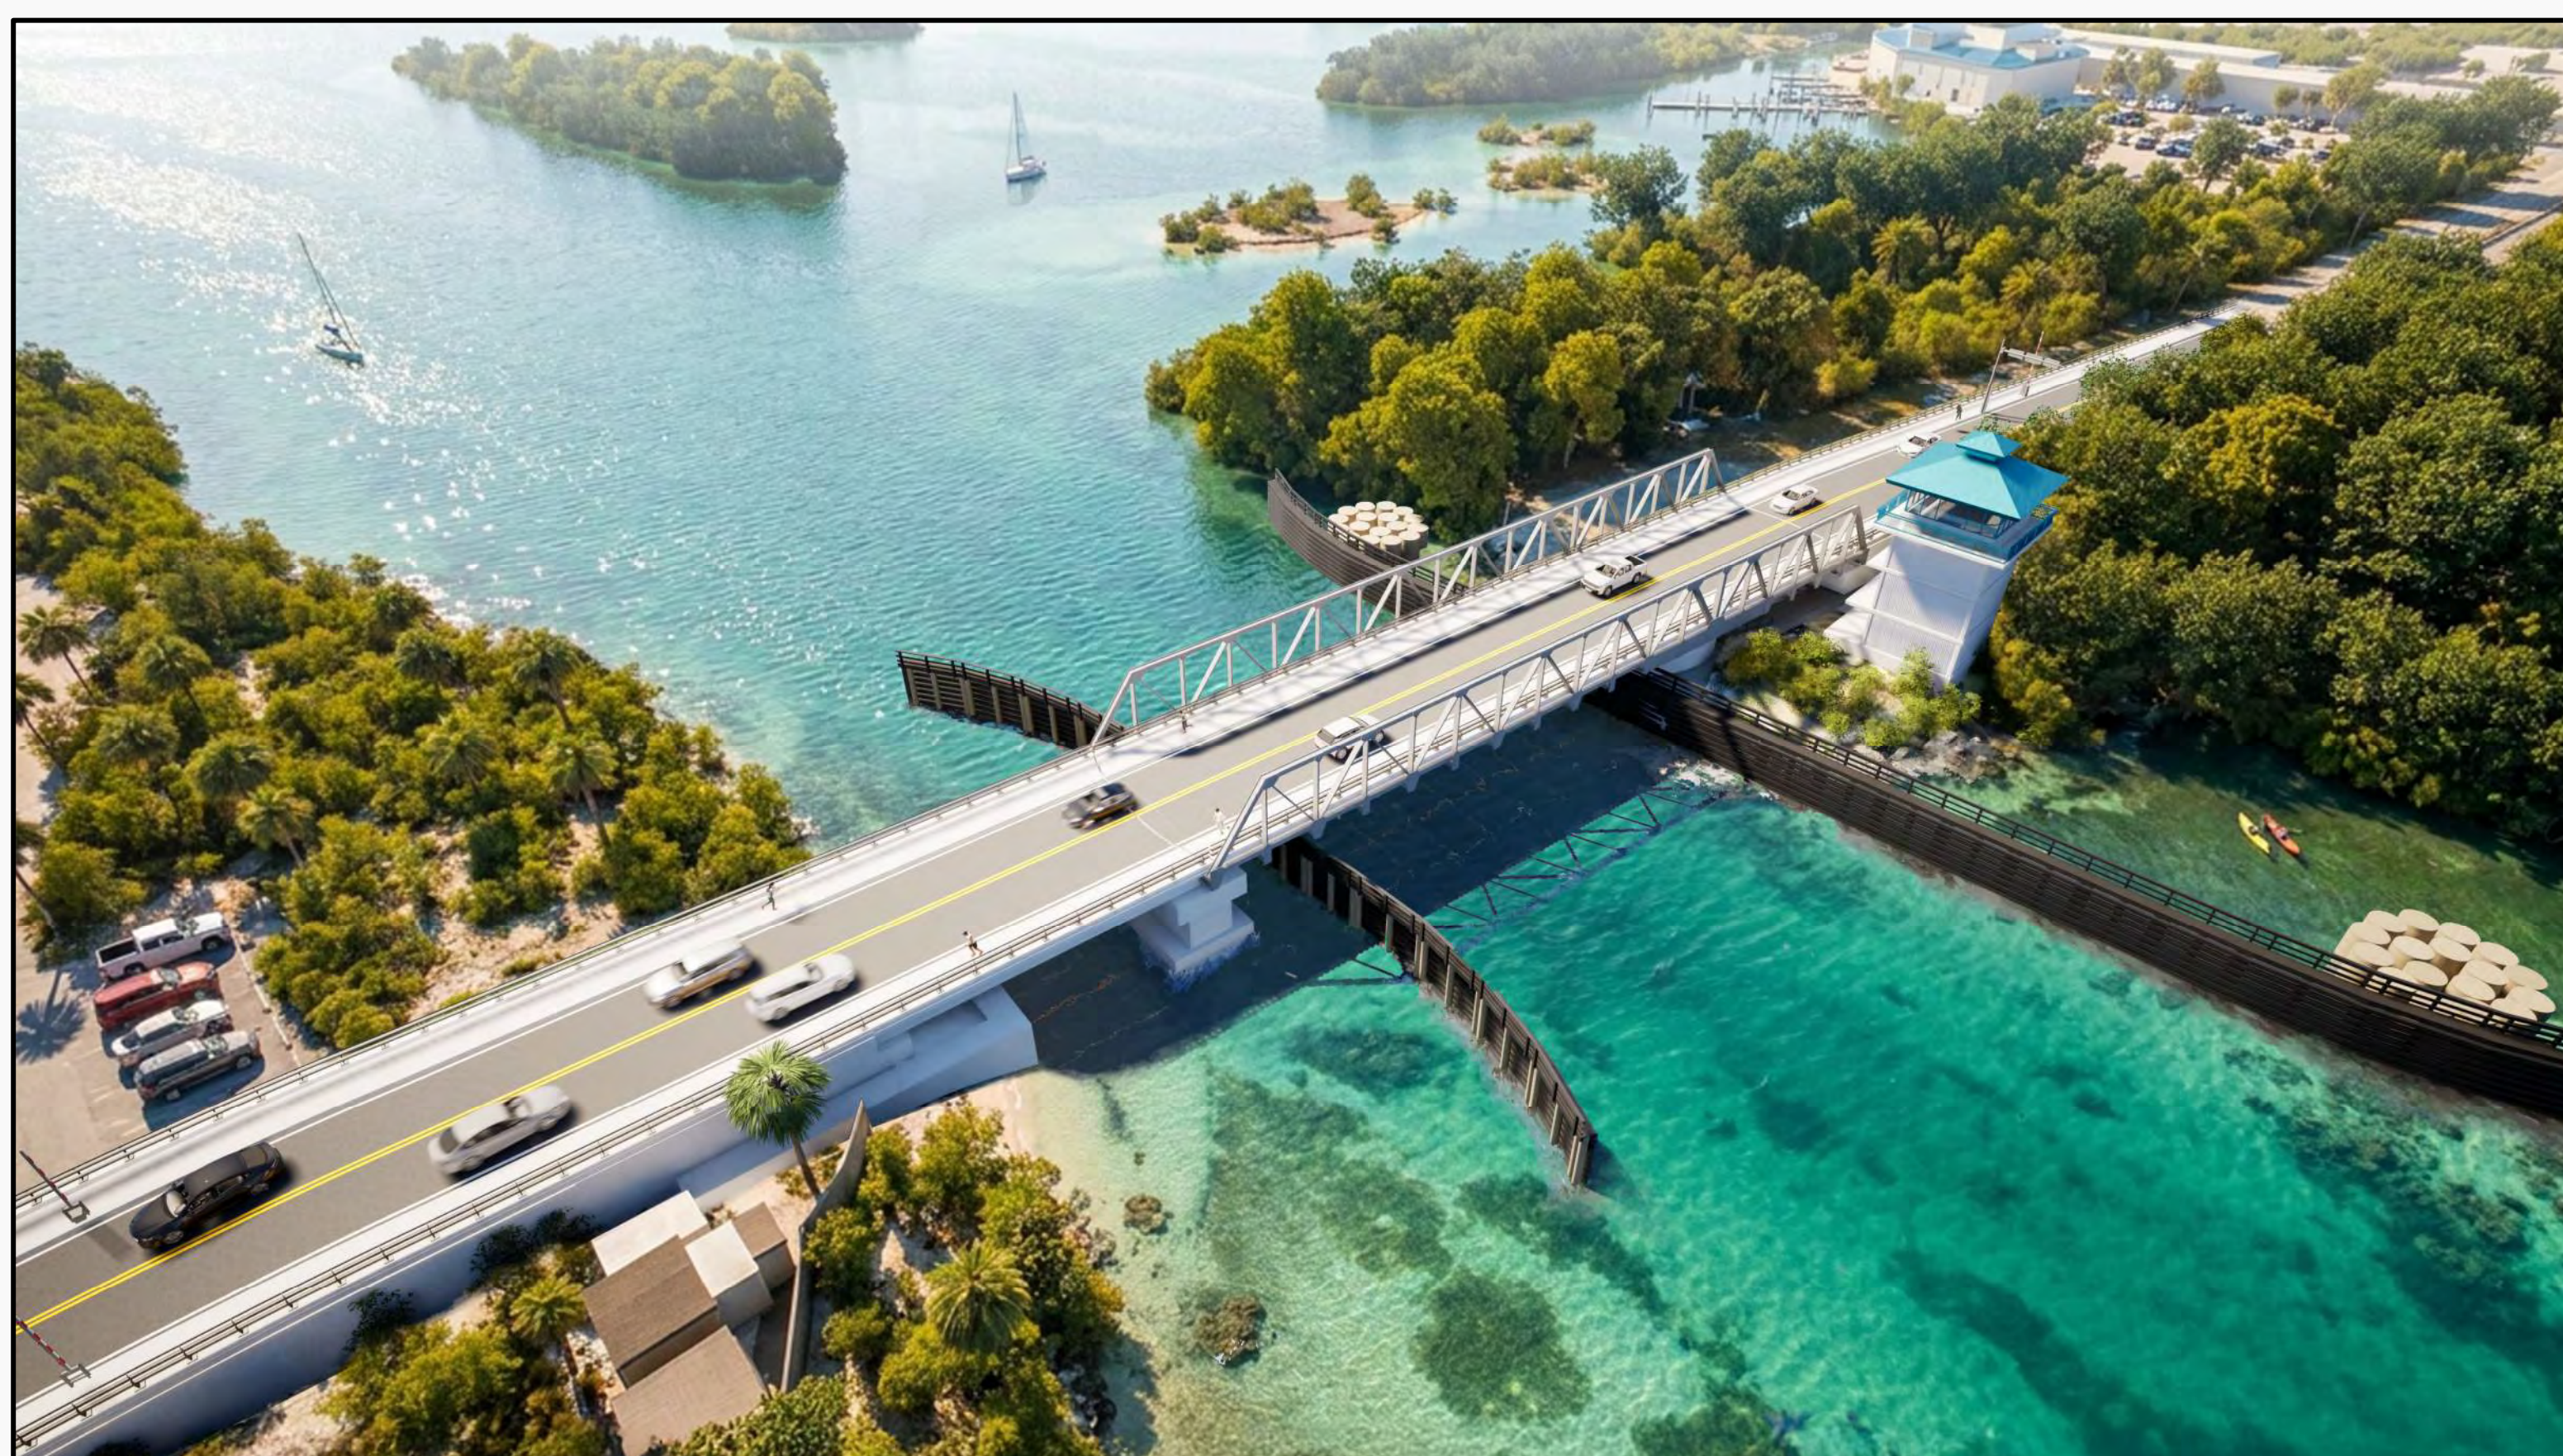
**Two-Lane
Swing Span**

**Two sidewalks,
one on each
side**

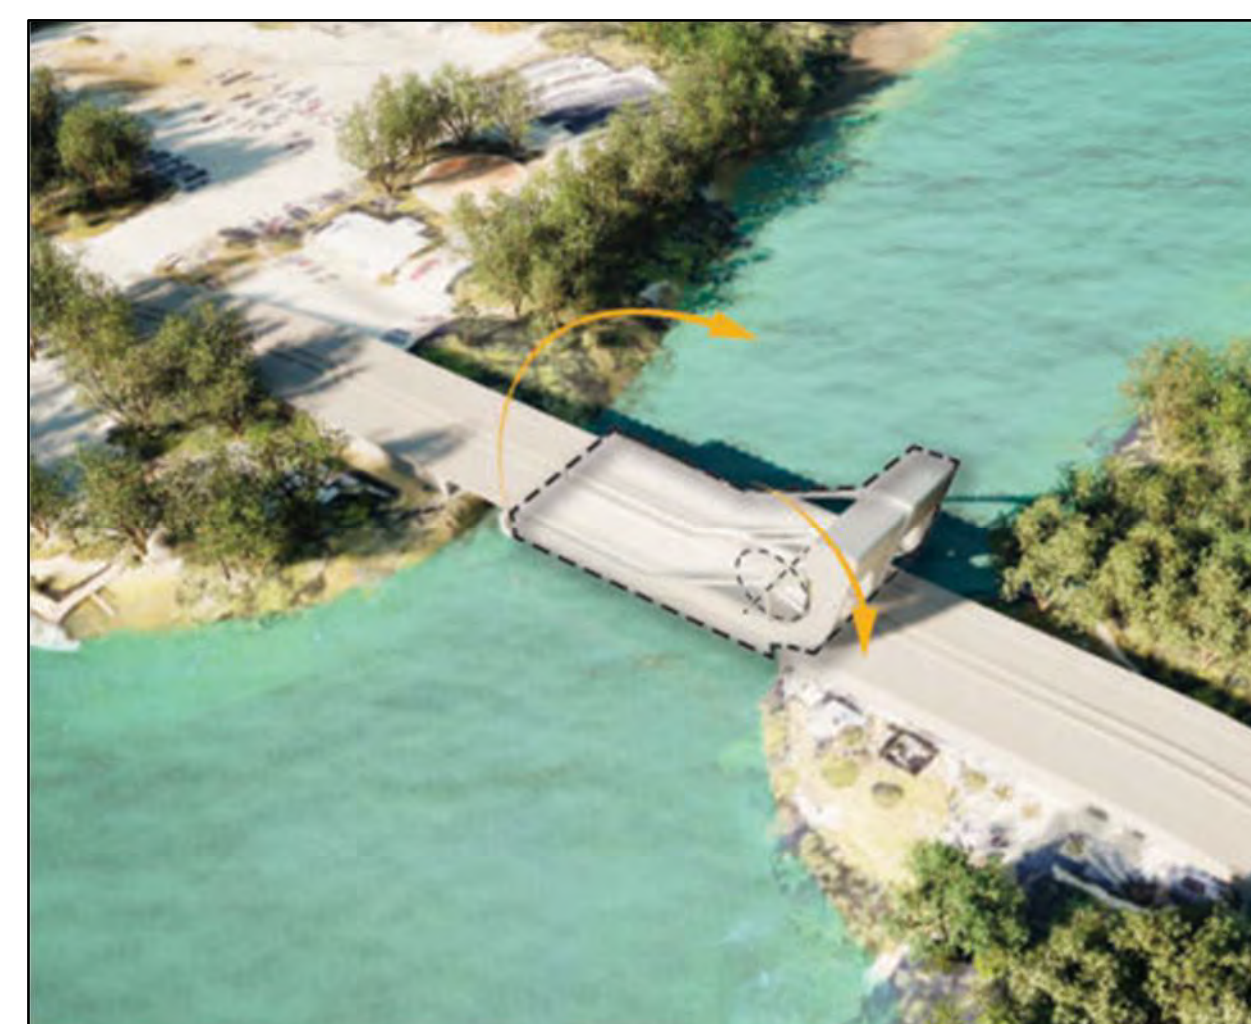
Span Motion Diagram

- **Rotates about a horizontal axis and translates at the same time**
 - Smallest movable span length
- **Rolling Lift Type with Overhead Counterweight**
 - Maximum clearance above the water
 - Resiliency:
 - Most durable with operating machinery located above the splash zone
 - Machinery is easily accessible without going below deck
- **Counterweight and machinery located on the east abutment**
 - Minimizes impacts to Blackburn Park
 - Requires rest pier in the waterway
- **Can be constructed to the north then slid to the existing alignment after existing bridge is removed**
 - Avoids a temporary movable span

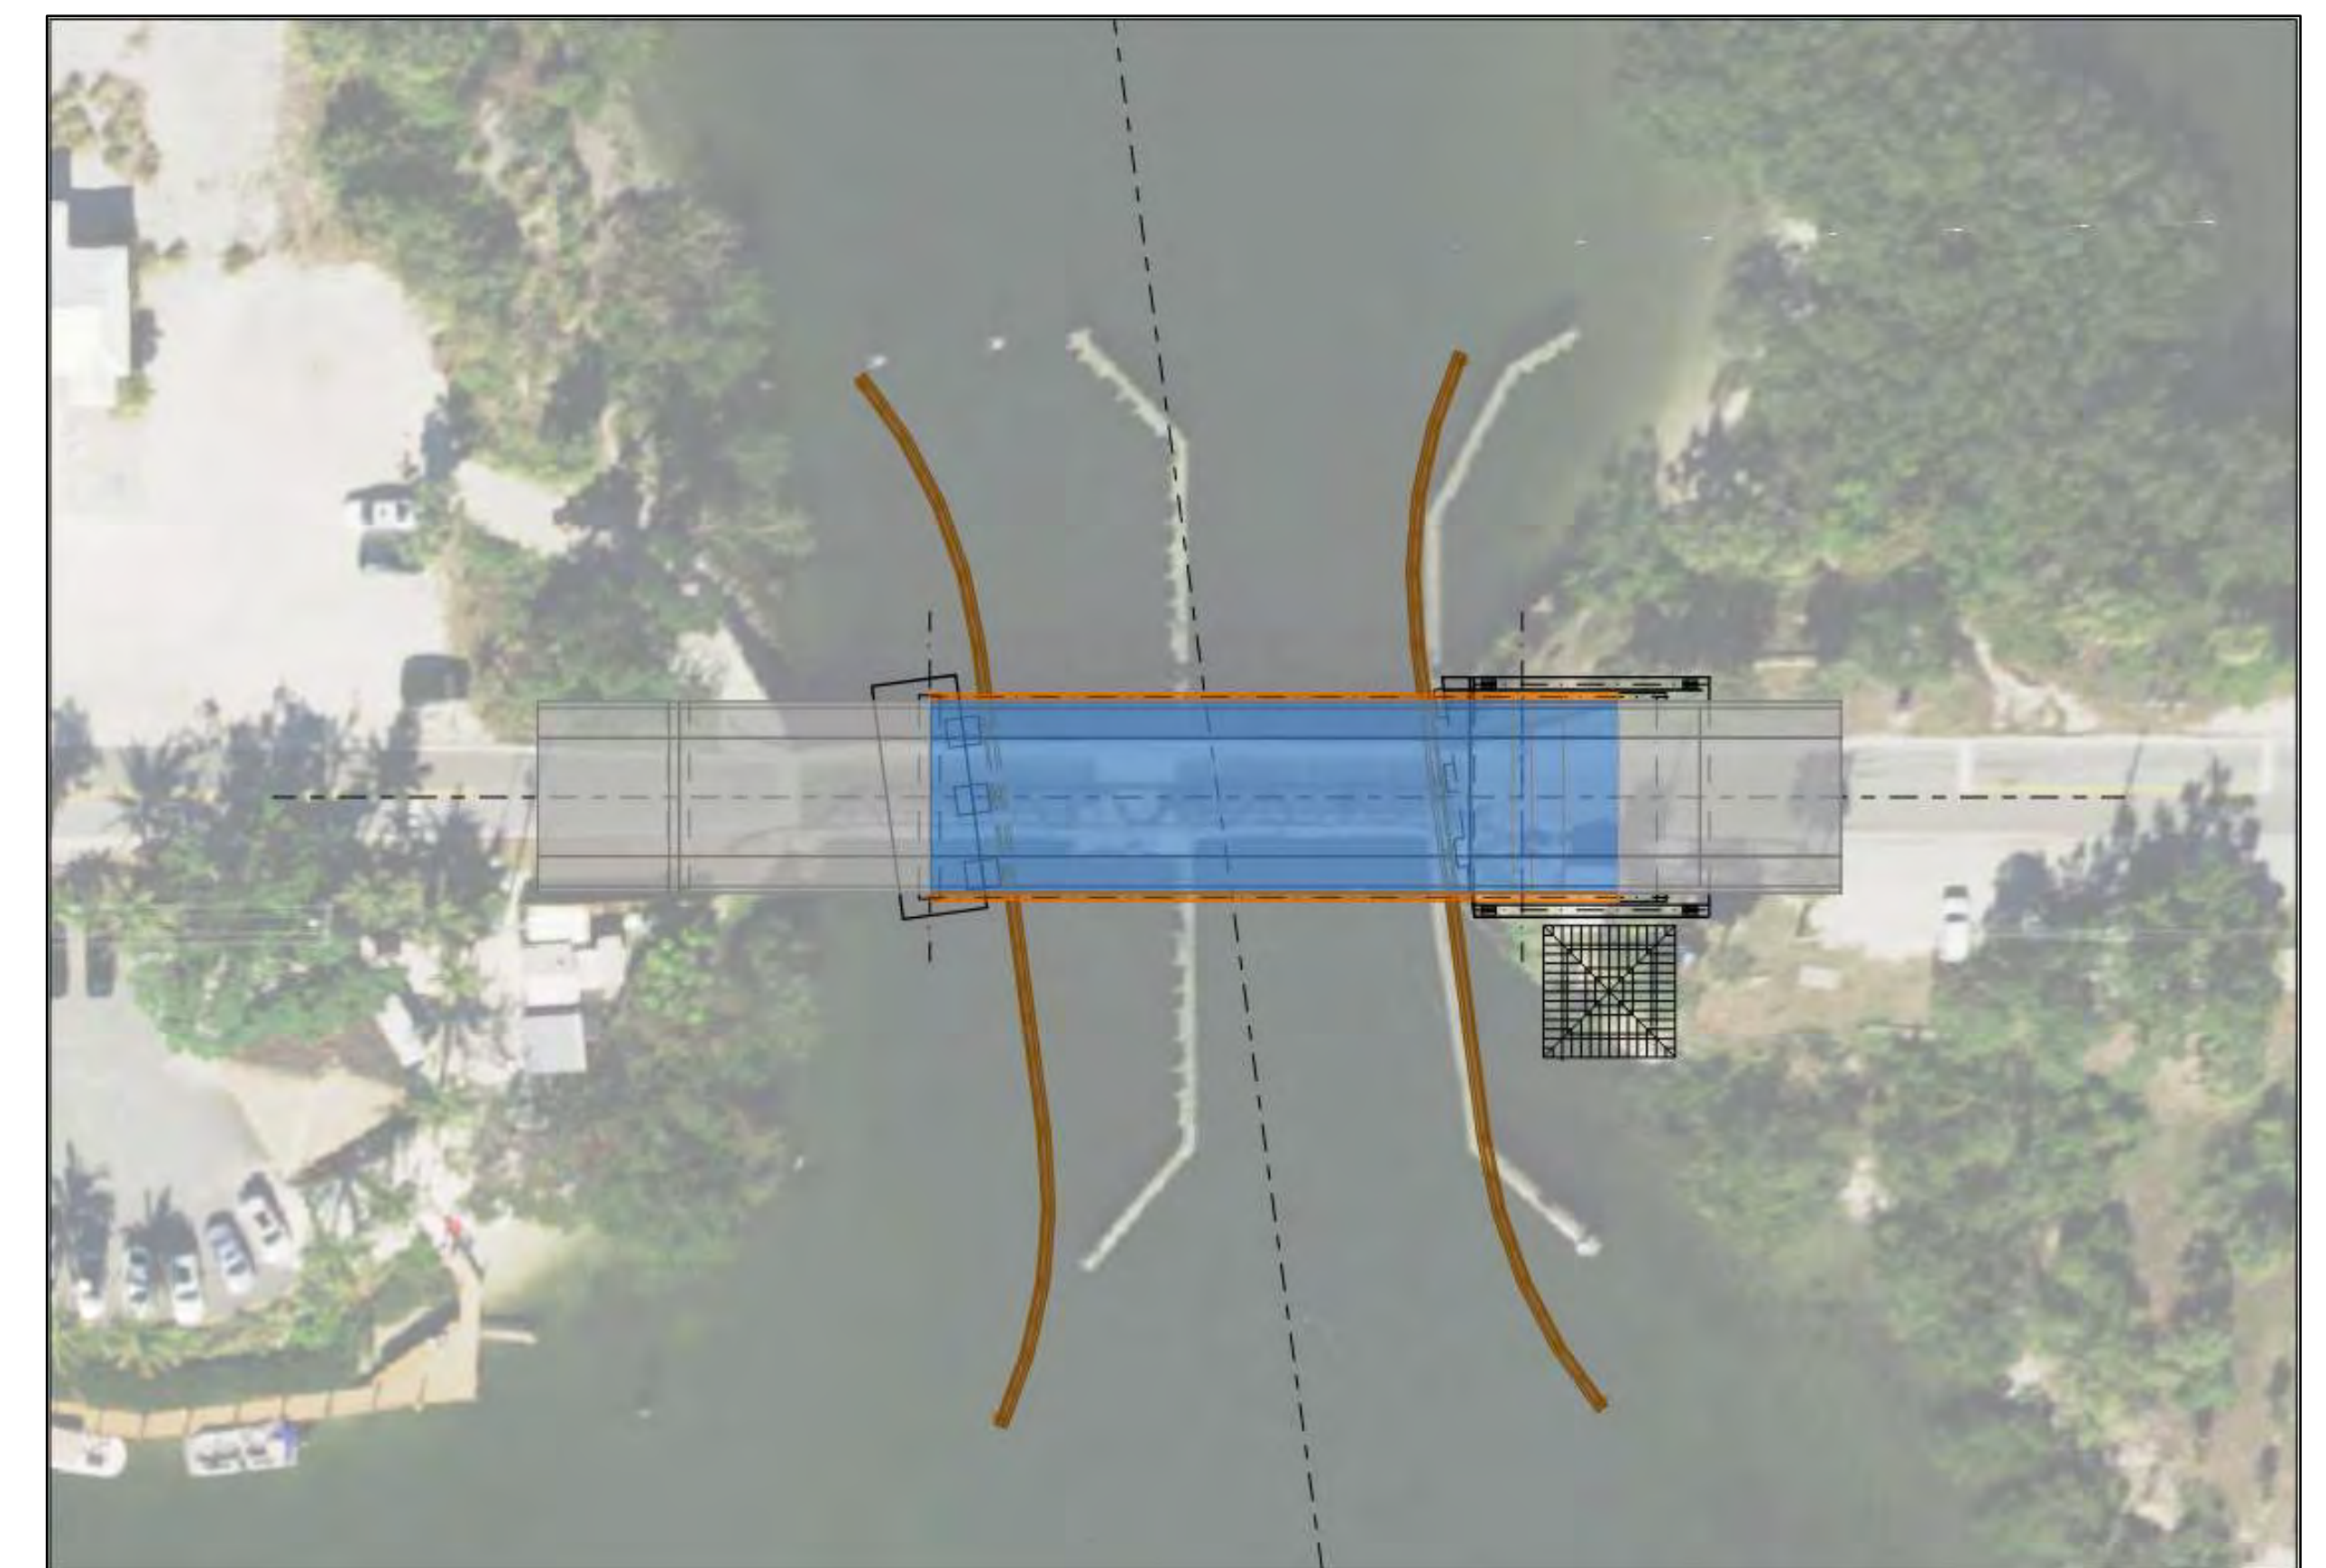
Bascule Bridge on Existing Alignment

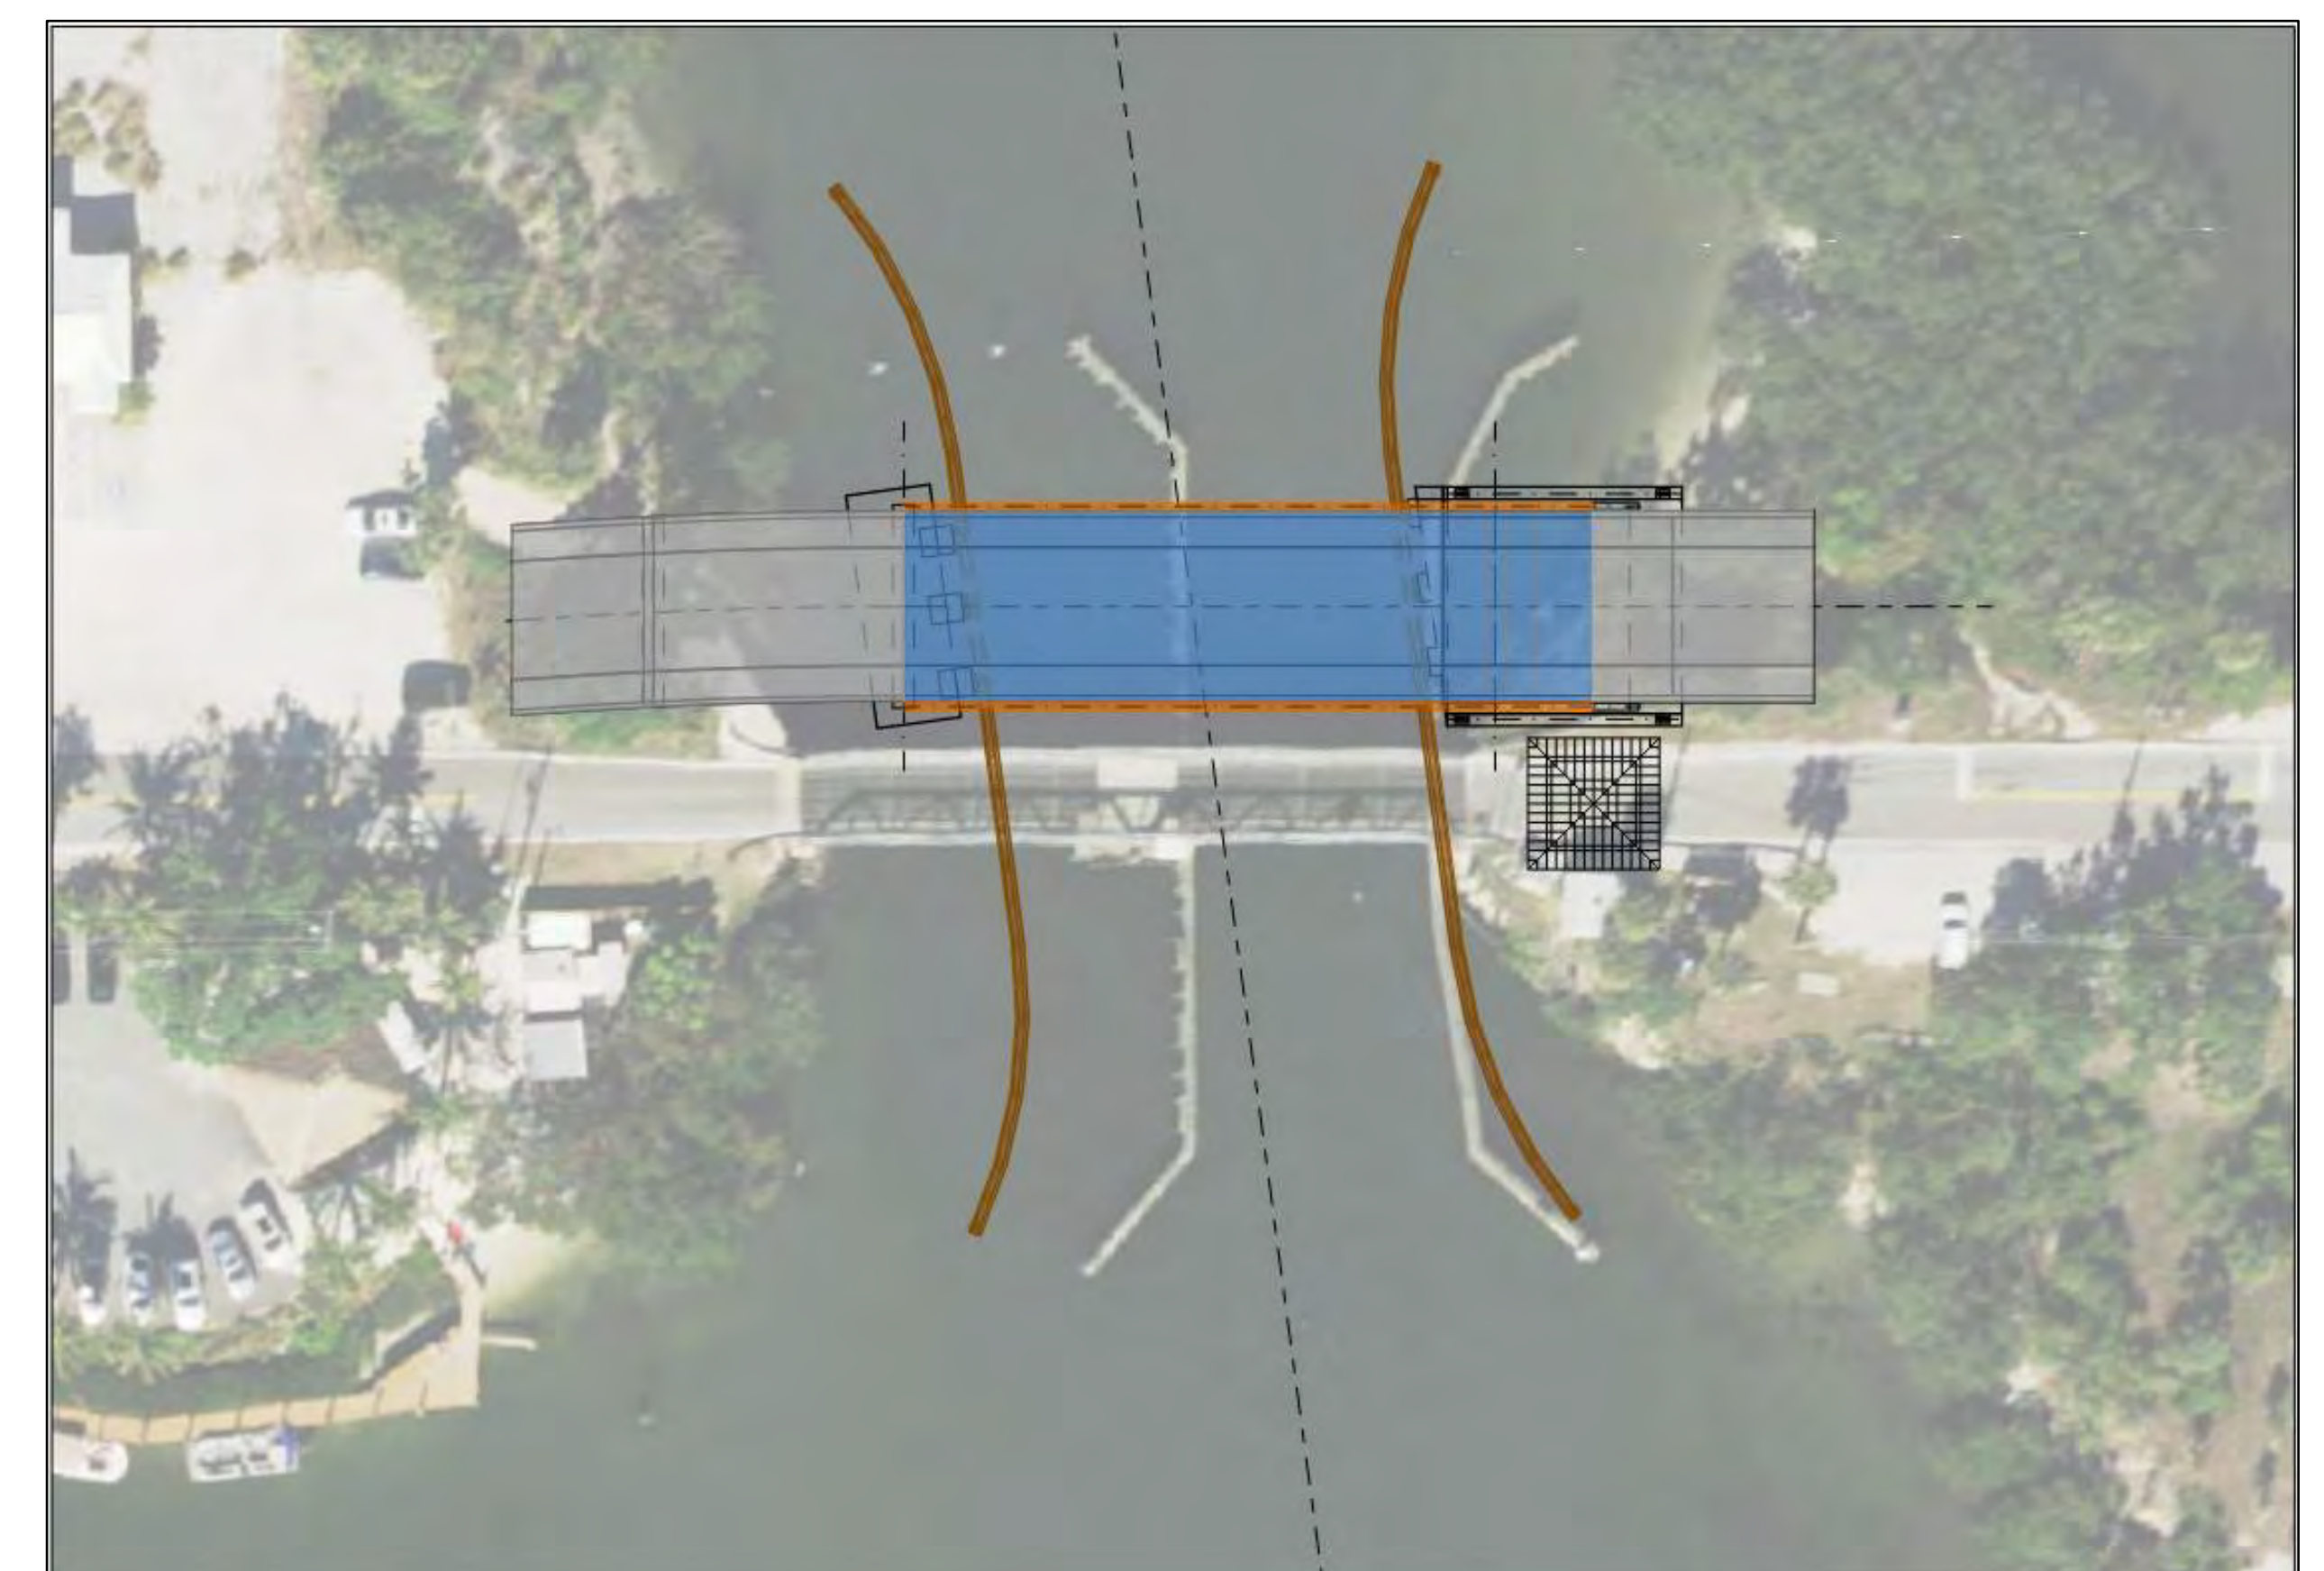
Bascule Bridge on Temporary Alignment to the North

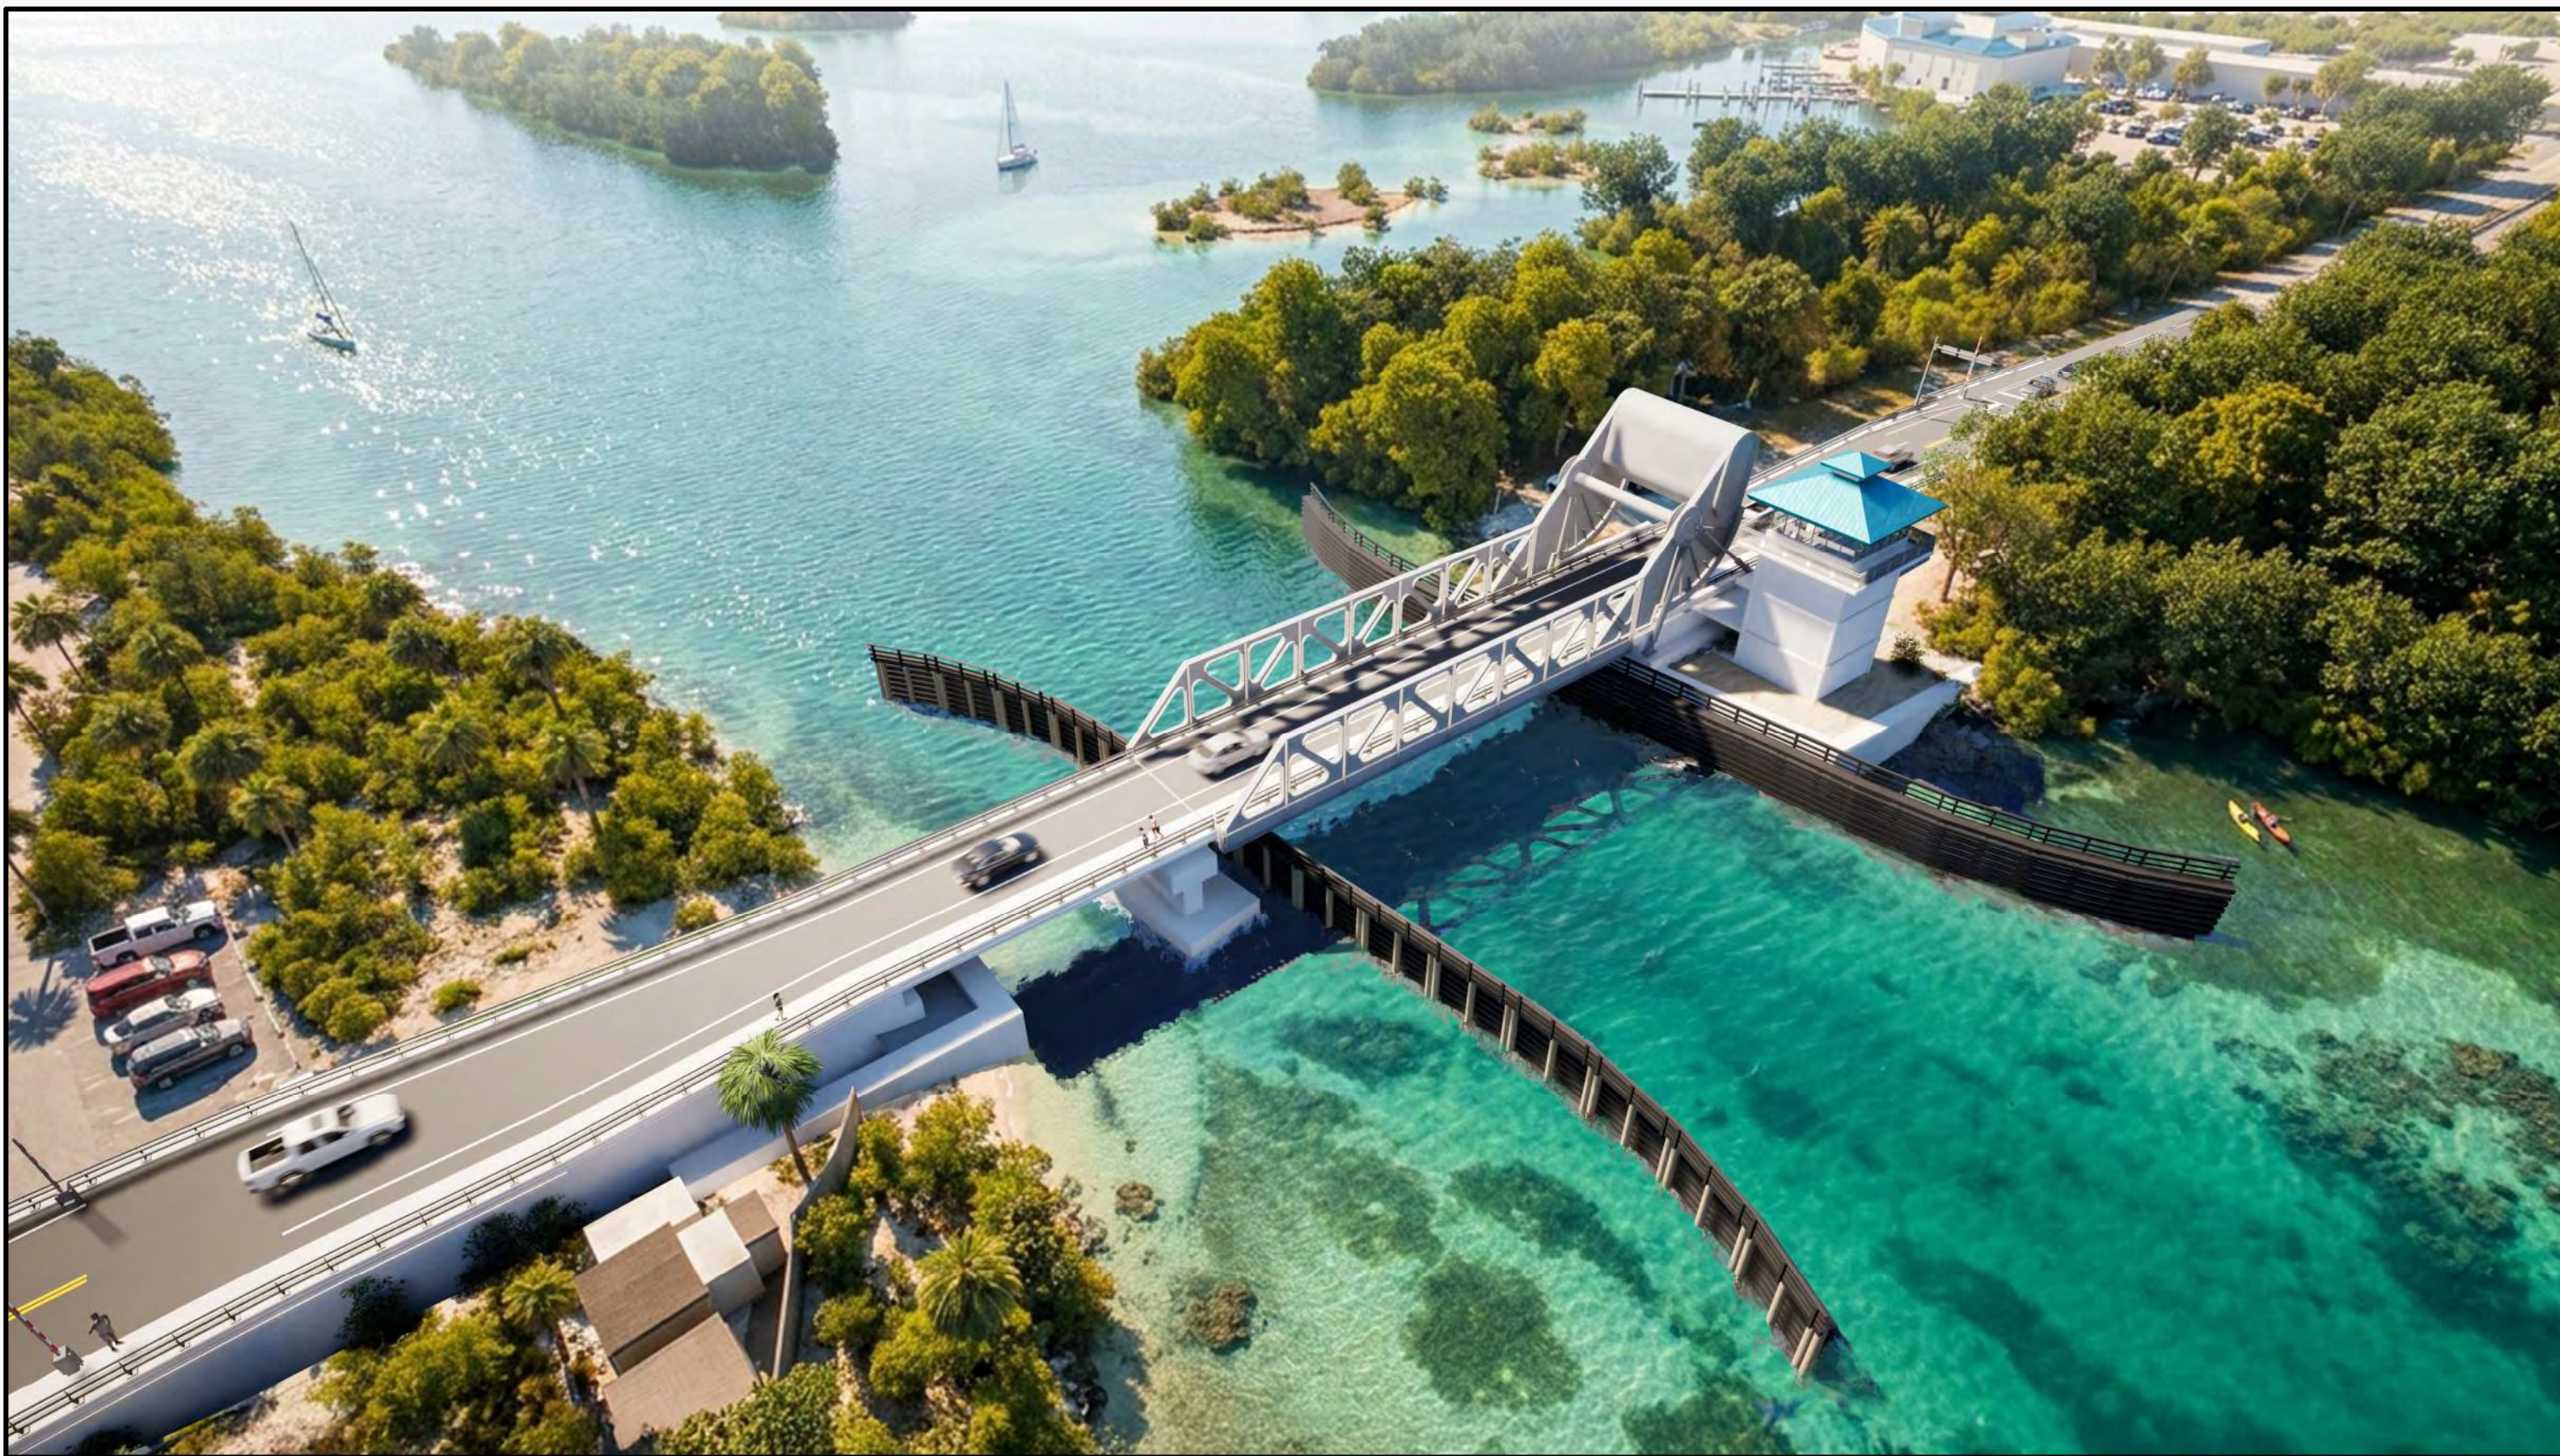
**Single-Lane
Bascule Span**

**One sidewalk on
the south side**
