TO THE ALTERNATIVES PUBLIC MEETING FOR THE BLACKBURN POINT BRIDGE REPLACEMENT STUDY

Purpose and Need: The purpose of the project is to review alternatives to replace the Blackburn Point Bridge (Bridge No. 170064) on Blackburn Point Road (County Road (CR) 789) over the Gulf Intracoastal Waterway in Osprey, Sarasota County, Florida. The need for the project is based on the following criteria:

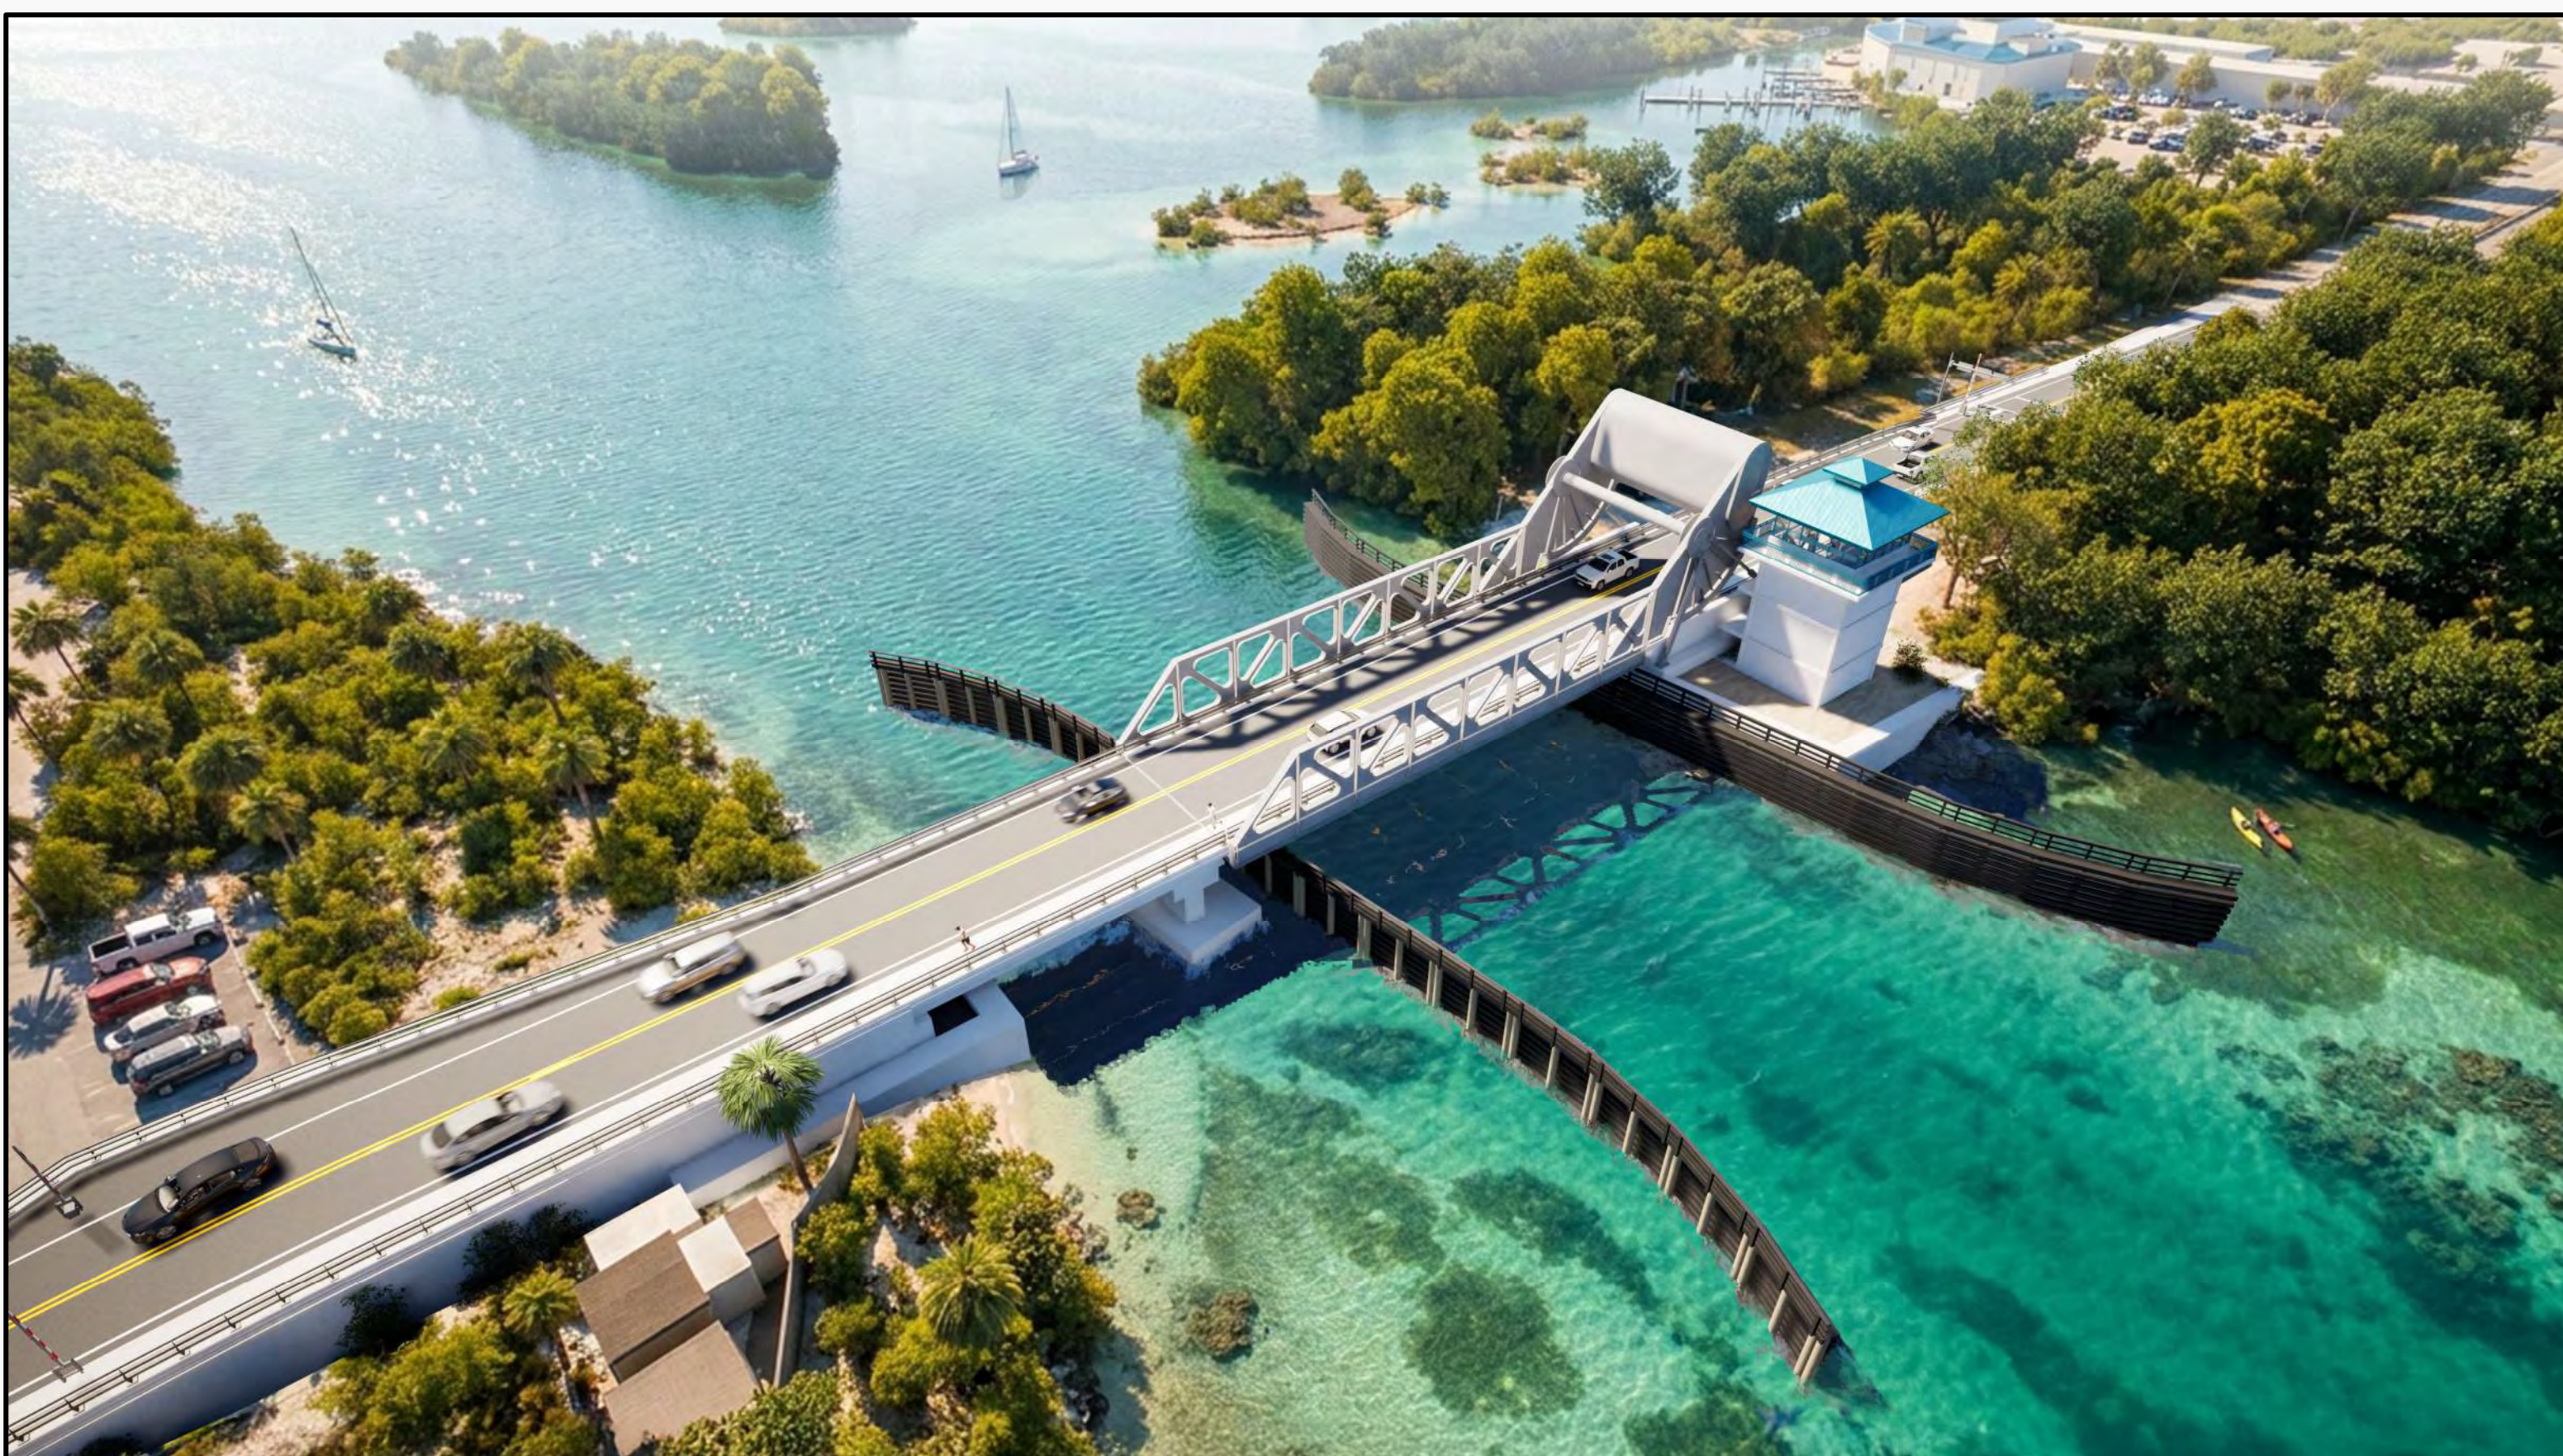
**Two-Lane
Bascule Span**

**One sidewalk
on the south
side**

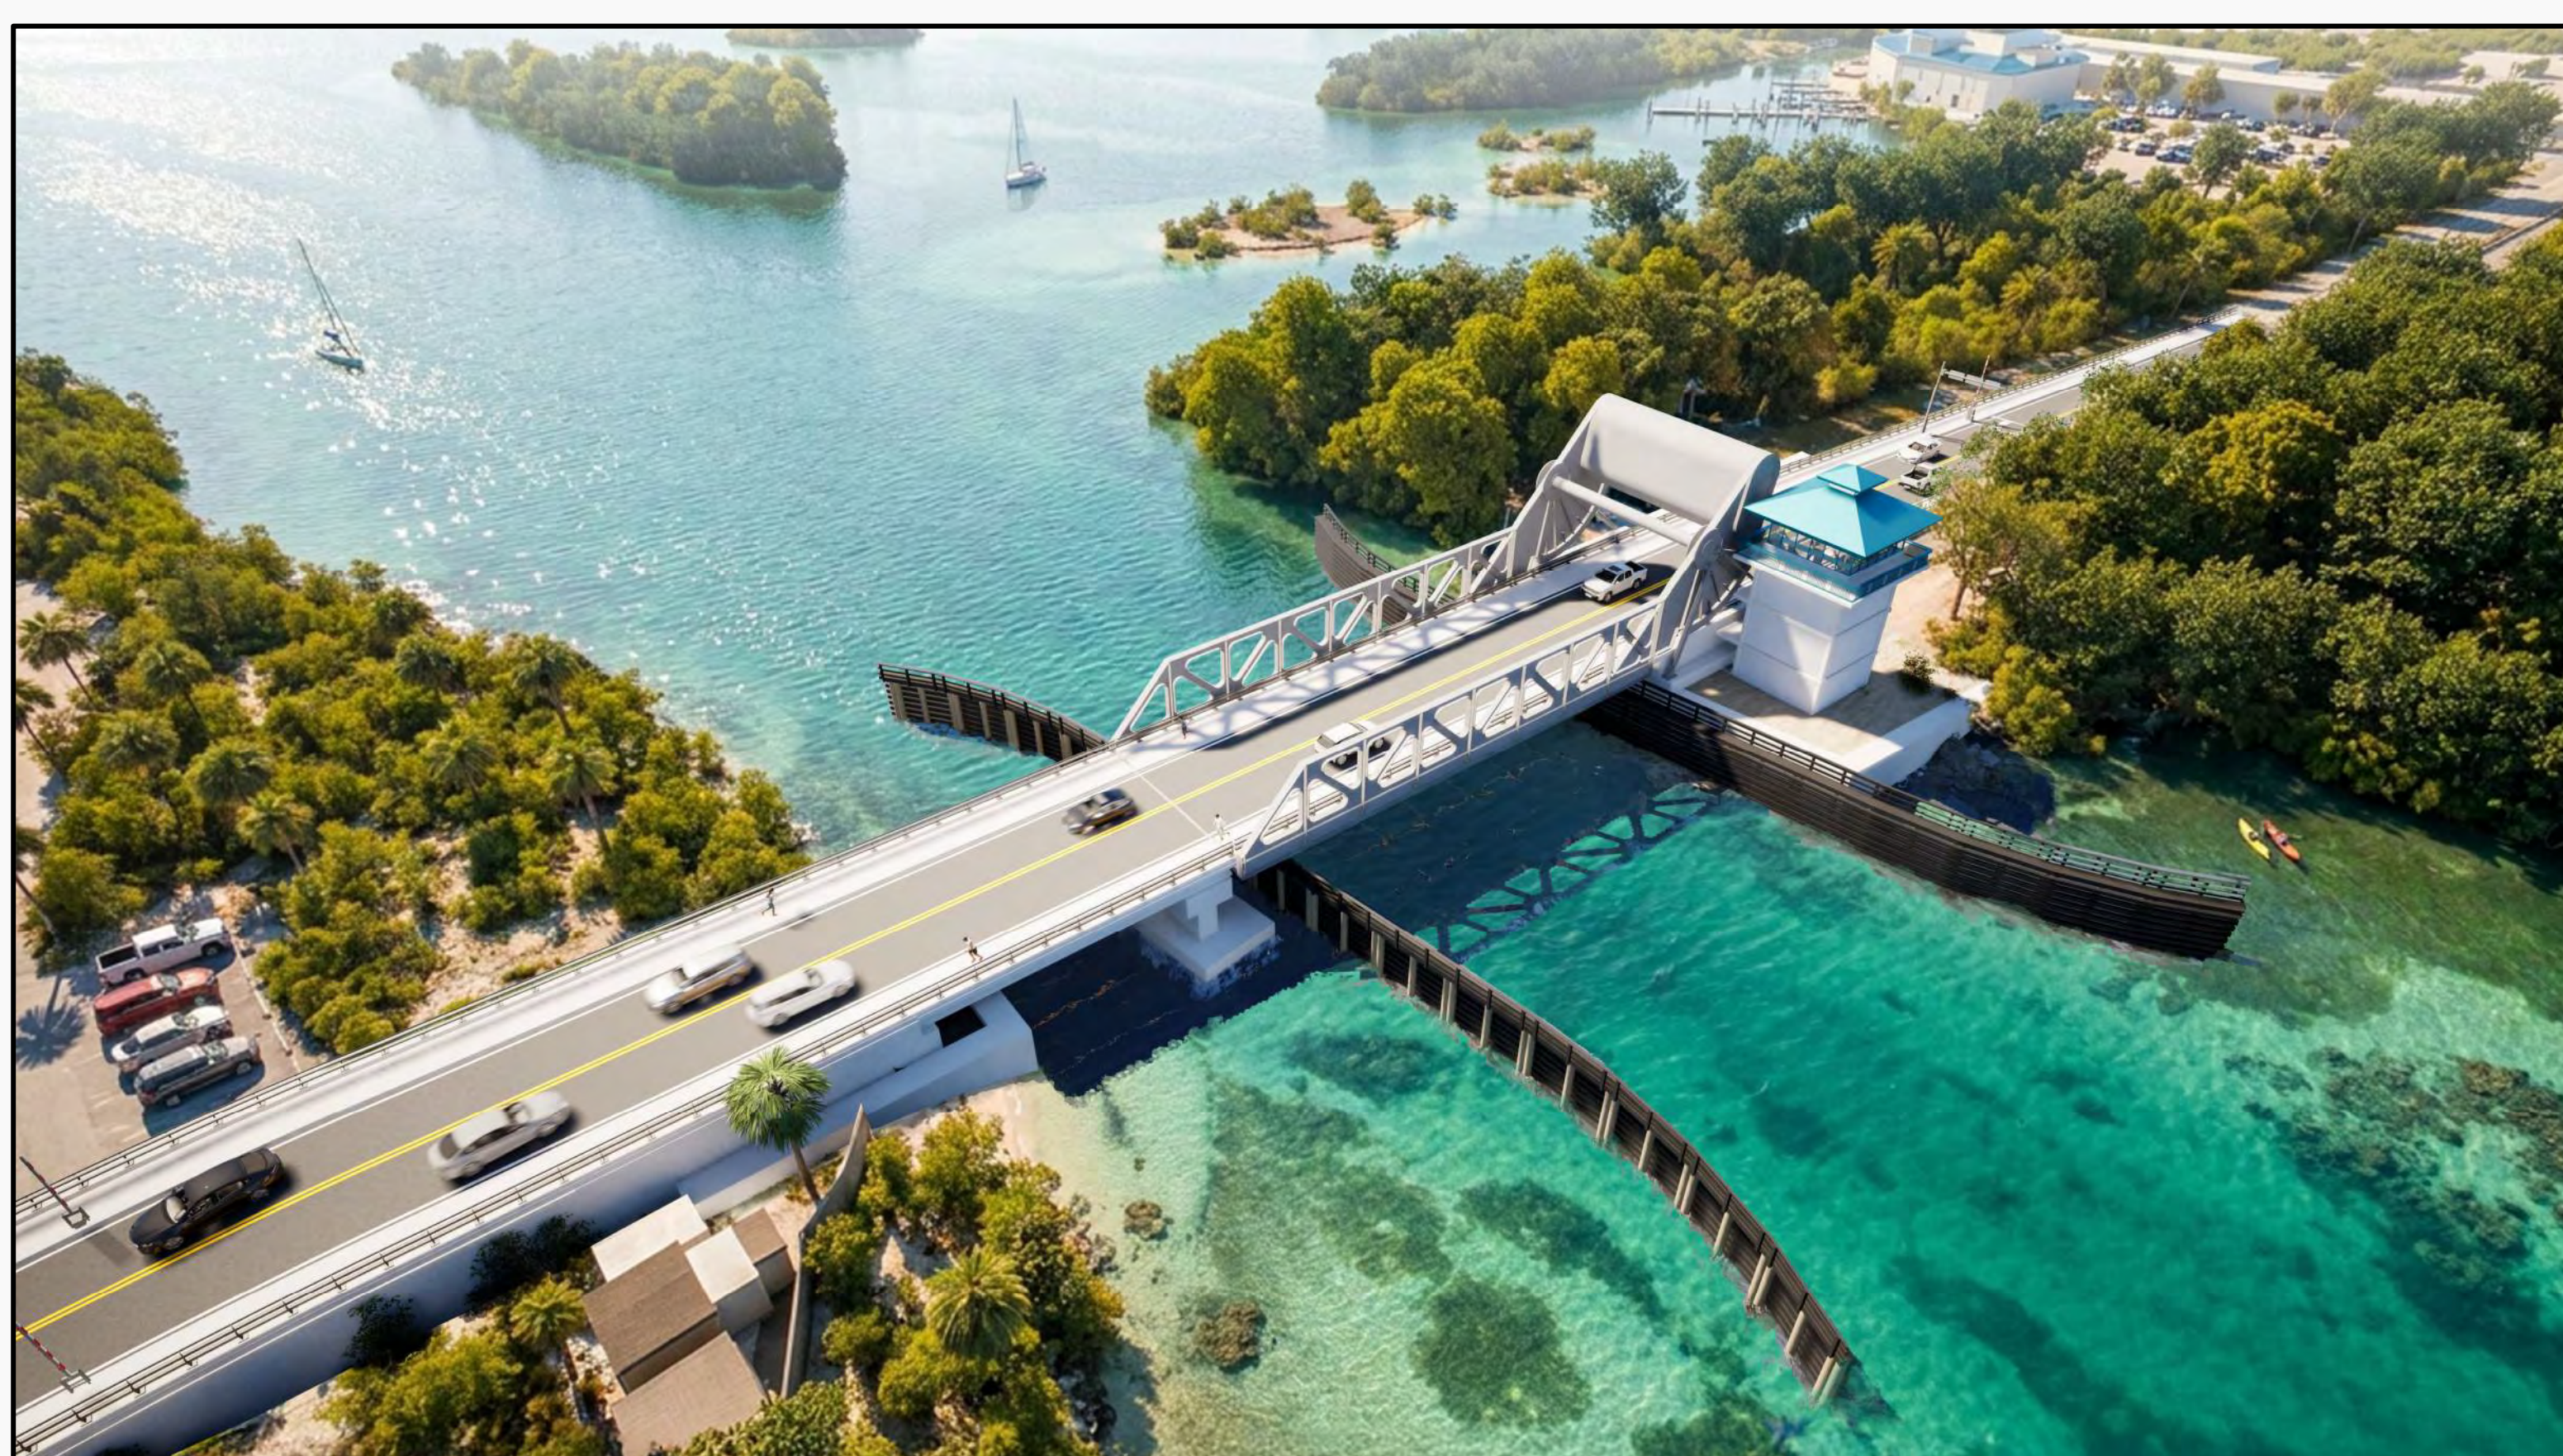
**Two-Lane
Bascule Span**

**Two sidewalks,
one on each
side**

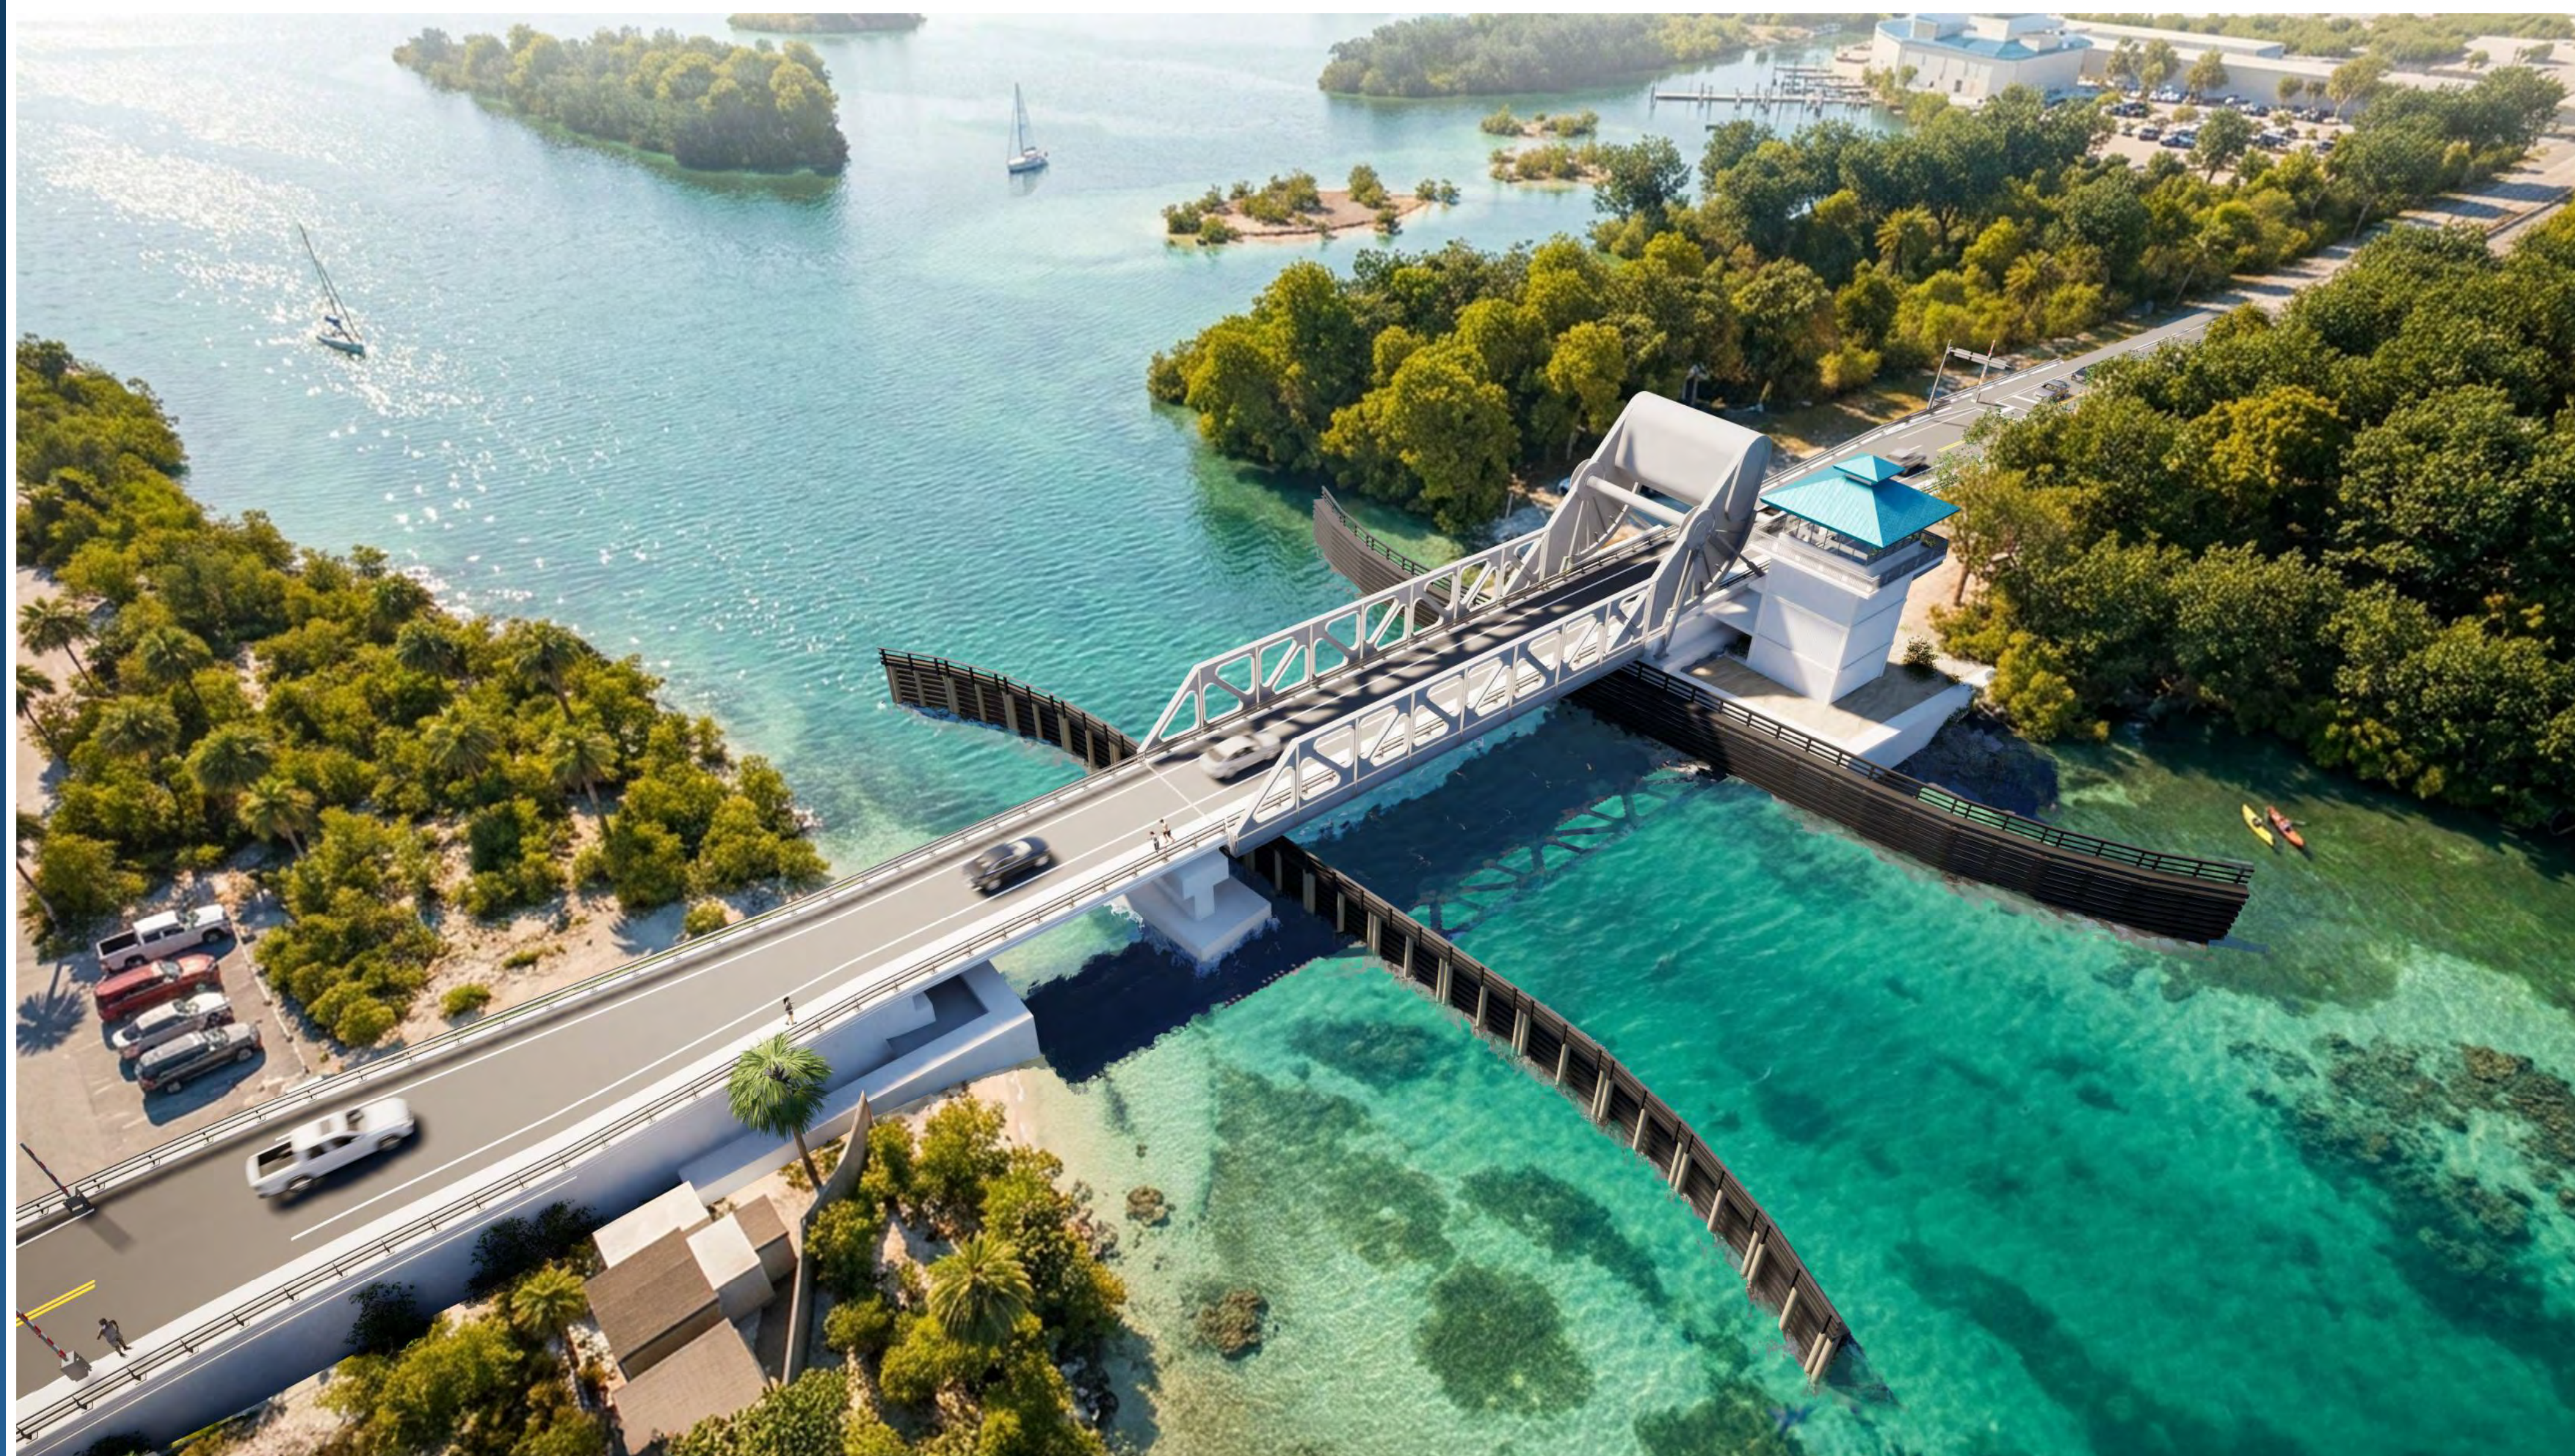
SINGLE-LANE BASCULE BRIDGE WITH ONE SIDEWALK

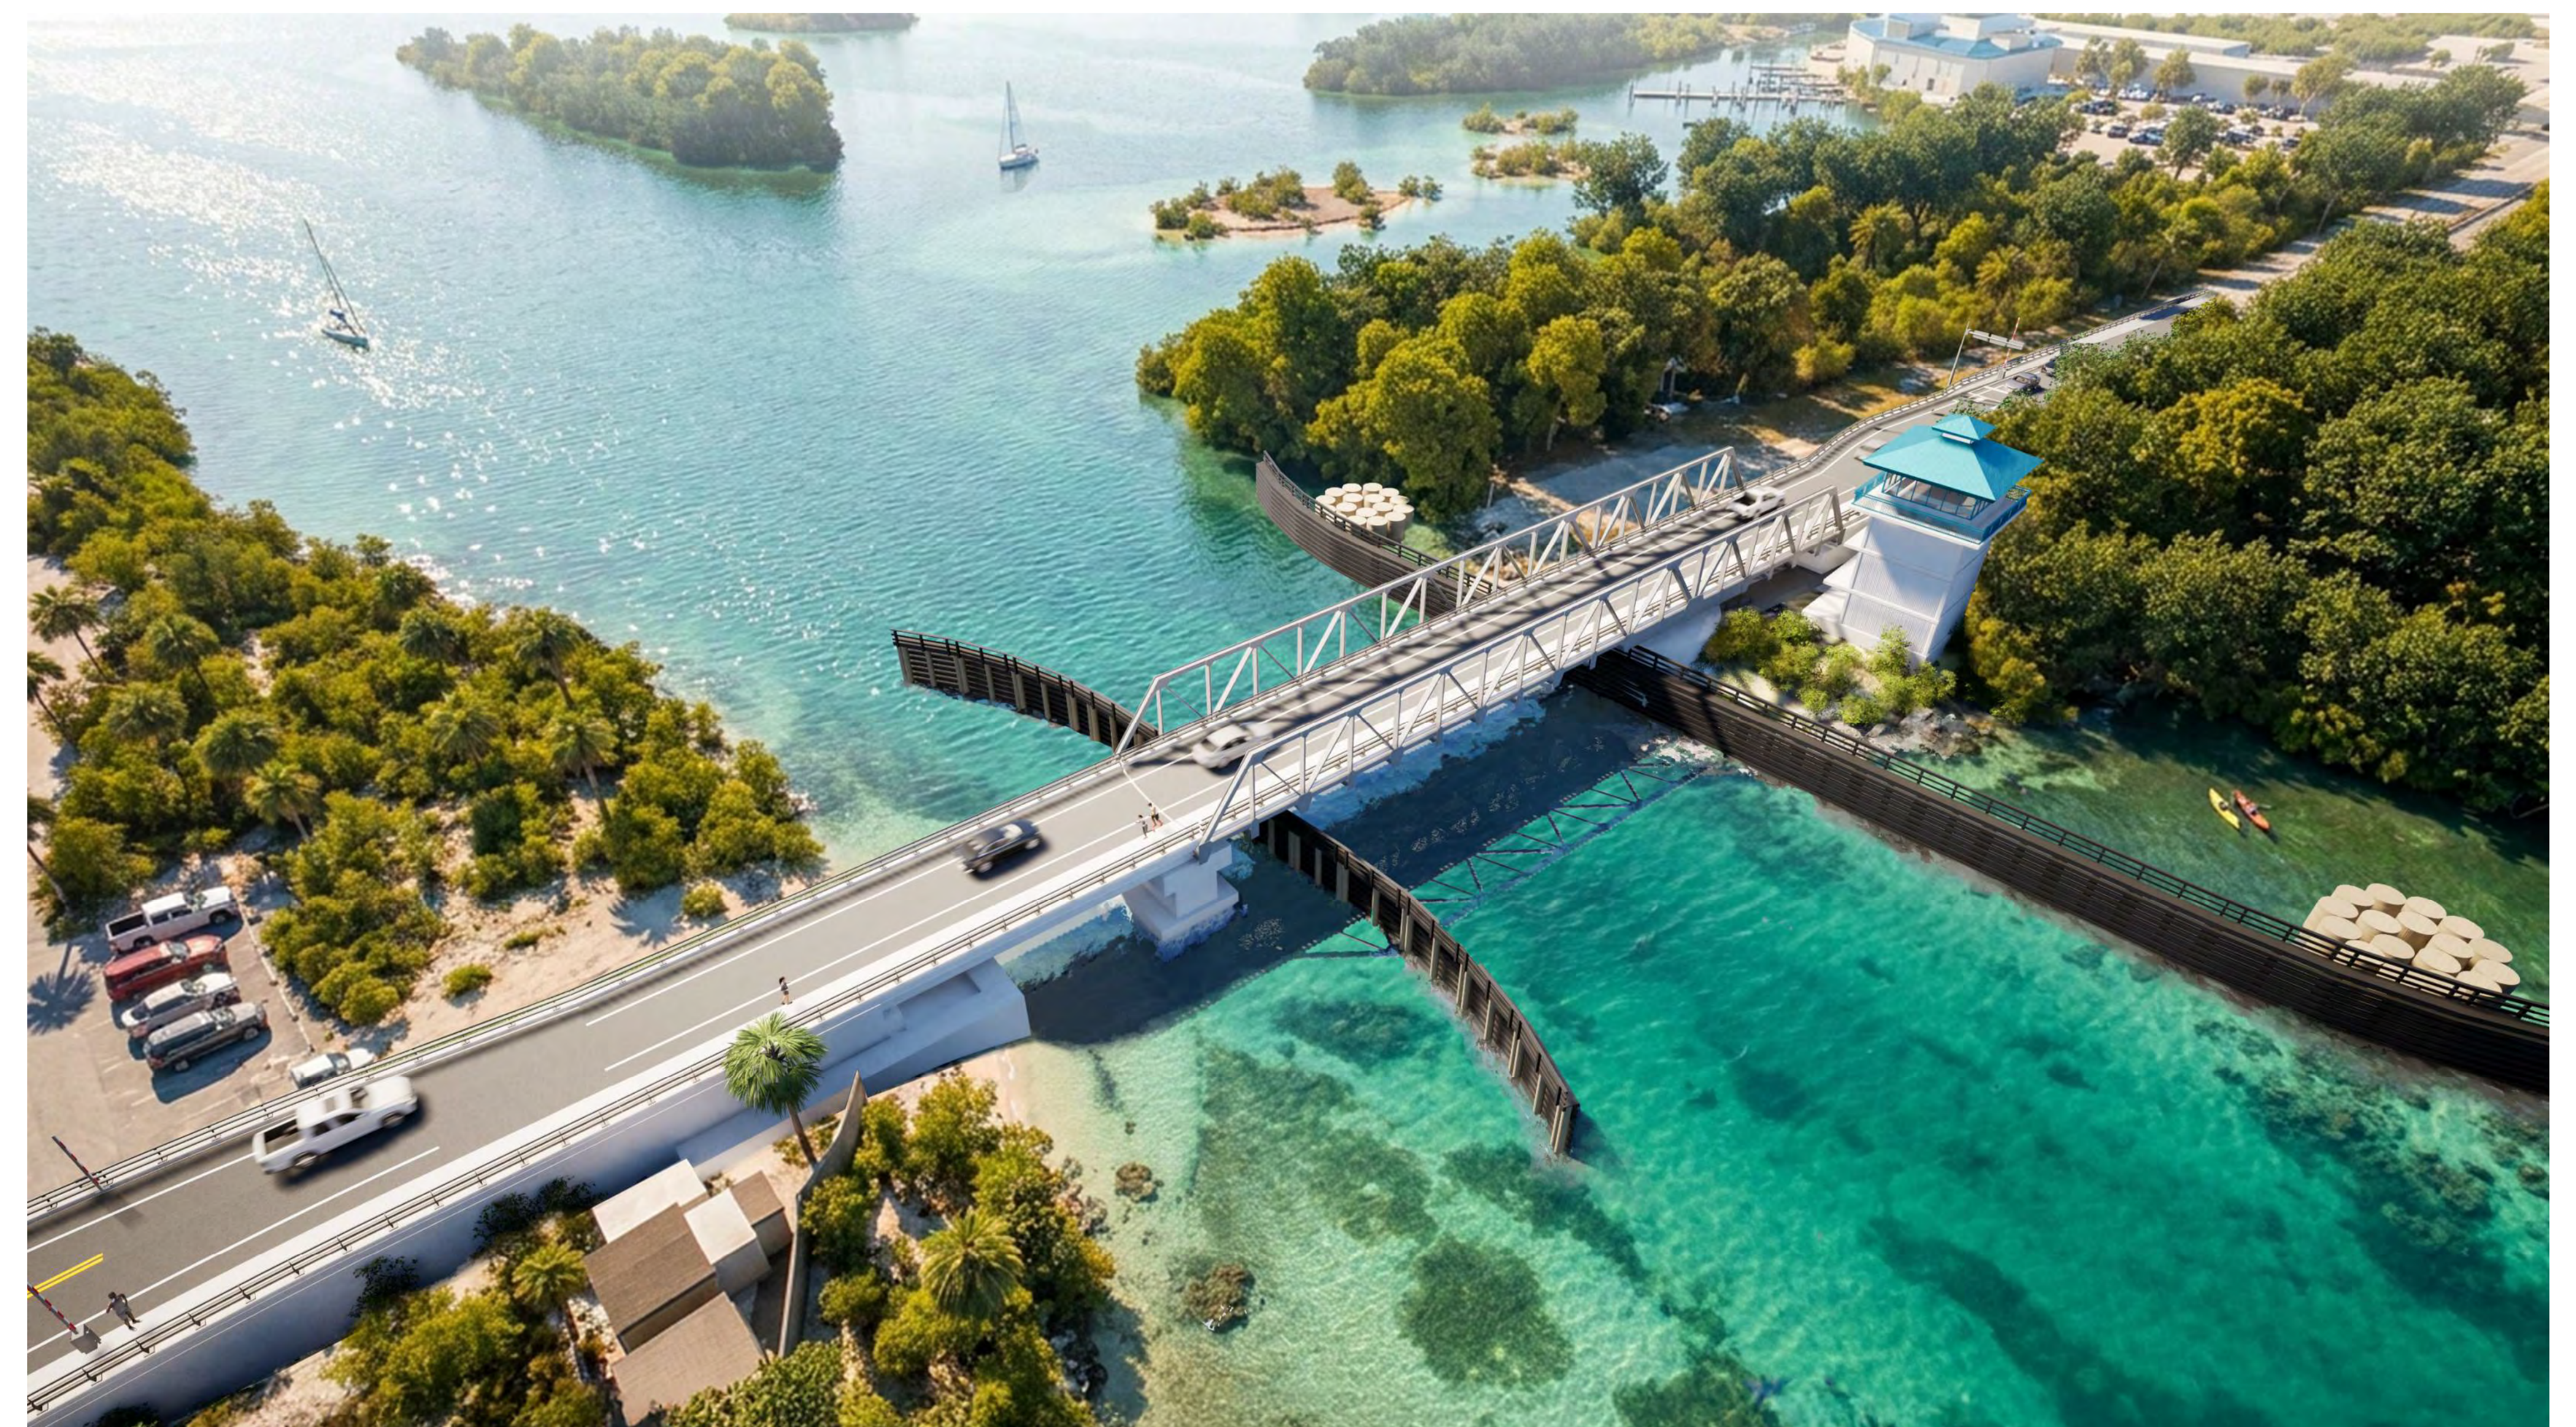
SINGLE-LANE SWING BRIDGE WITH ONE SIDEWALK

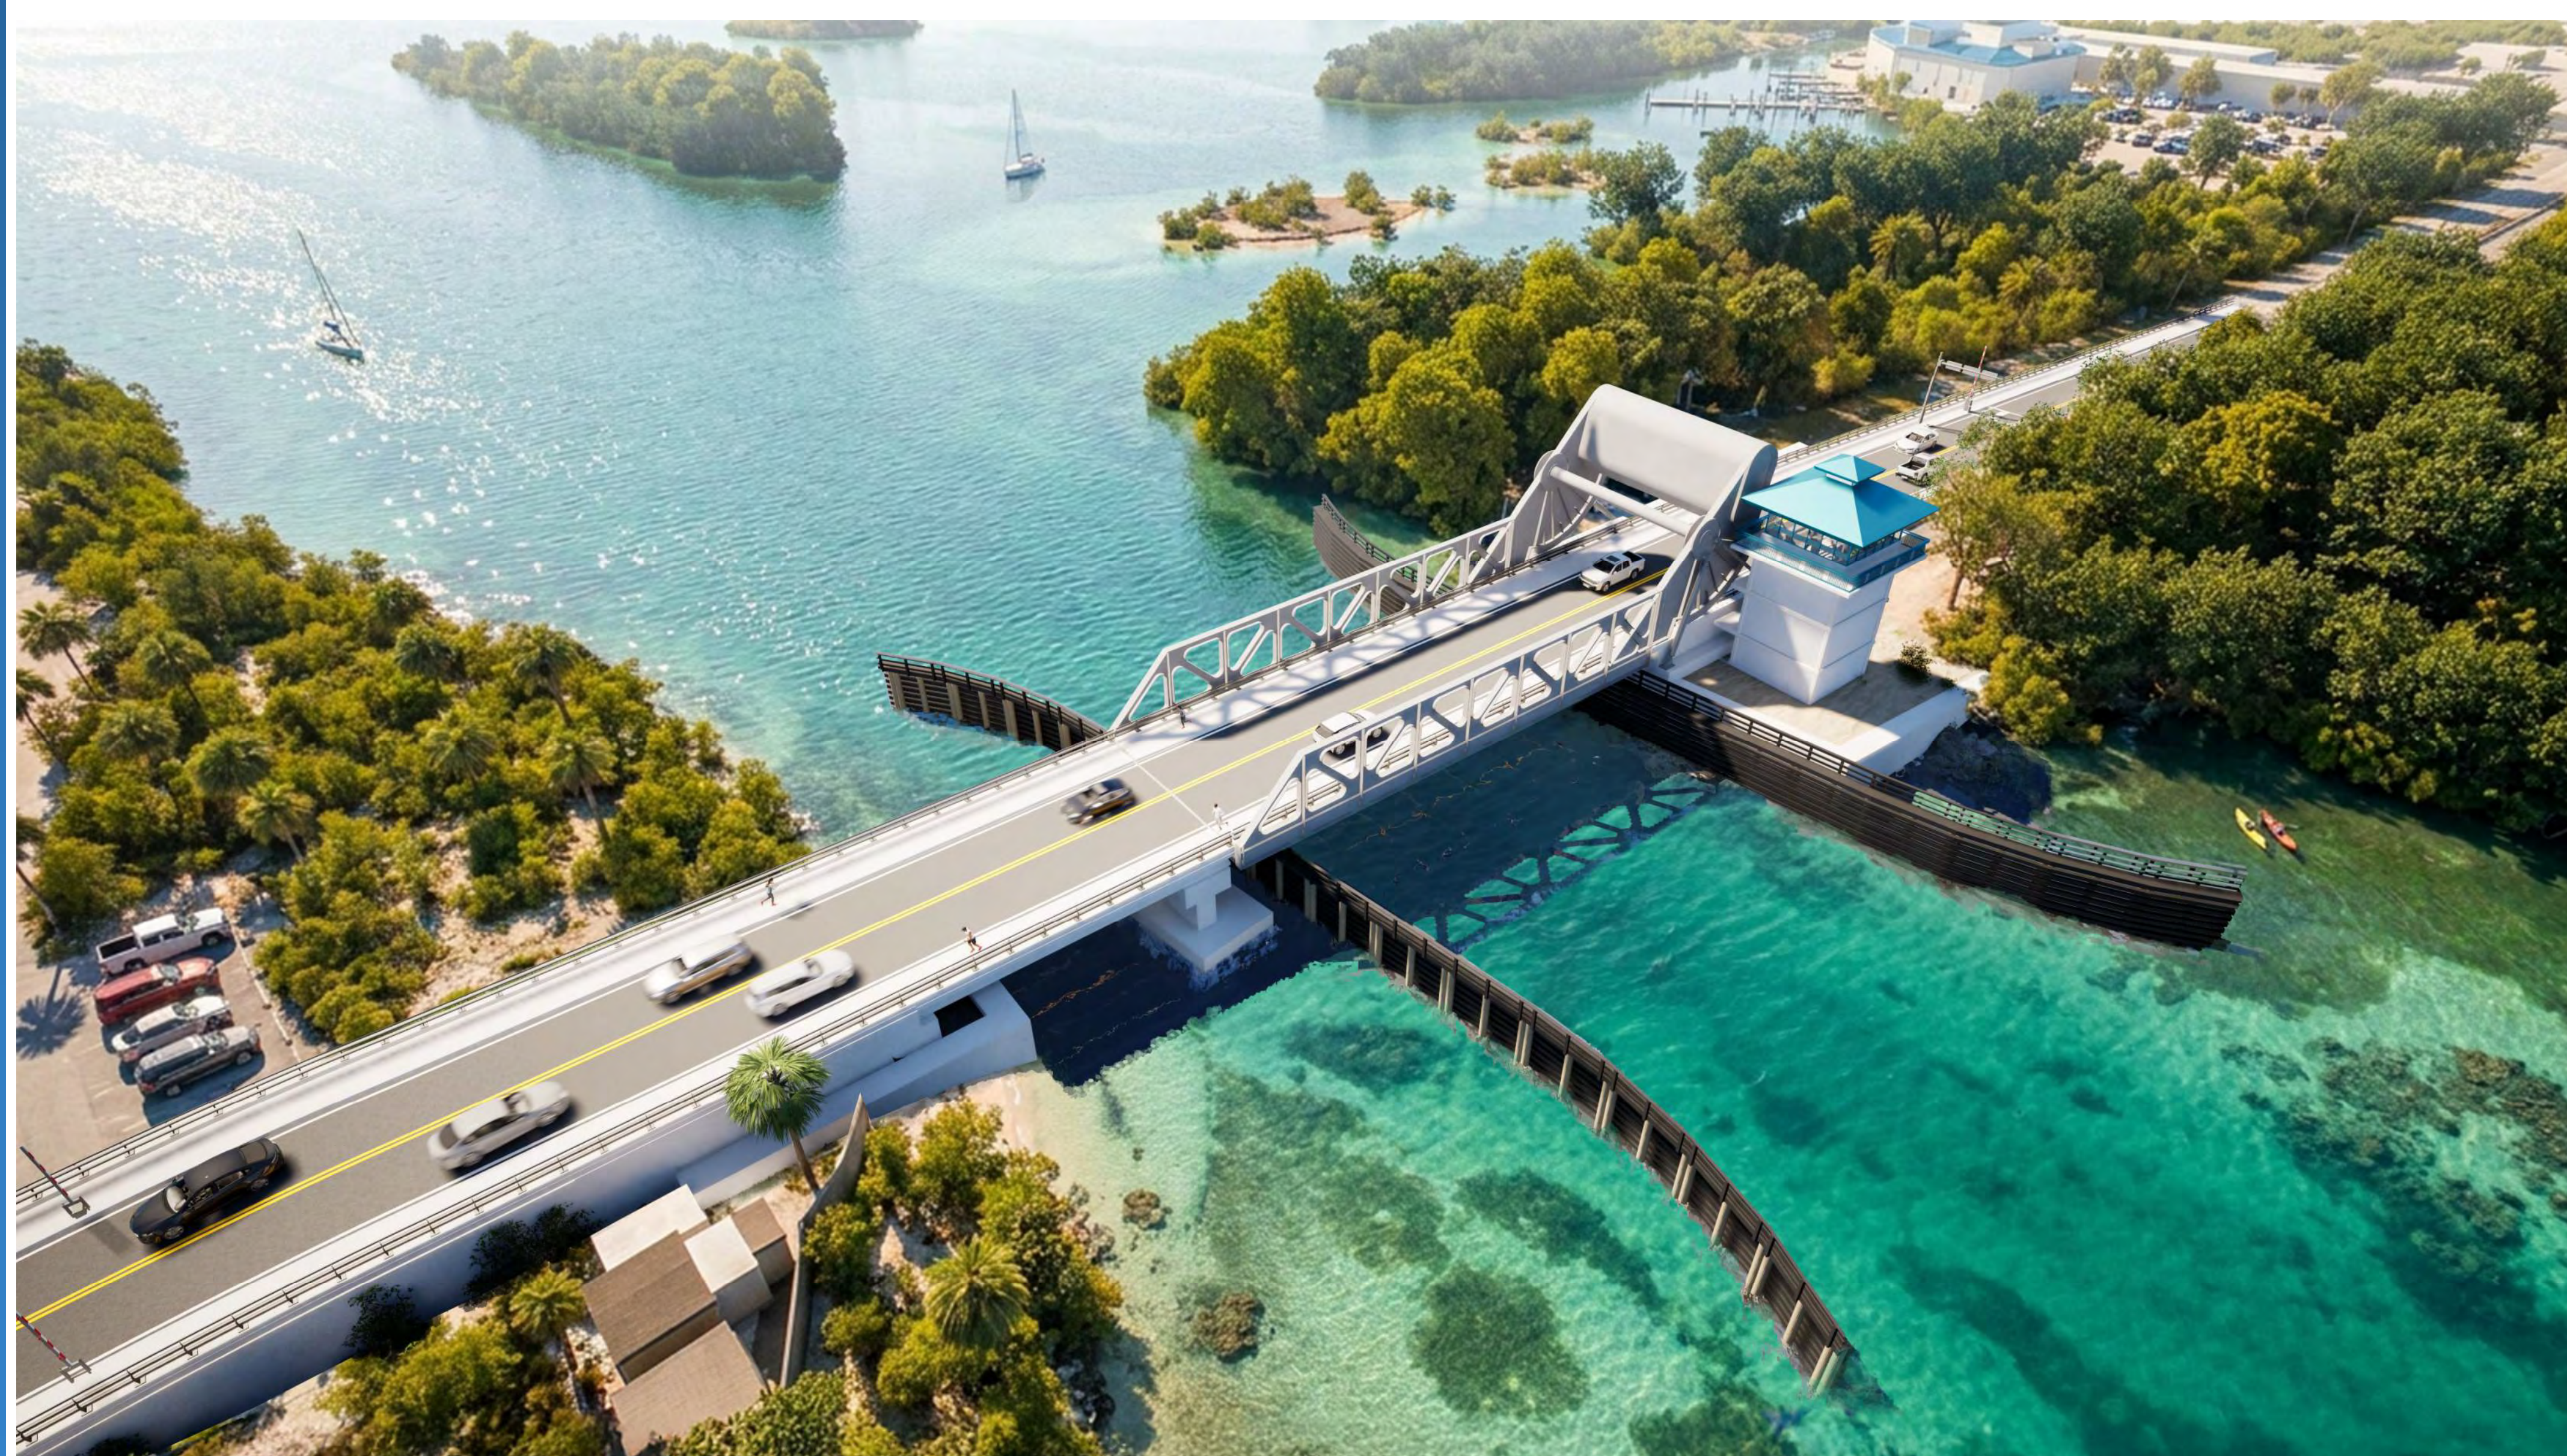
TWO-LANE BASCULE BRIDGE WITH TWO SIDEWALKS

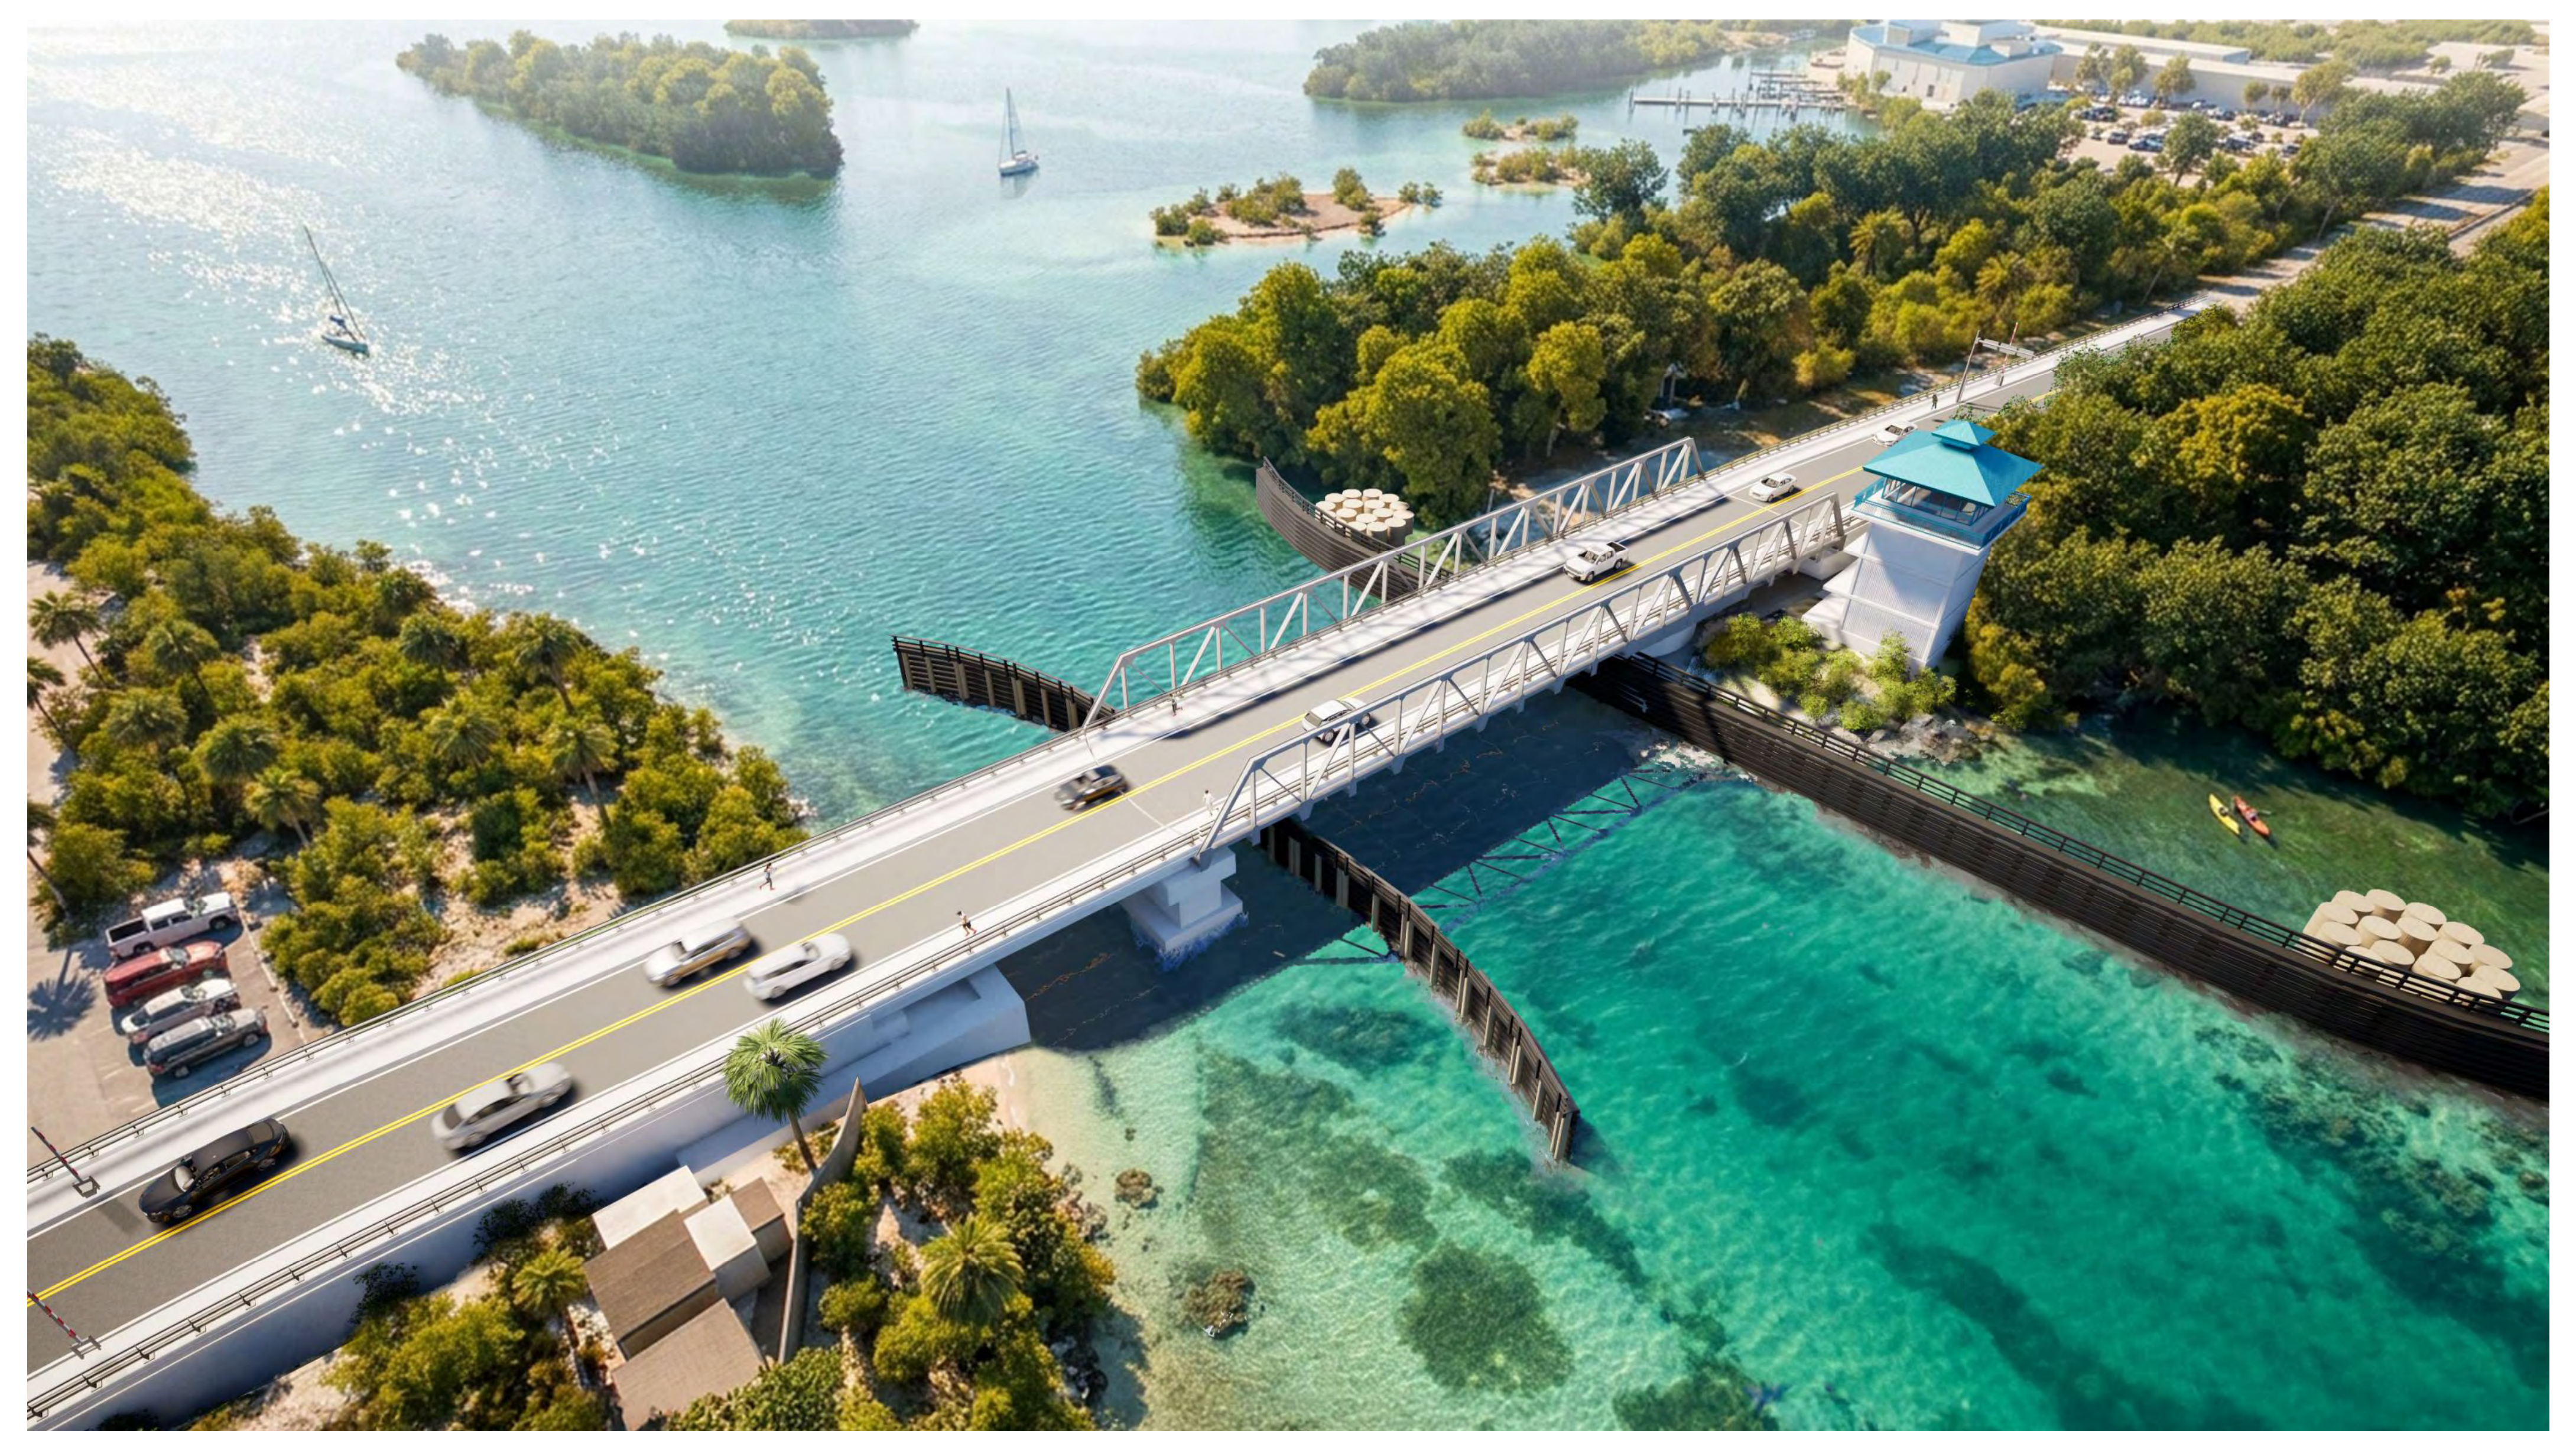
TWO-LANE SWING BRIDGE WITH TWO SIDEWALKS
