TO THE ALTERNATIVES PUBLIC MEETING FOR THE BLACKBURN POINT BRIDGE REPLACEMENT STUDY

Purpose and Need: The purpose of the project is to review alternatives to replace the Blackburn Point Bridge (Bridge No. 170064) on Blackburn Point Road (County Road (CR) 789) over the Gulf Intracoastal Waterway in Osprey, Sarasota County, Florida. The need for the project is based on the following criteria:

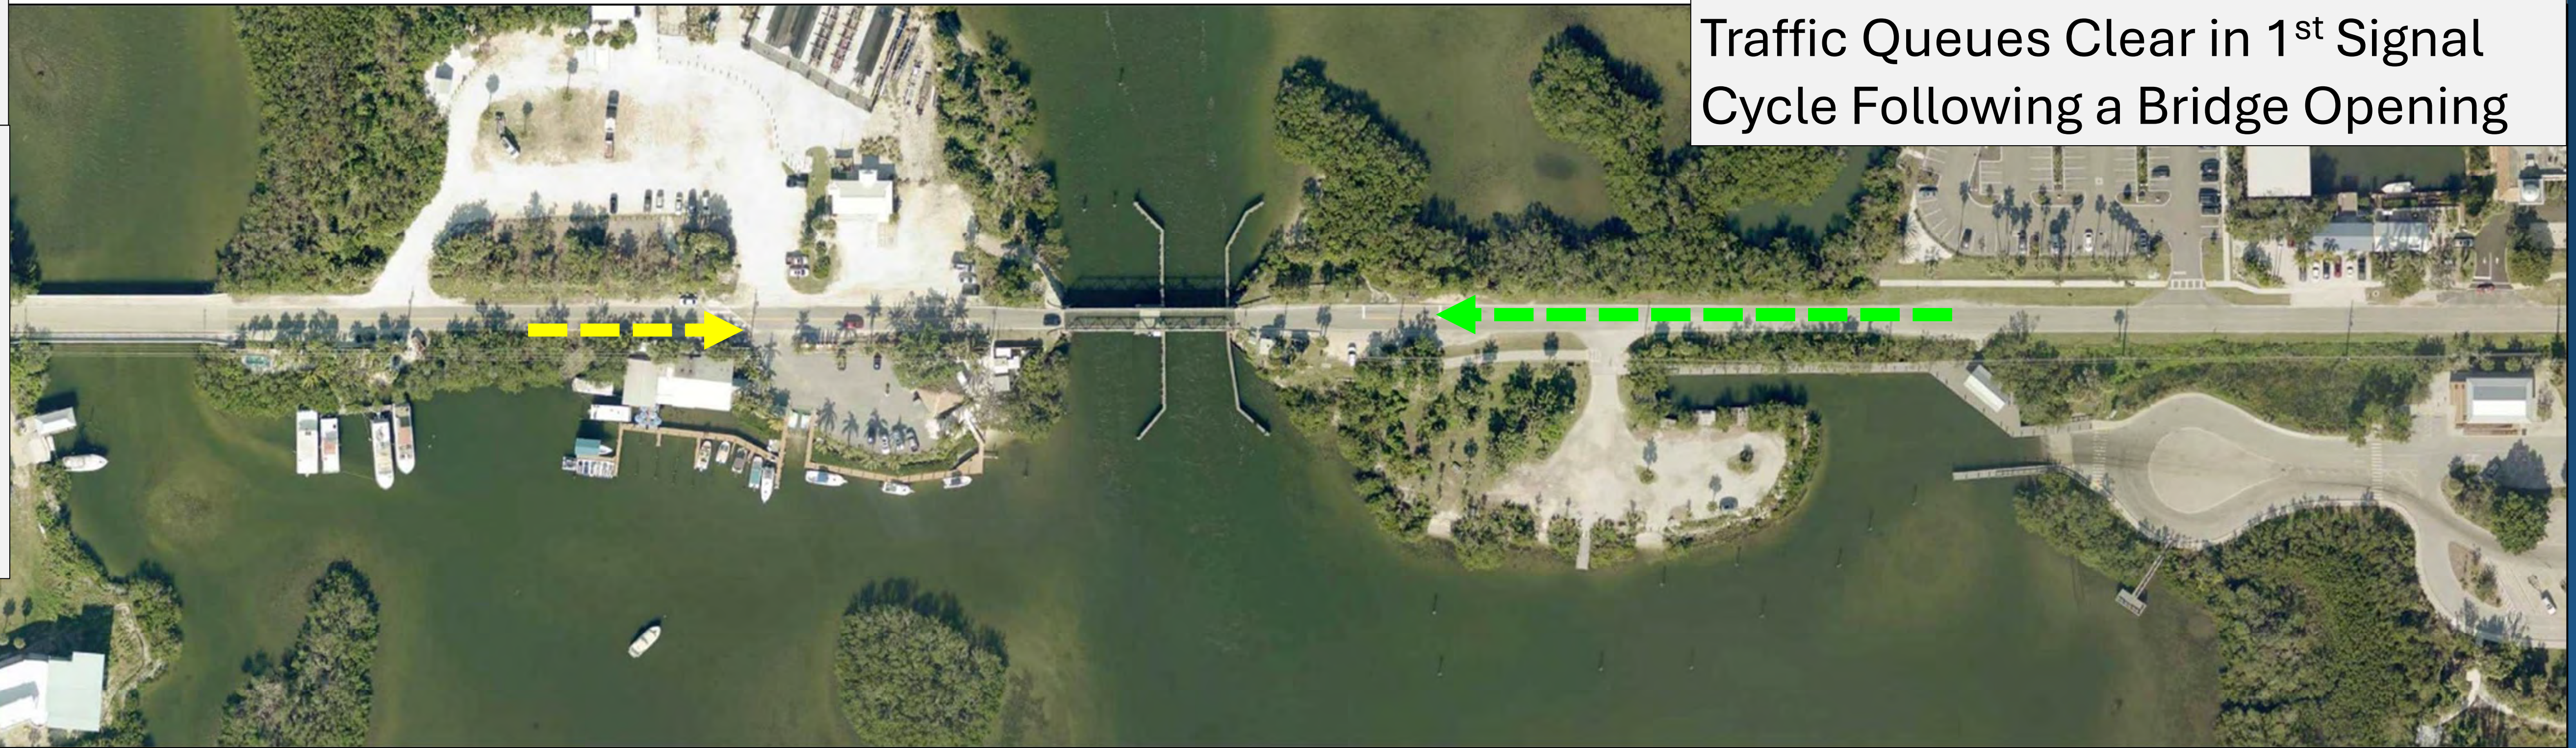
AM Peak Hour Traffic – Queue following a 7-minute Bridge Opening

- Each Signal Cycle is 195 seconds, including 70 seconds green each direction
- Bridge operations are assumed every 20 minutes

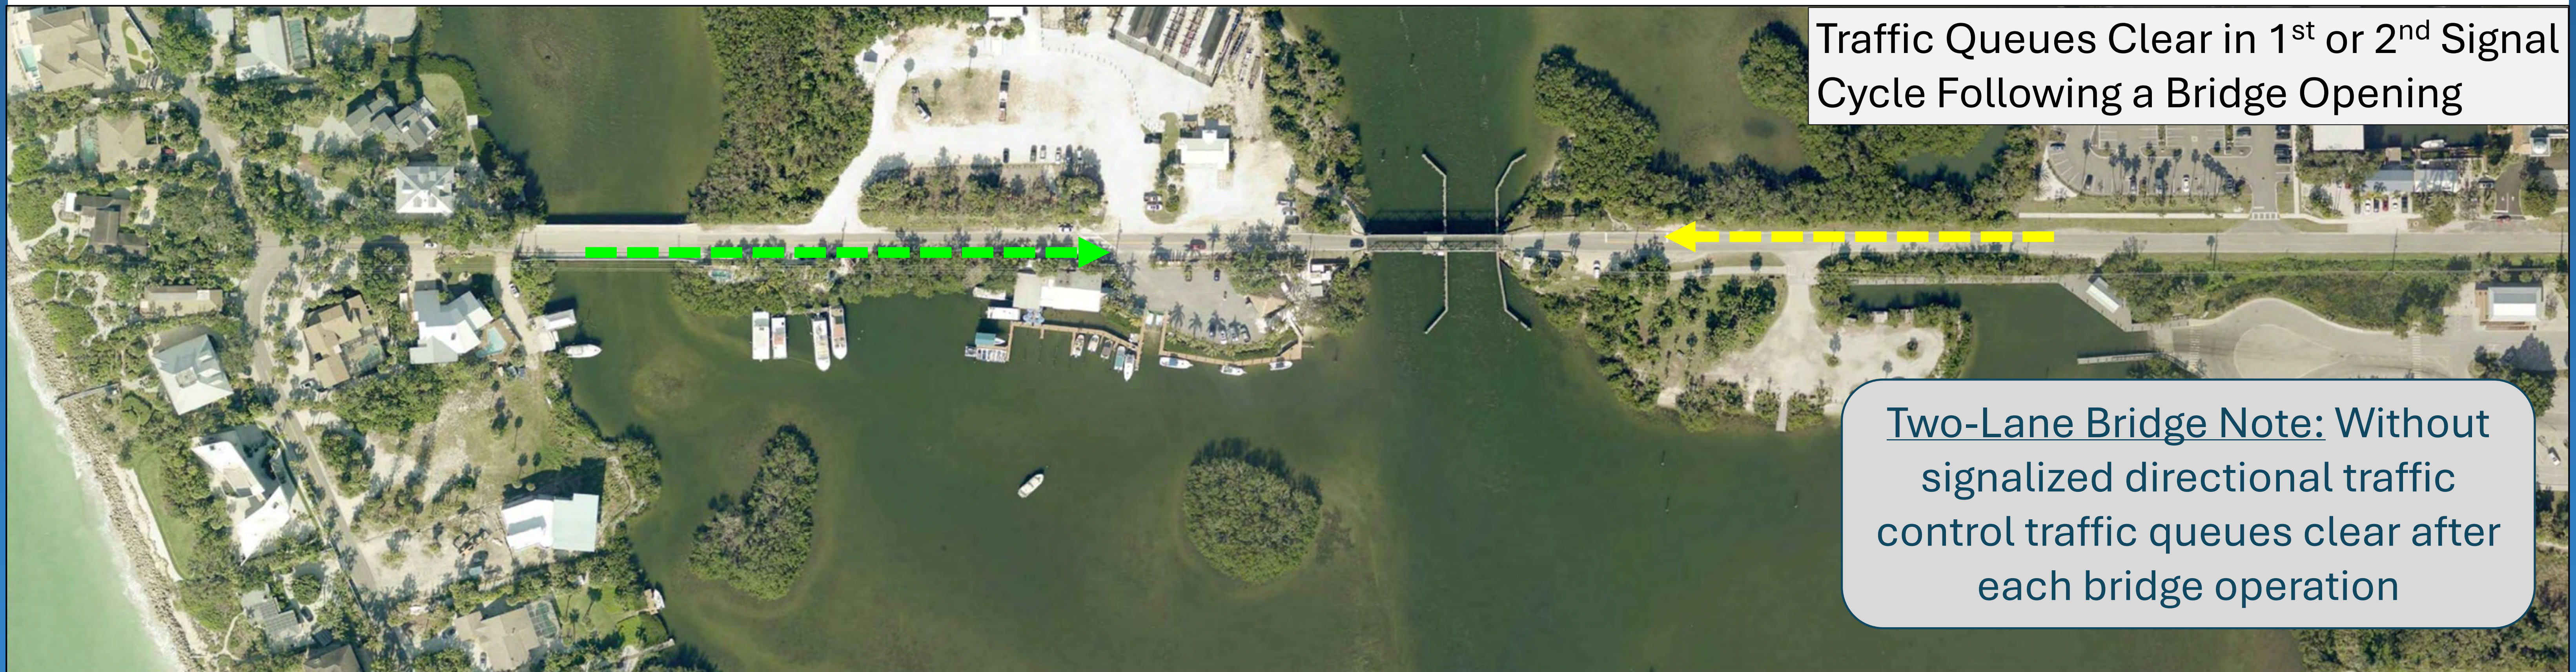
PM Peak Hour Traffic – Queue following a 7-minute Bridge Opening

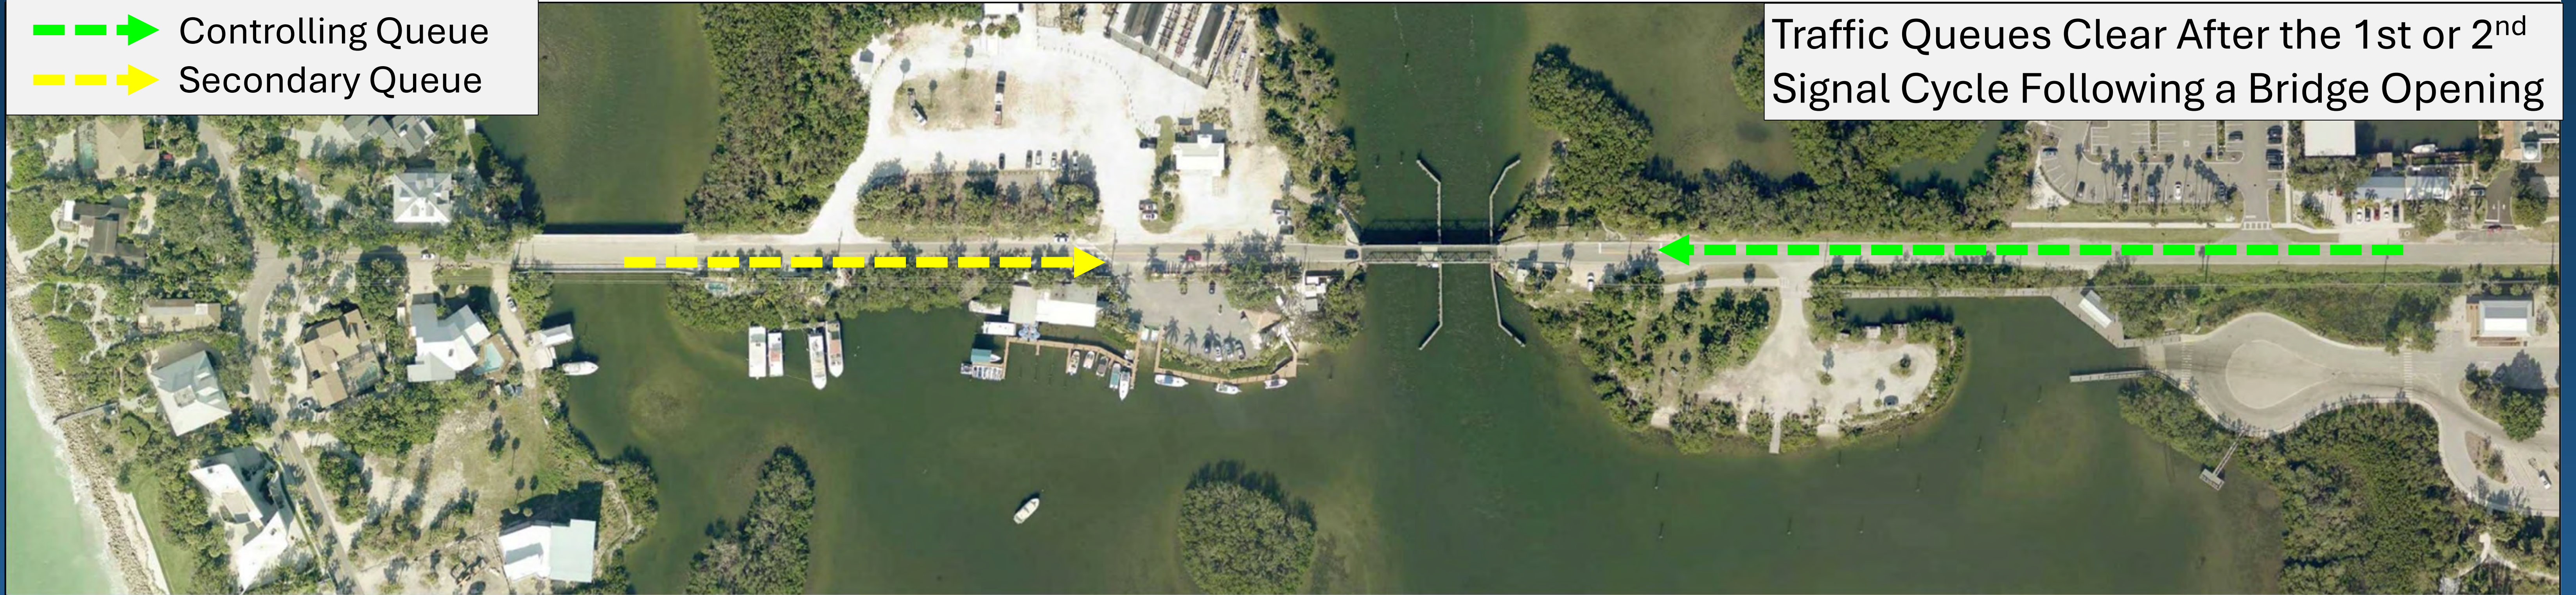
AM Peak Hour Traffic – Queue following a 7-minute Bridge Opening

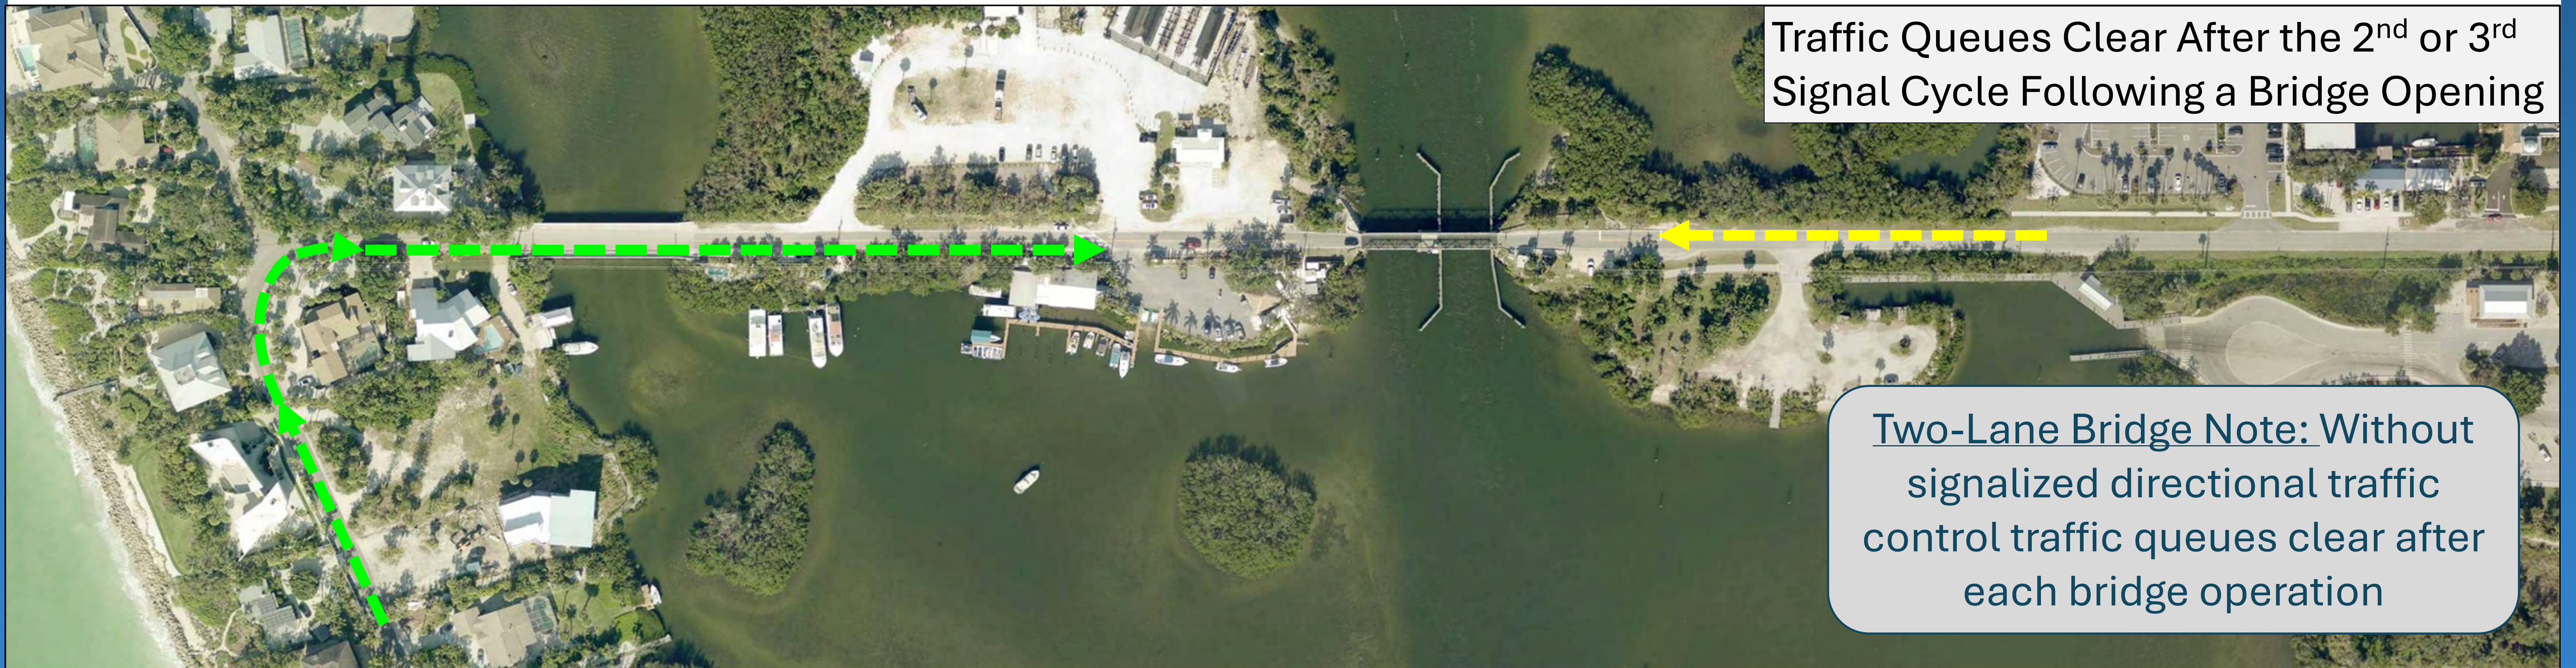
PM Peak Hour Traffic – Queue following a 7-minute Bridge Opening
