The Blackburn Point Bridge Project Development and Environment (PD&E) Study

Project Introduction Presentation

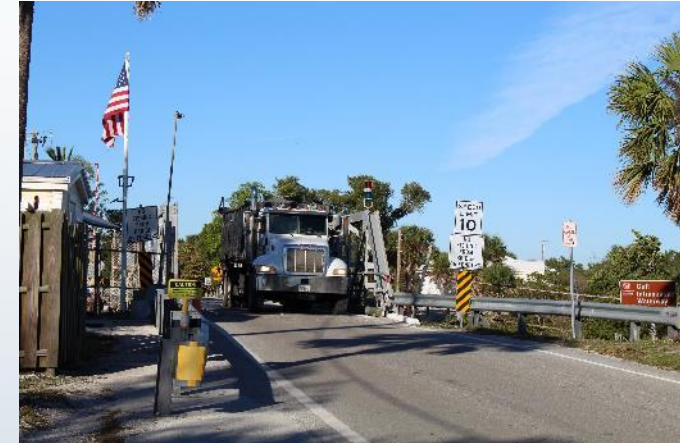
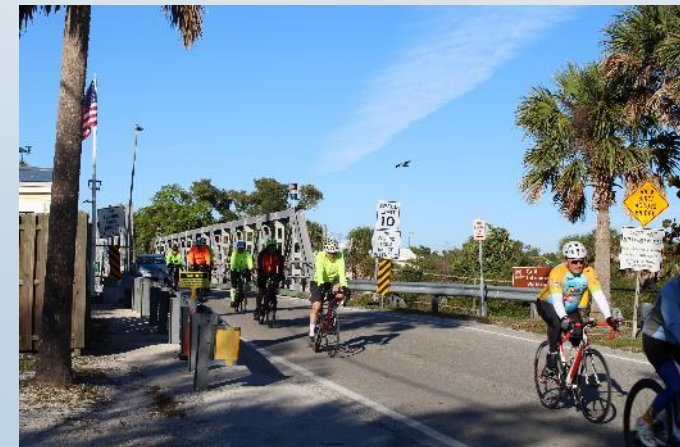
BRIDGE DEFICIENCIES

Blackburn Point Bridge

- Constructed in 1925-26
- Listed on the National Register of Historic Places and the Sarasota County Register of Historic Places
- Substandard features include:
 - Bridge is classified as functionally obsolete (insufficient width)
 - Bridge railings
 - Swing span superstructure and machinery is located in the splash zone

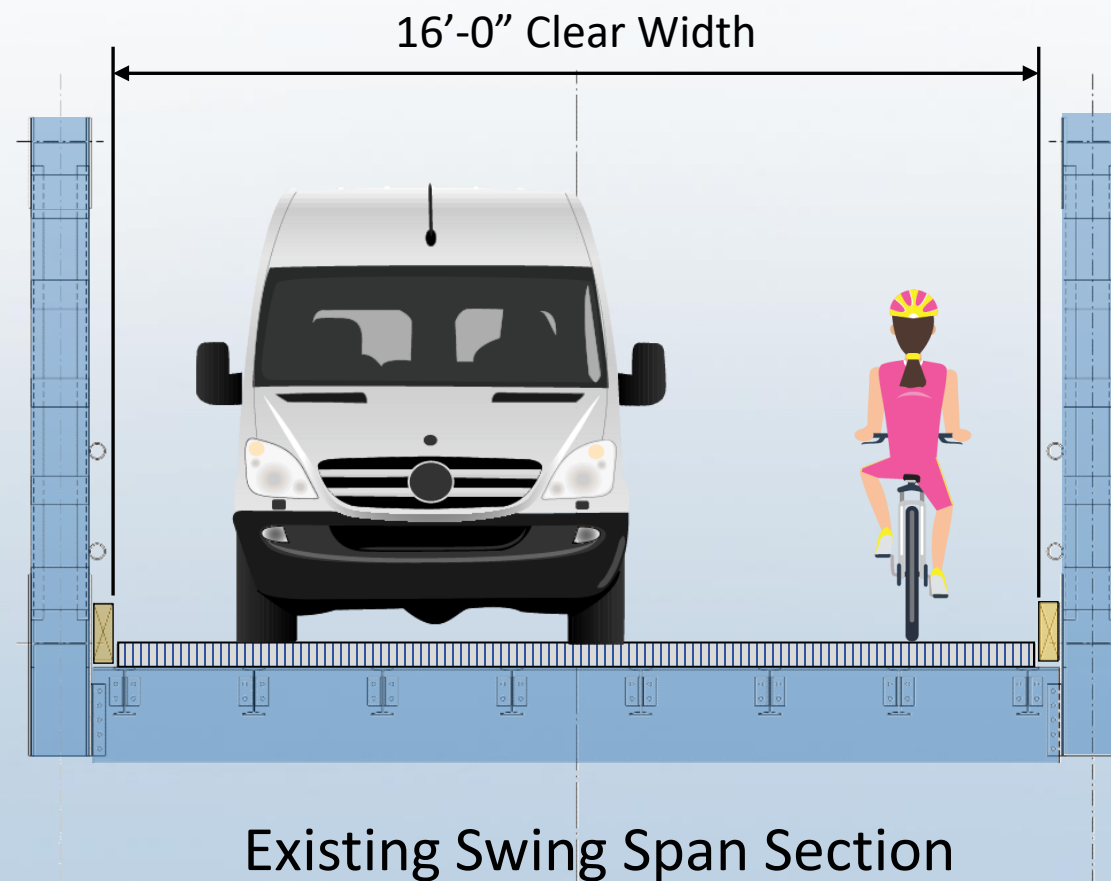
BRIDGE DEFICIENCIES

Bridge Width Deficiencies:

- Substandard clear roadway width of only one, 16-foot-wide travel lane
- Despite frequent daily pedestrian and bicycle use, the bridge does not feature shoulders, sidewalks or bicycle lanes
- Minimum required lane and shoulder widths prescribed by the American Association of State Highway and Transportation Officials (AASHTO) are not met.

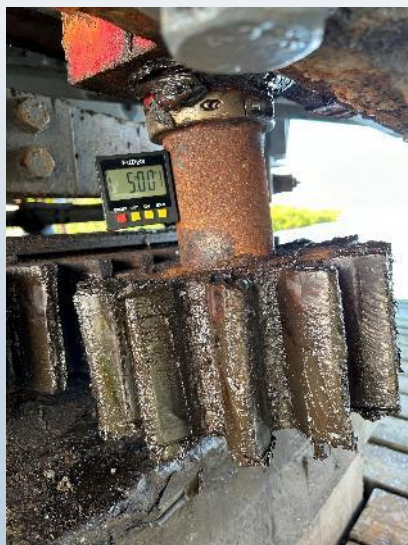
BRIDGE DEFICIENCIES

Ongoing Repairs:

- Pinion shaft was replaced three (3) times in the past four (4) years

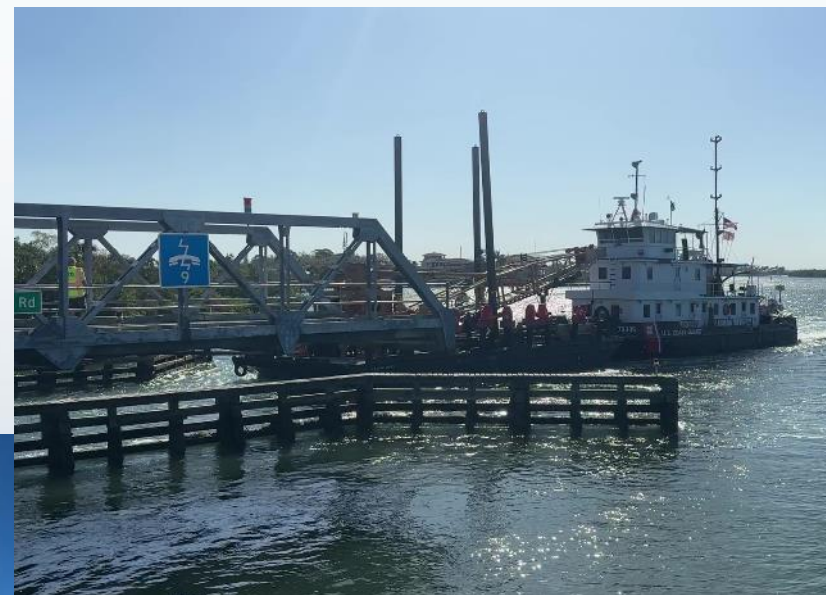
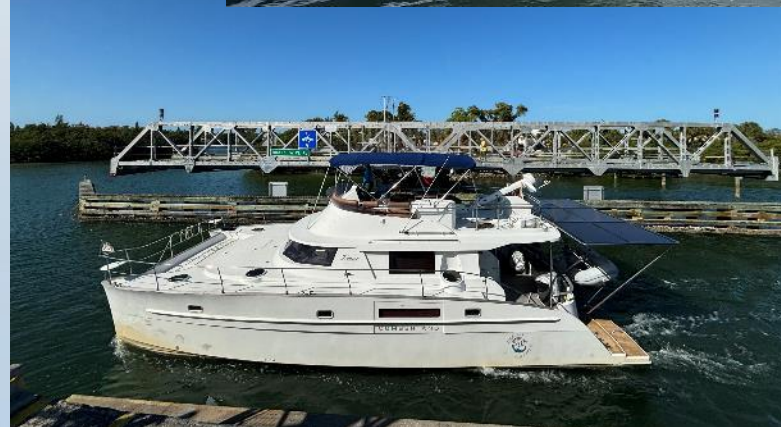
BRIDGE DEFICIENCIES

Substandard Navigational Clearances:

The USCG has determined that the existing navigational clearances are an unreasonable obstruction to navigation for the Gulf Intracoastal Waterway.

Existing Navigation Clearances:

- Horizontal – 51 feet
- Vertical – 9.3 feet

US Coast Guard Guide Clearances (Gulf Intracoastal Waterway):

- Horizontal – 90 feet
- Vertical – 21 feet

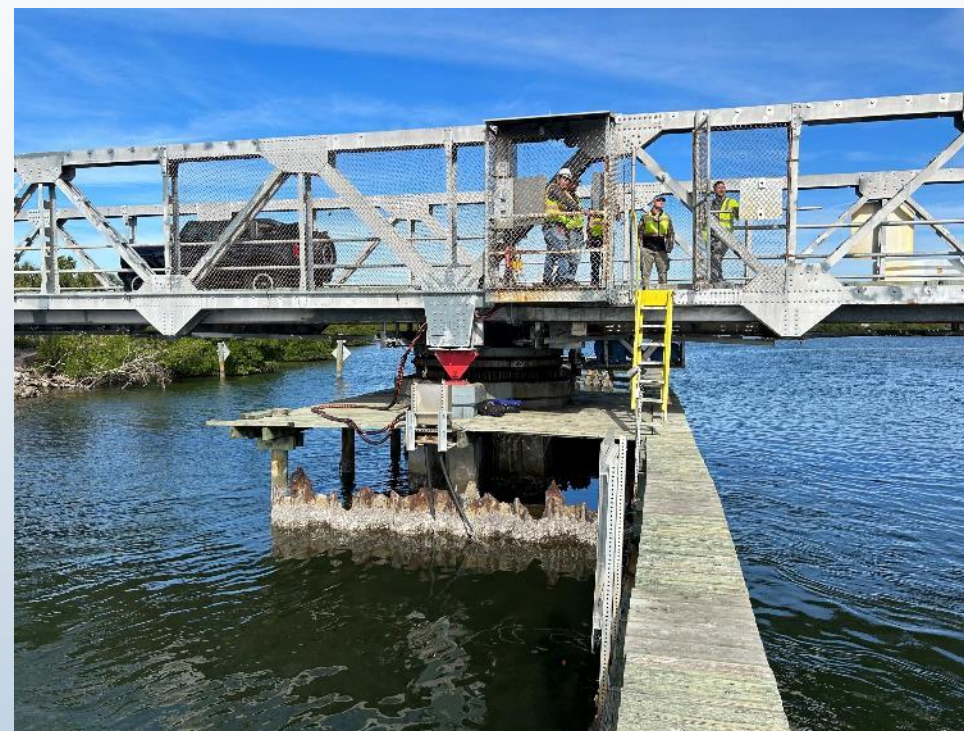
BRIDGE DEFICIENCIES

Marine Vulnerabilities:

- Existing bridge does not meet current standards for protection from damage due to coastal storm wave action
- Existing swing bridge is not capable of sustaining a direct vessel collision
- The existing bridge low members are within the splash zone, subject to:
 - Wave impact in large coastal storms
 - Accelerated corrosion due to saltwater and salt laden air

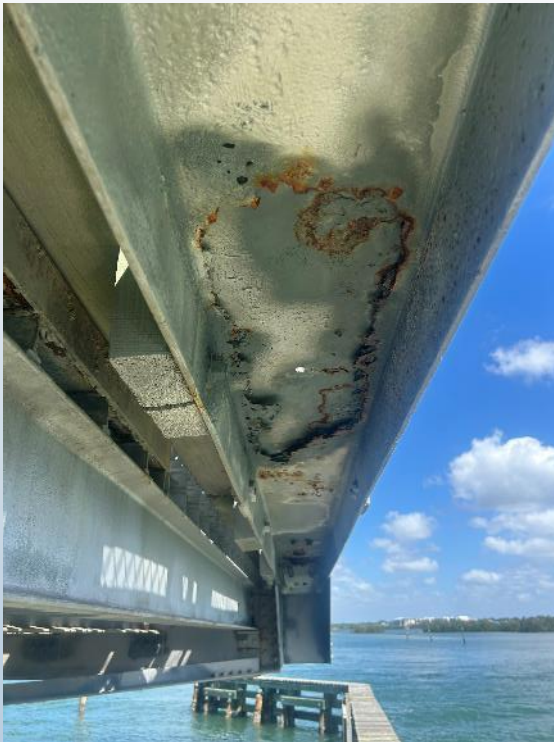
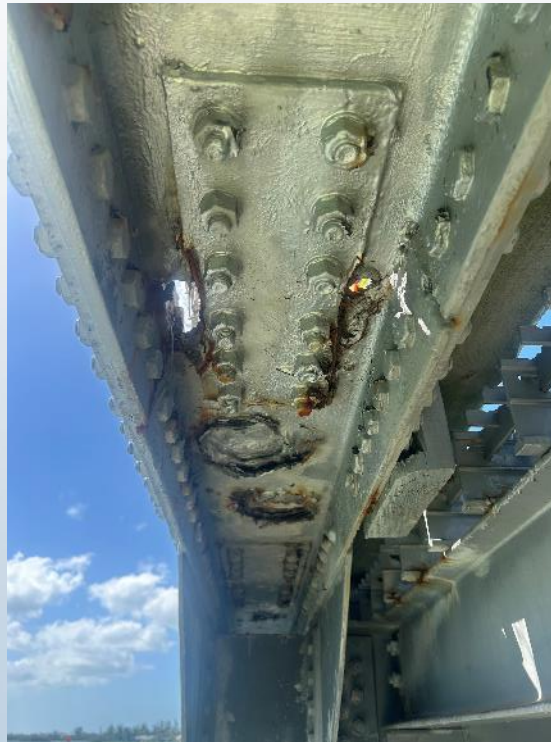
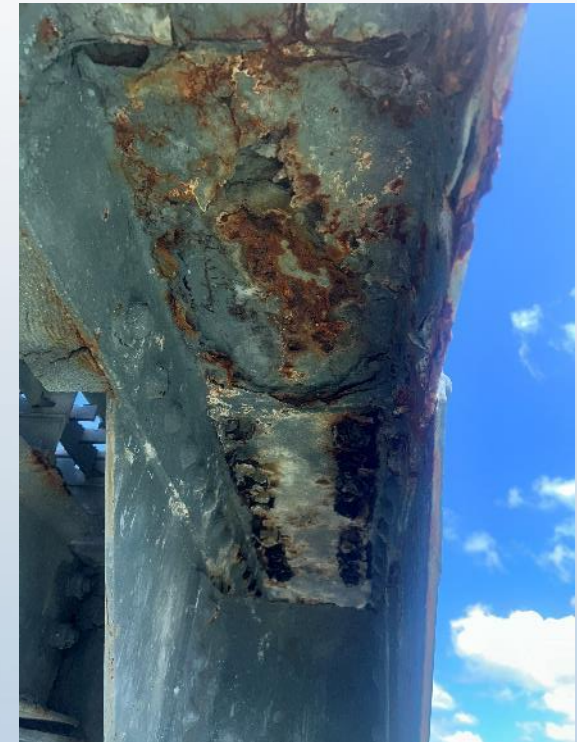
Photographs representative of existing conditions of the swing bridge's main lower truss members

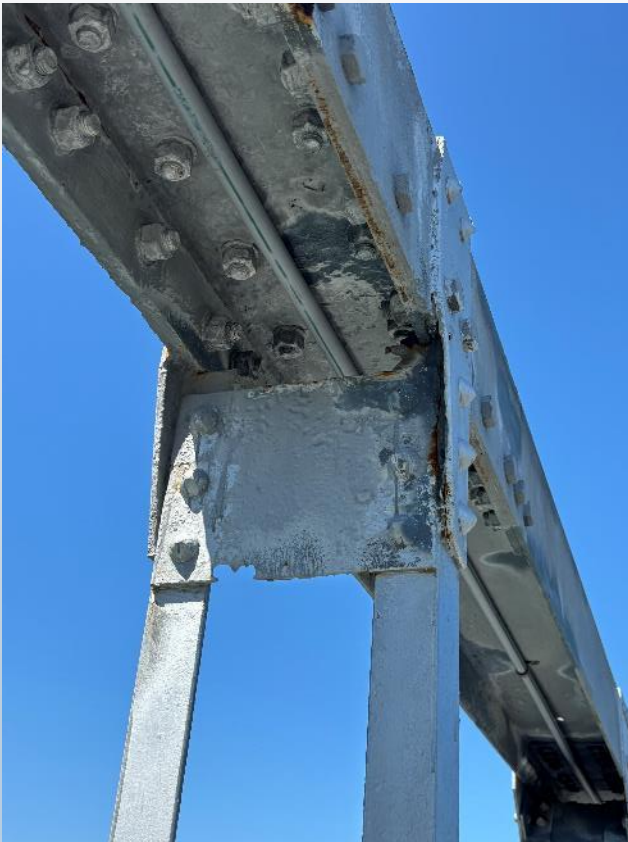
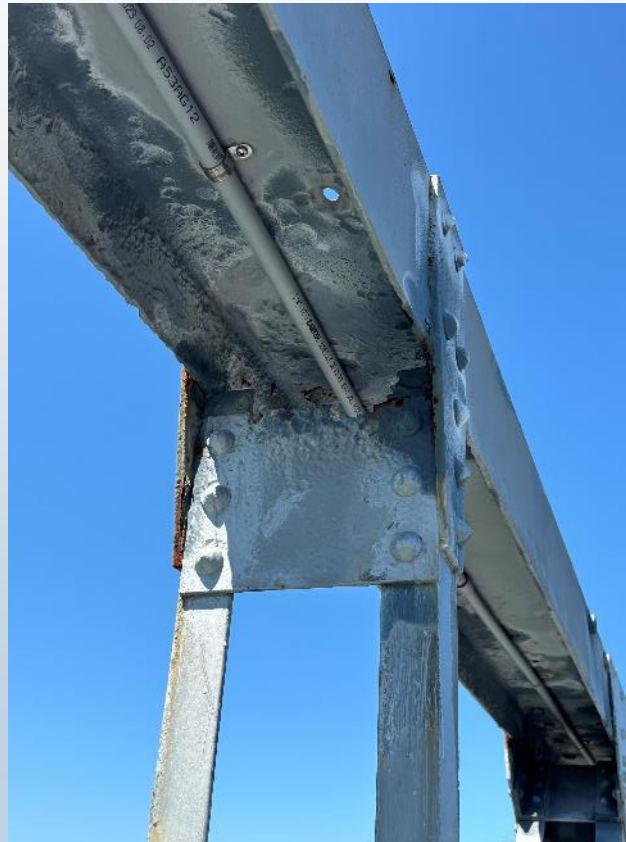
Photographs representative of existing conditions of the swing bridge's main upper truss members

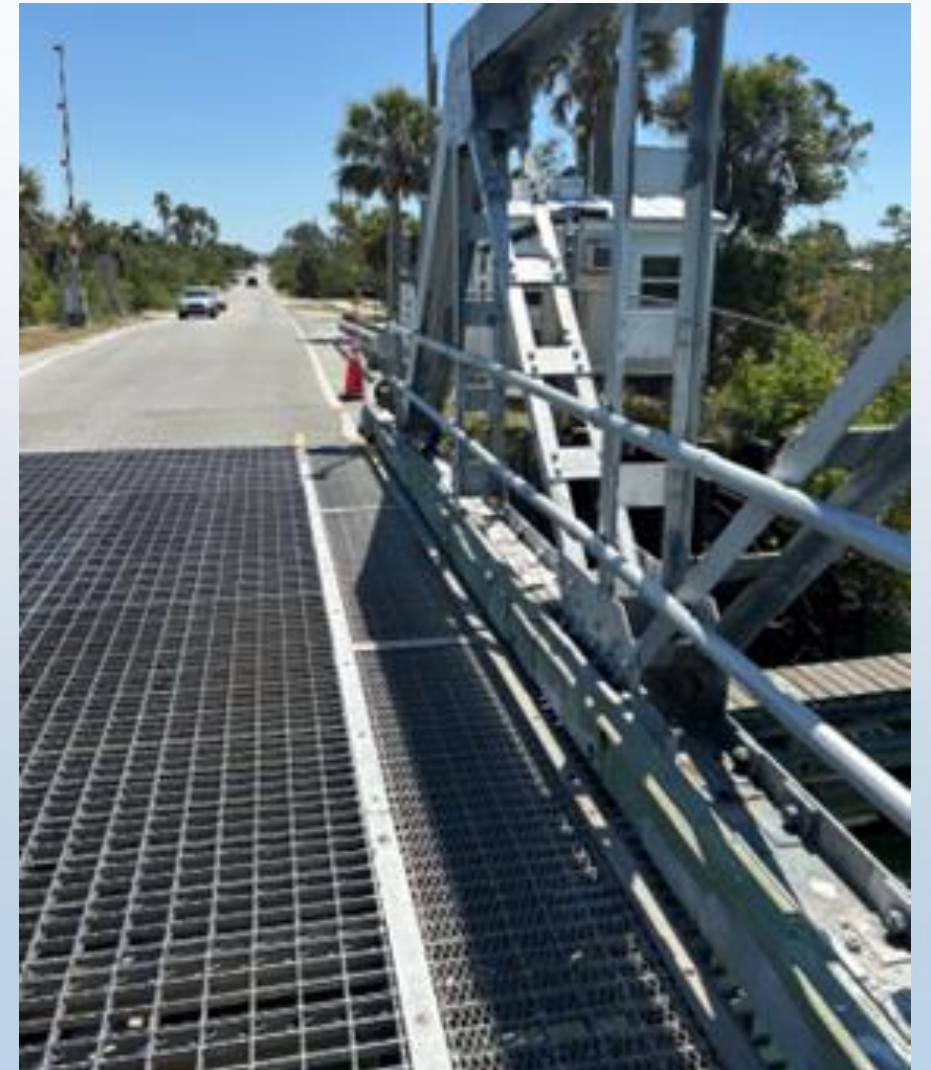
SAFETY

Bridge Railings:

Existing bridge railings do not meet current standards for pedestrians or bicycles.

Existing bridge railings do not meet current geometric and crash testing safety standards for vehicles.

Proposed improvements will provide bridge railings and traffic gates that meet current safety standards for pedestrians, bicyclists, and vehicles.

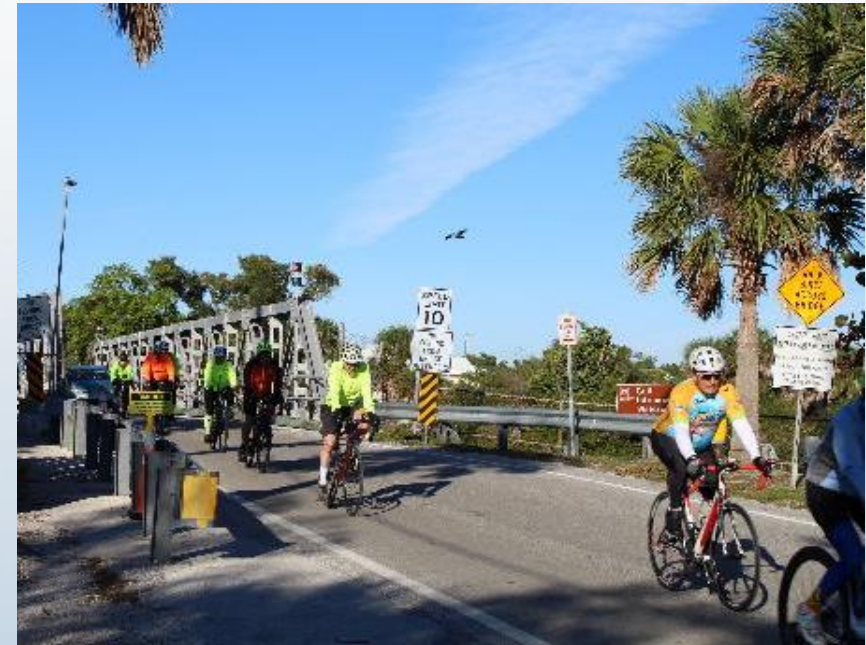
SAFETY

Modal Interrelationships:

There are no sidewalks on the bridge to meet current accessibility requirements established by the Americans with Disabilities Act (ADA).

There are no bicycle lanes on the bridge. The bridge has an open grid metal deck which is problematic for bicyclists. An existing warning sign at each end of the bridge states "Walk Bikes Across Bridge".

The proposed improvements for this project will provide sidewalks, bicycle lanes, and a solid bridge deck for enhanced safety.

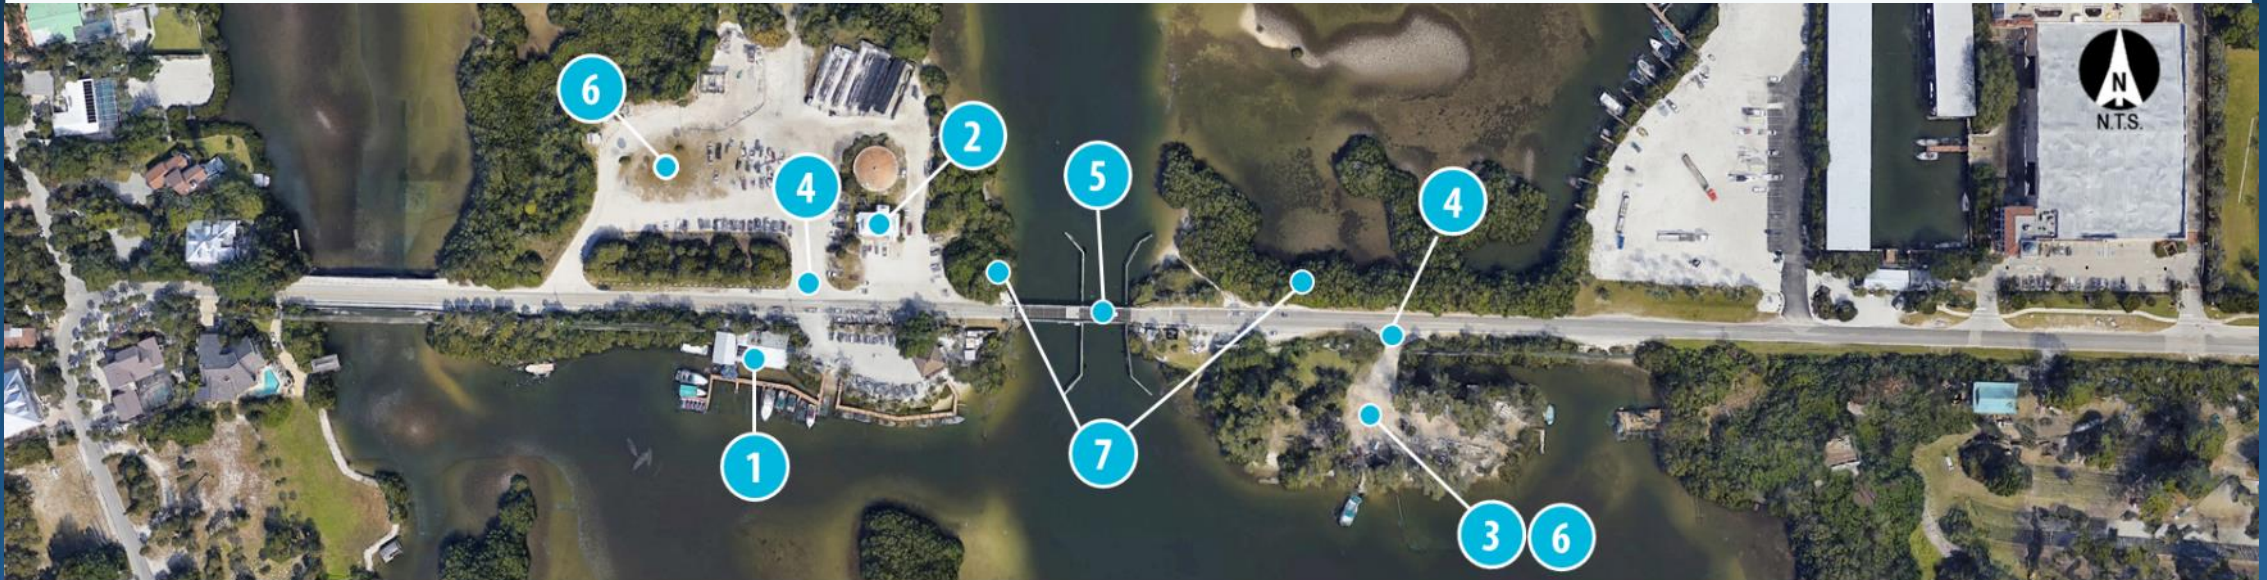
ALTERNATIVE CONSIDERATIONS

1. Constrained Site

- 1 Casey Key Fish House
- 2 Casey Key Library
- 3 Blackburn Point Park
- 4 Adjacent Driveways

2. Potential Environmental Impacts

- 5 Historic Bridge
- 6 Blackburn Point Park
- 7 Natural Environment

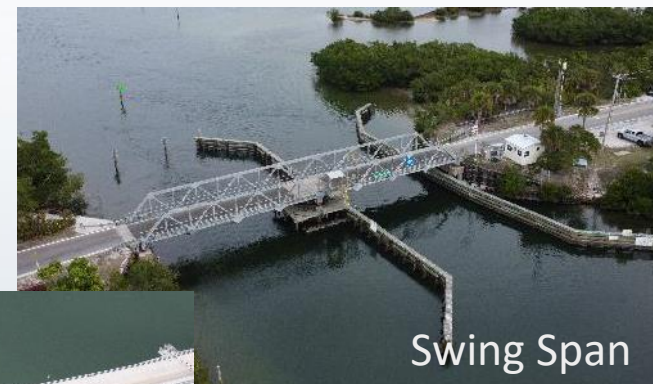
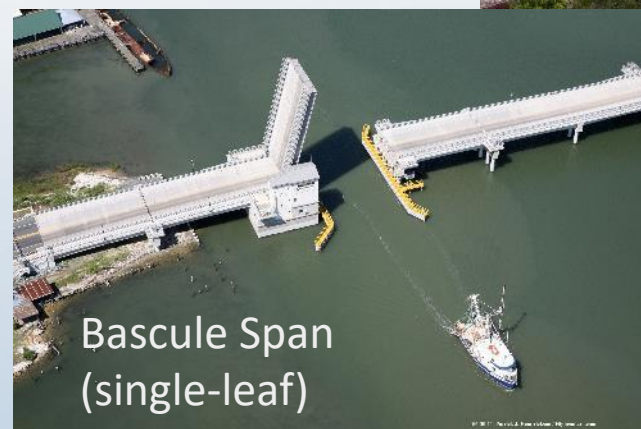
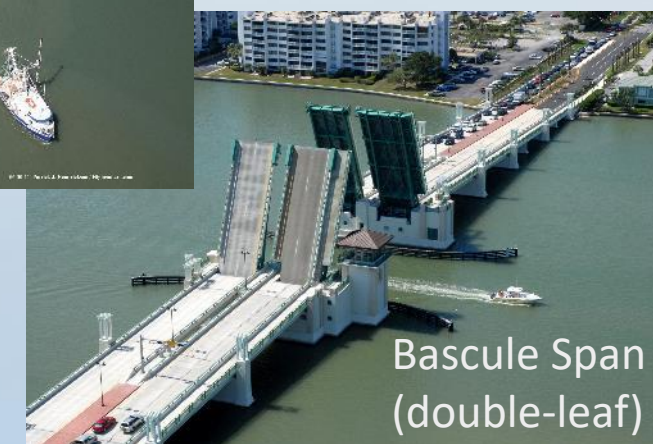
PROJECT ALTERNATIVES

- No-Build:
 - Retain the existing single-lane bridge and repair as necessary to maintain operation and structural adequacy.
- Replace with a new bridge:
 - Bridge Types:
 - Swing Span
 - Bascule Span
