WELCOME

TO THE ALTERNATIVES PUBLIC MEETING FOR THE BLACKBURN POINT BRIDGE REPLACEMENT STUDY

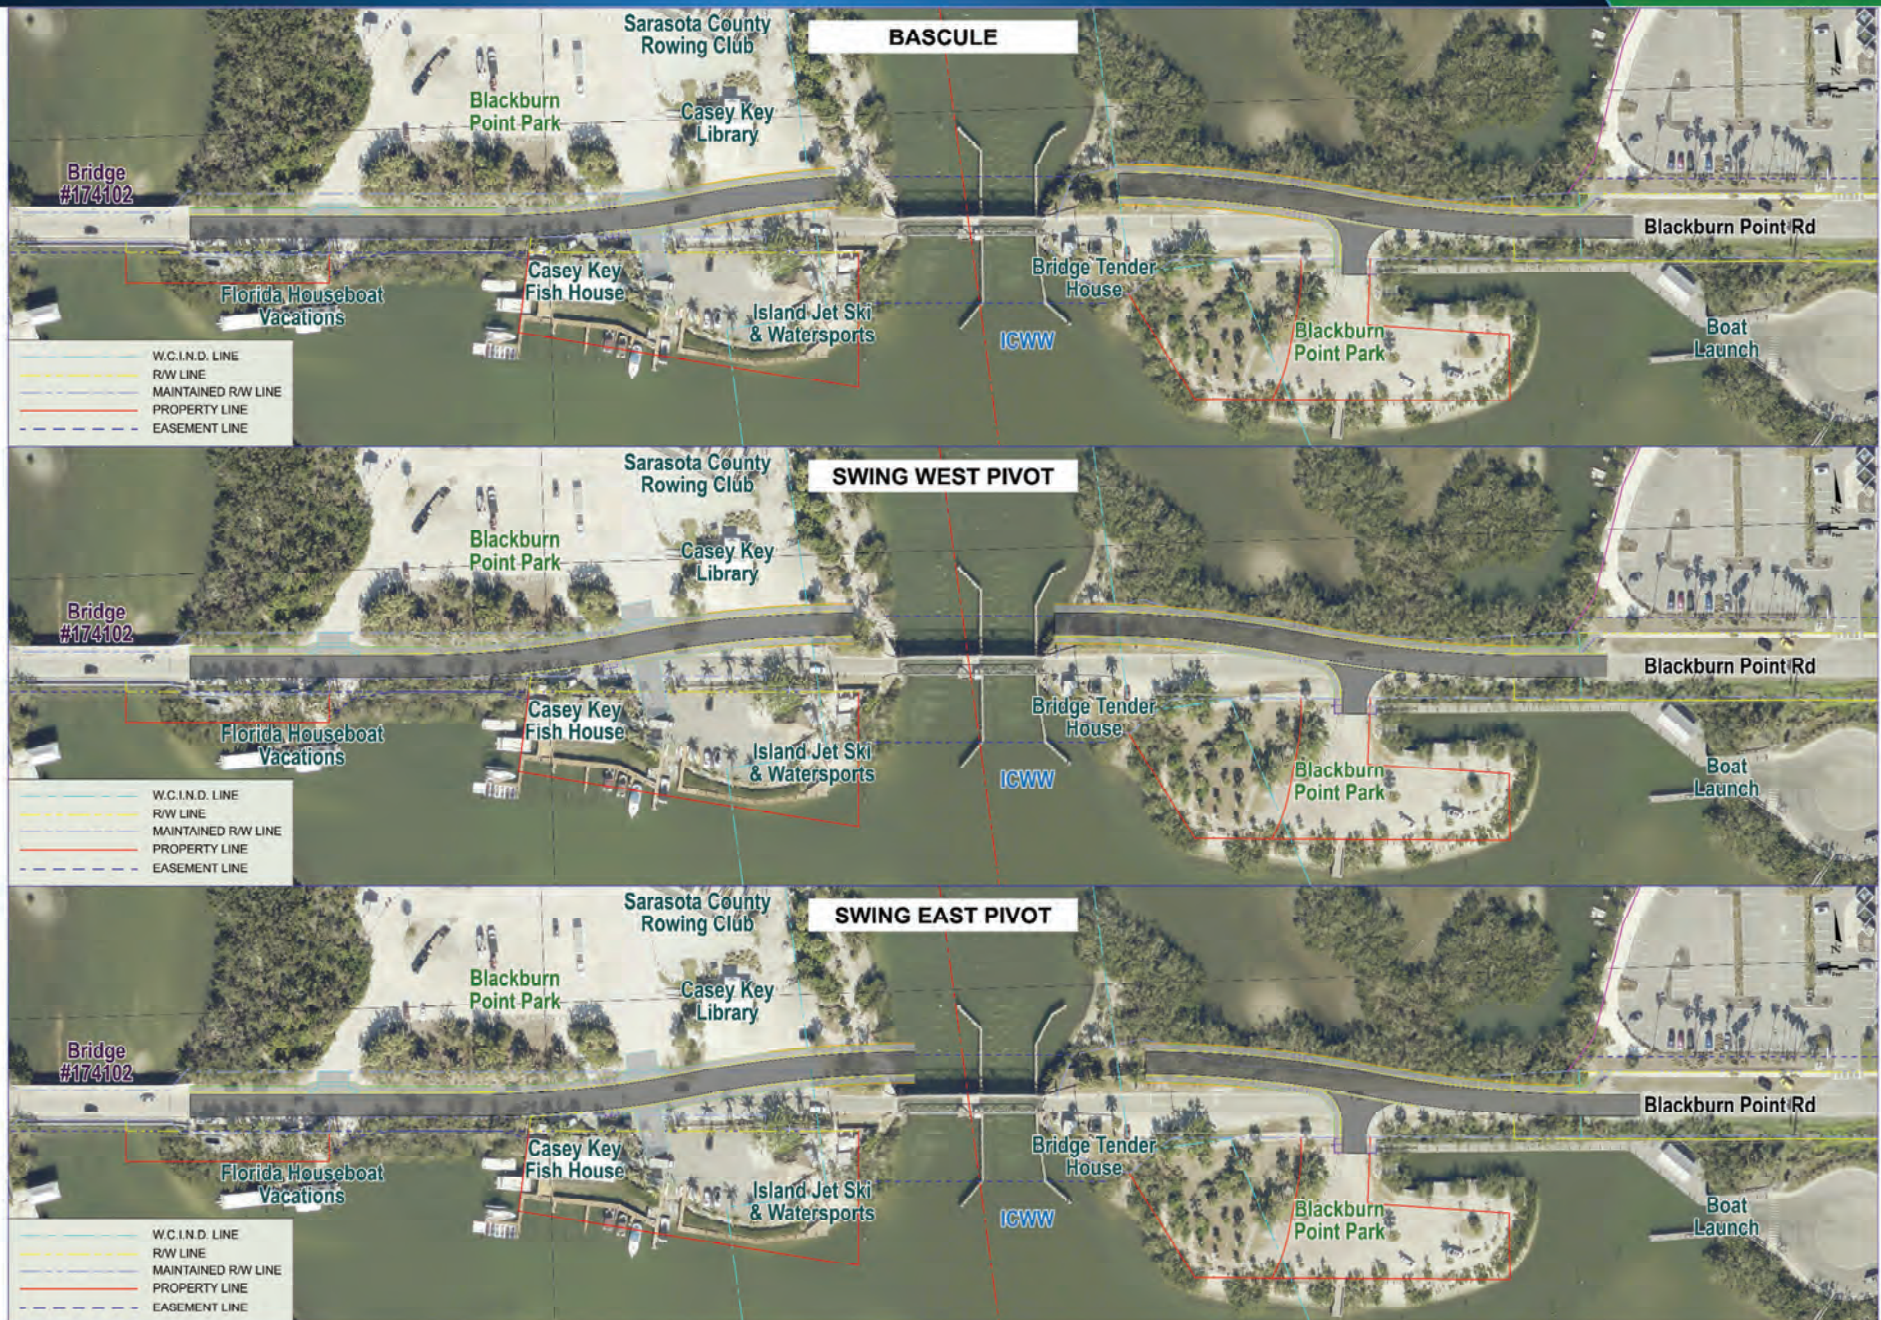
NORTH ALIGNMENT

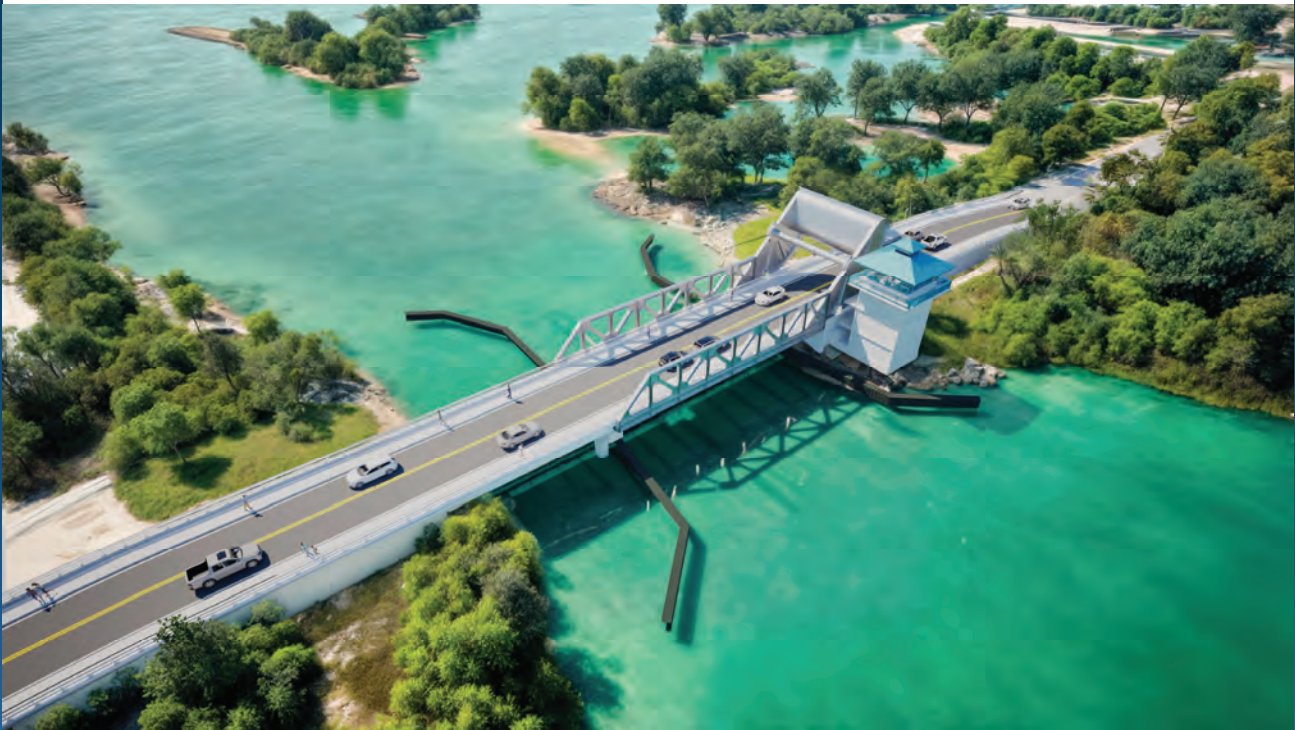
Single-leaf bascule on Existing Alignment

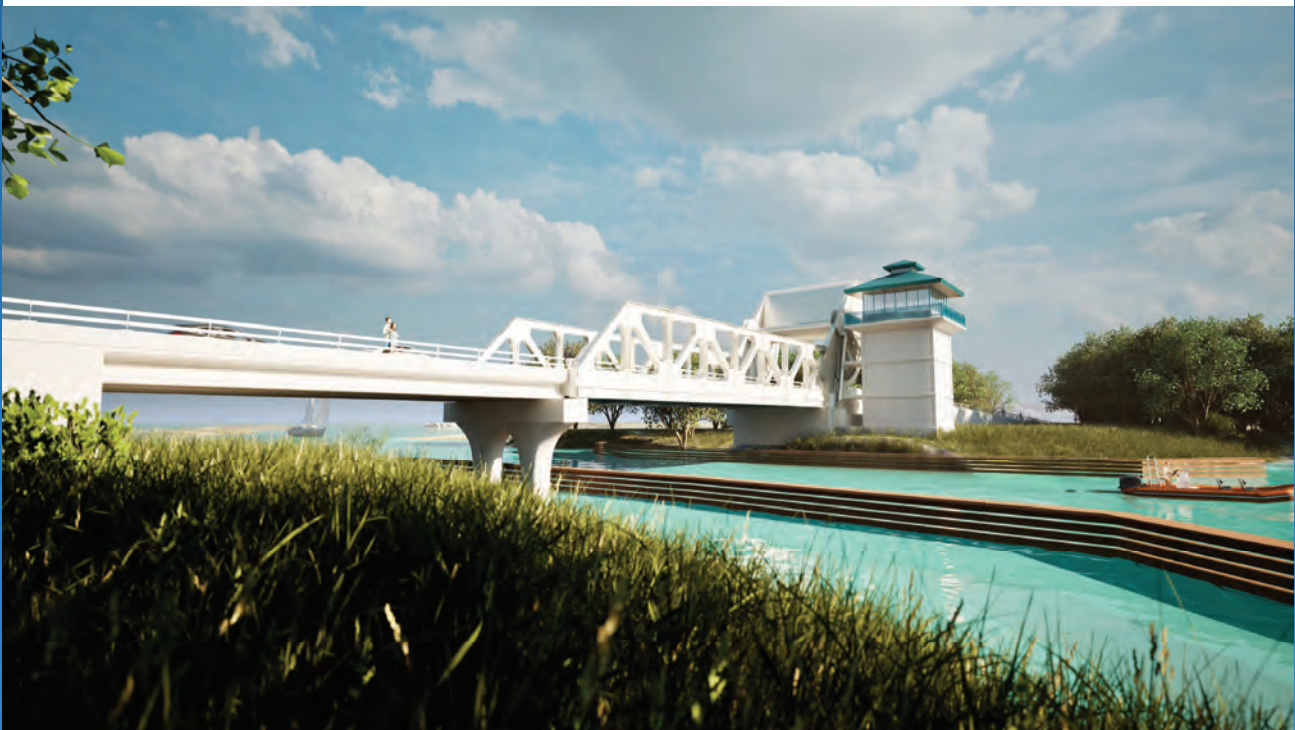
Single-leaf bascule on North Alignment

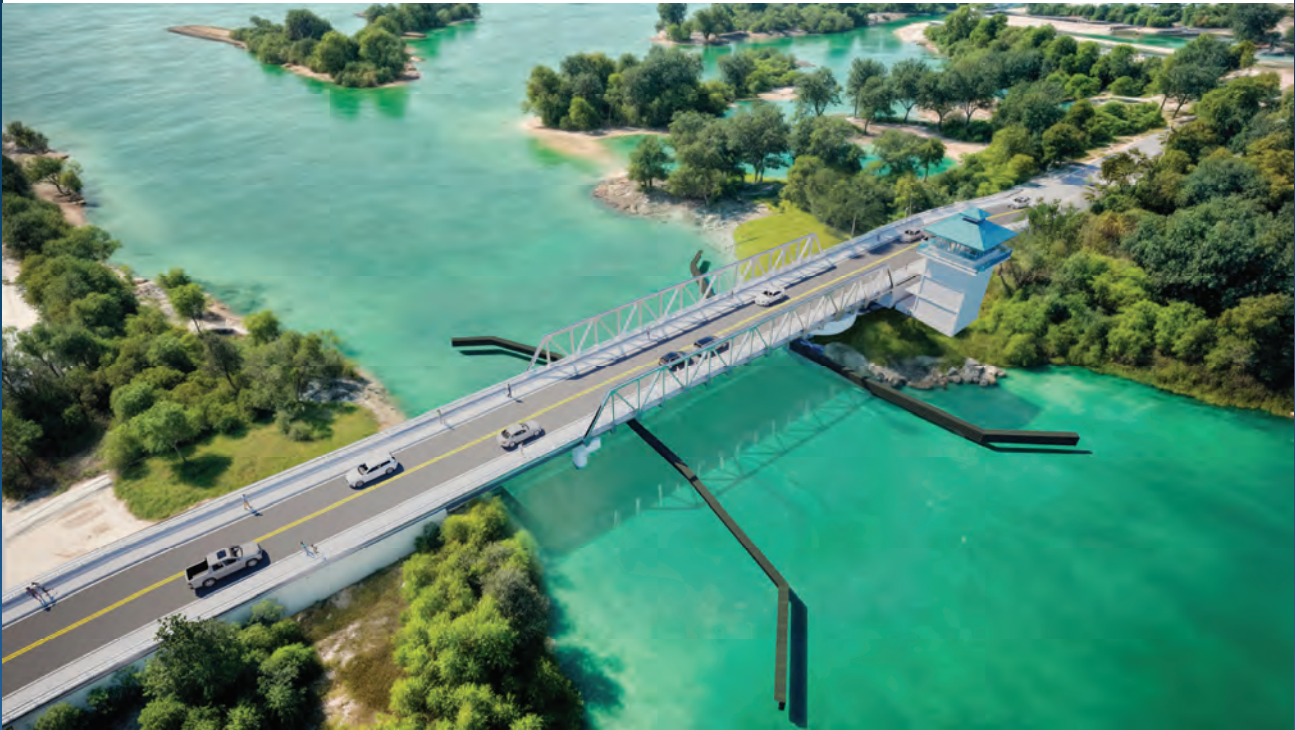
Bob-tailed swing span, pivot located east of channel - Existing Alignment

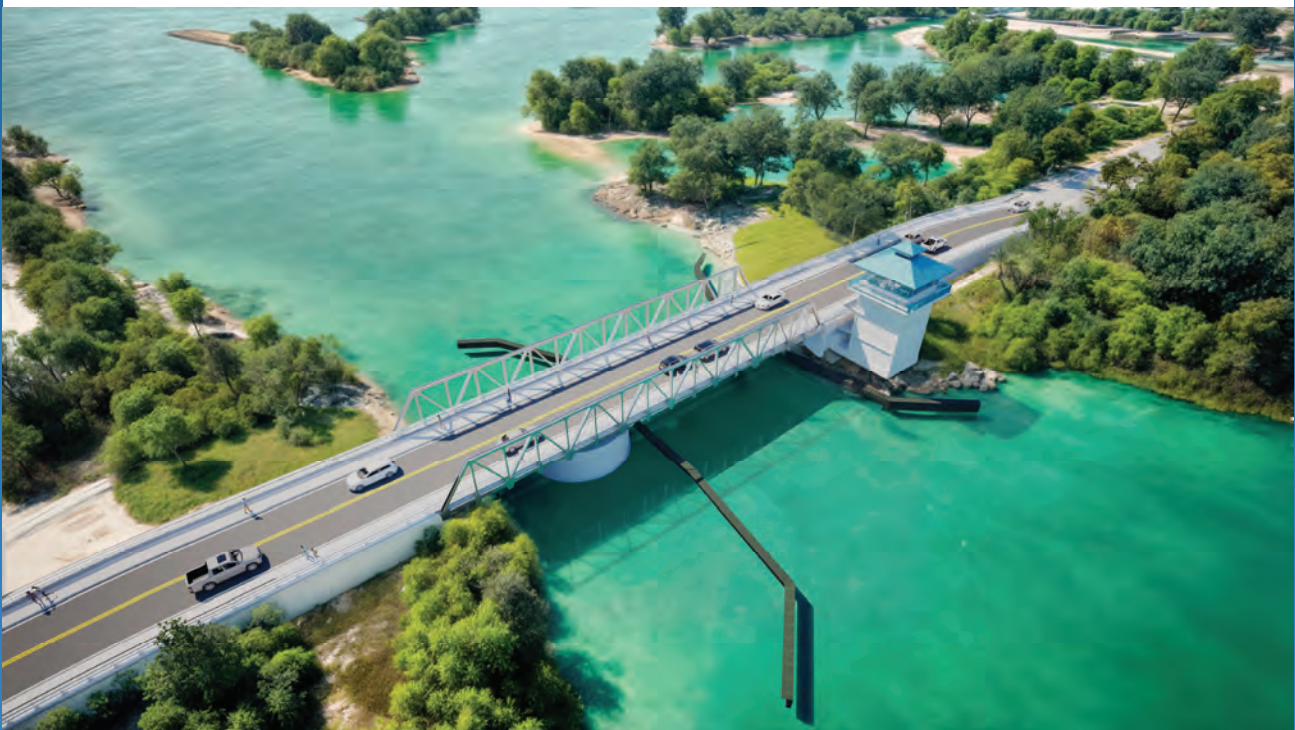
Bob-tailed swing span, pivot located west of channel - Existing Alignment

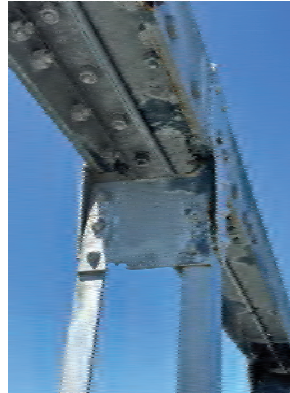
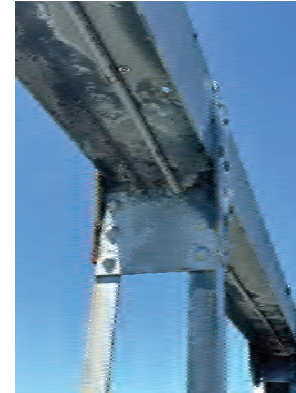
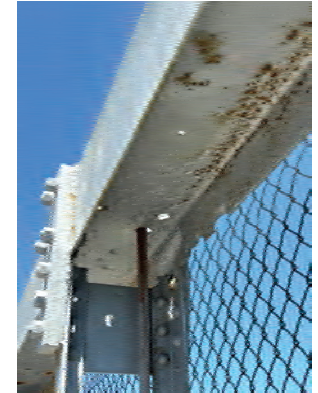
Photographs representative of existing conditions of the swing bridge's main upper truss members

- Steel truss corrosion
- Piling deterioration
- Fender system deterioration & impact damage

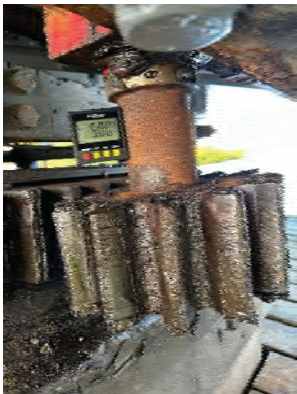
Bent Main Pinion
Gear Shaft

- Pinion shaft was replaced three (3) times in the past four (4) years
- Fender system repairs
- Structural repairs

2020	Stringer at rest pier 1 trimmed to avoid hitting steel nose plate on approach pavement
2021	Replace conduit system on fender
2021	Riprap at NW Wingwall
2022	Center bearing rehabilitated, new pinion shaft, floorbeam retrofits
2023	Repair grid deck welds
2024	Pinion shaft emergency replacement (again) due to deformation. New limit switches.
2025	Pinion shaft emergency replacement (again) due to deformation

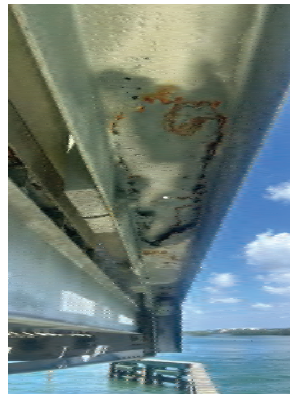
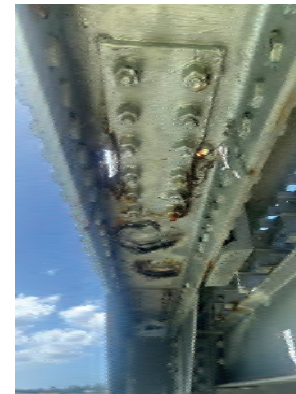
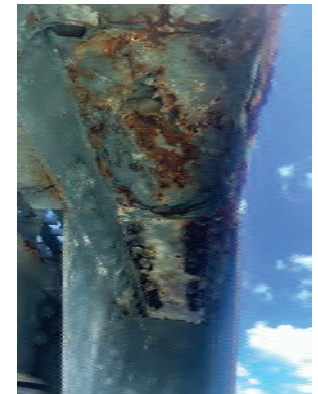
Photographs representative of existing conditions of the swing bridge's main lower truss members

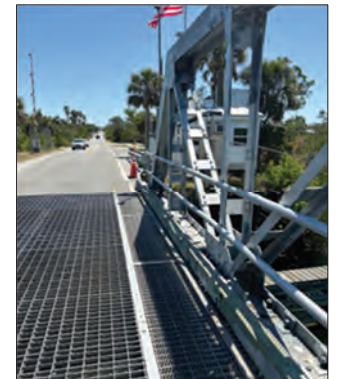
Existing Railing

Existing bridge railings do not meet current standards for pedestrians or bicyclists.

Existing bridge railings do not meet current geometric and crash testing safety standards for vehicles.

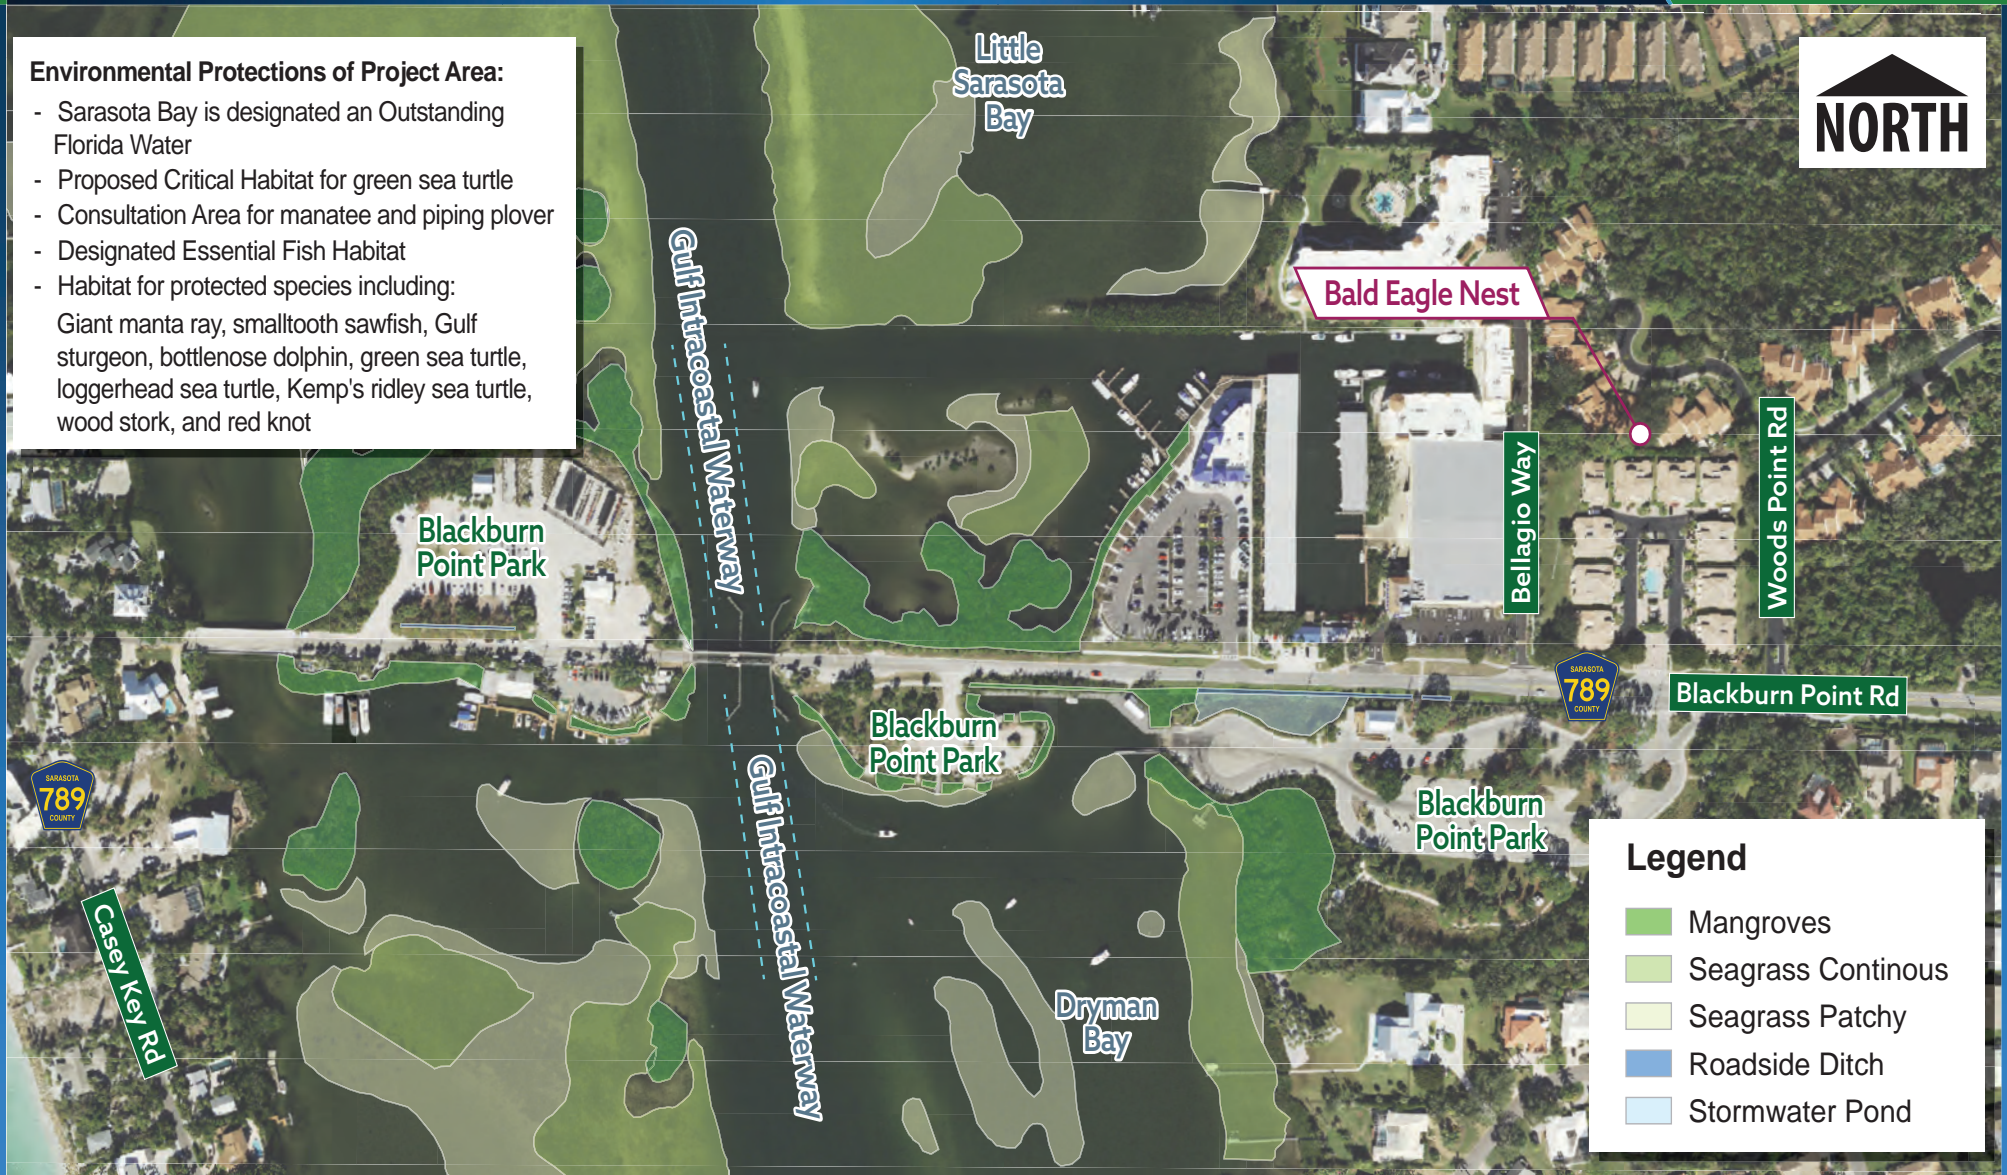
Legend

- Mangroves
- Seagrass Continous
- Seagrass Patchy
- Roadside Ditch
- Stormwater Pond

- Sarasota Bay is designated an Outstanding Florida Water
- Proposed Critical Habitat for green sea turtle
- Consultation Area for manatee and piping plover
- Designated Essential Fish Habitat
- Habitat for protected species including:
Giant manta ray, smalltooth sawfish, Gulf sturgeon, bottlenose dolphin, green sea turtle, loggerhead sea turtle, Kemp's ridley sea turtle, wood stork, and red knot

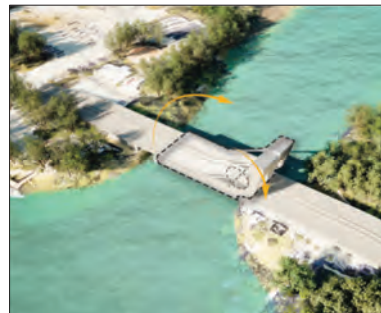
Span Motion Diagram

Bascule Bridge

- **Rotates about a horizontal axis and translates at the same time**
 - Smallest movable span length
- **Rolling Lift Type with Overhead Counterweight**
 - Maximum clearance above the water
 - Resiliency:
 - Most durable with operating machinery located above the splash zone
 - Machinery is easily accessible without going below deck
- **Counterweight and machinery located on the east abutment**
 - Minimizes impacts to Blackburn Park
 - Requires rest pier in the waterway
- **Can be constructed to the north then slid to the existing alignment after existing bridge is removed – this avoids a temporary bridge**

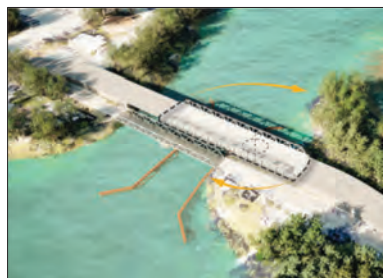
Span Motion Diagram

Swing Bridge with Pivot Located East of the Channel

- **Bob-tailed configuration (long span over channel, shorter back span) reduces movable span length**
- **East pivot minimizes impacts to Blackburn Pt. Park**
- **East pivot results in swing span over land**
 - Pushes control house back from channel restricting bridge operator's view off the channel
- **Resiliency:**
 - Pivot machinery is below deck level
 - Close to splash zone – exposed to salt air
 - Difficult to access for maintenance
- **Requires large fender system to protect swing span from vessel impact when open**
- **Construction challenges:**
 - Requires a temporary bridge to construct on the existing alignment

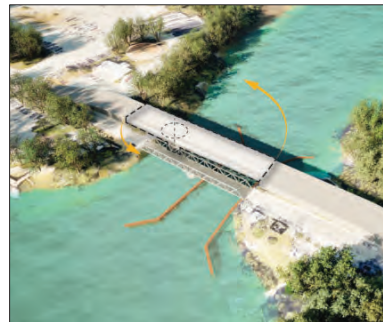
Span Motion Diagram

Swing Bridge with the Pivot Located West of the Channel

- **Bob-tailed configuration (long span over channel, shorter back span) reduces movable span length**
- **West pivot increases impacts to Blackburn Pt. Park**
- **Resiliency:**
 - Pivot machinery is below deck level
 - Close to splash zone – exposed to salt air
 - Difficult to access for maintenance
- **Requires large fender system to protect swing span from vessel impact when open**
- **Construction challenges:**
 - Requires a temporary bridge to construct on the existing alignment
