# **The Blackburn Point Bridge Project Development and Environment (PD&E) Study**

Alternatives Public Meeting

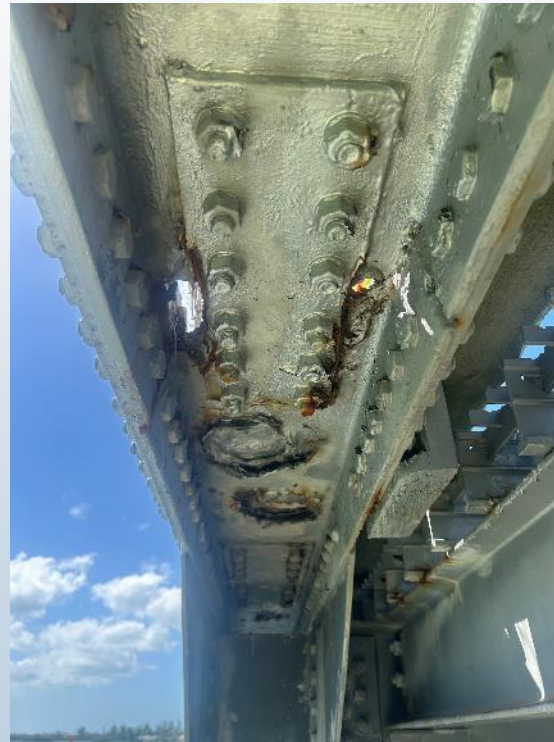
Photographs representative of existing conditions of the swing bridge's main lower truss members

Truss members subjected to tension under truck loading are susceptible to fracture

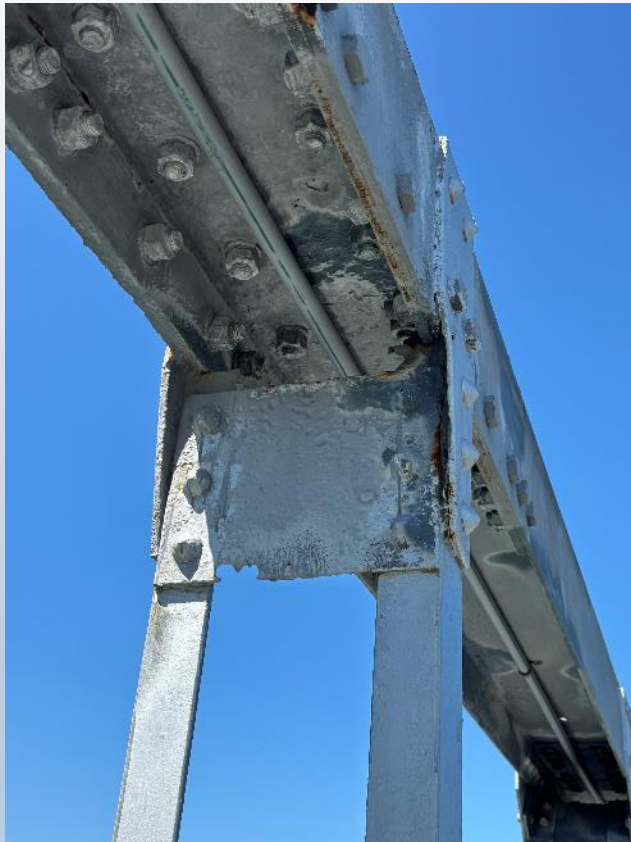
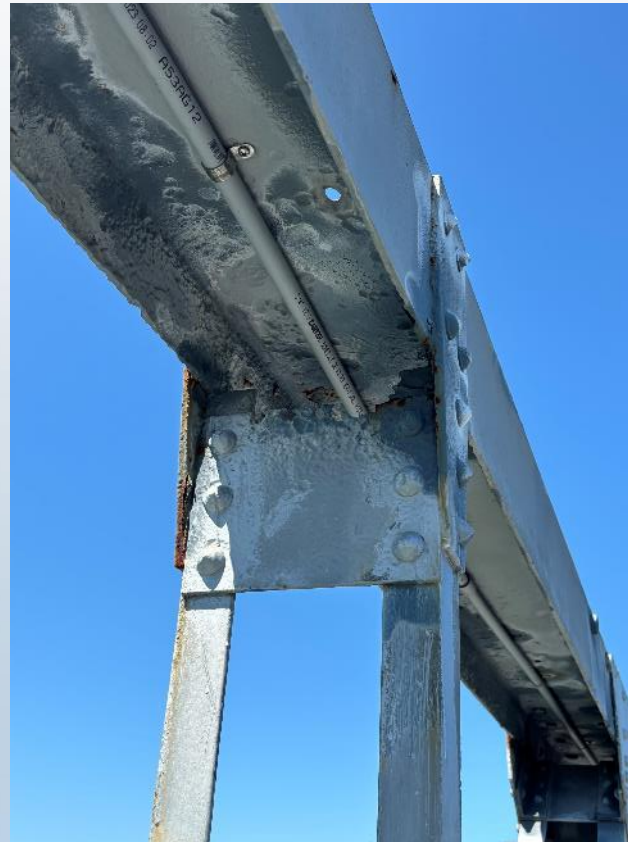
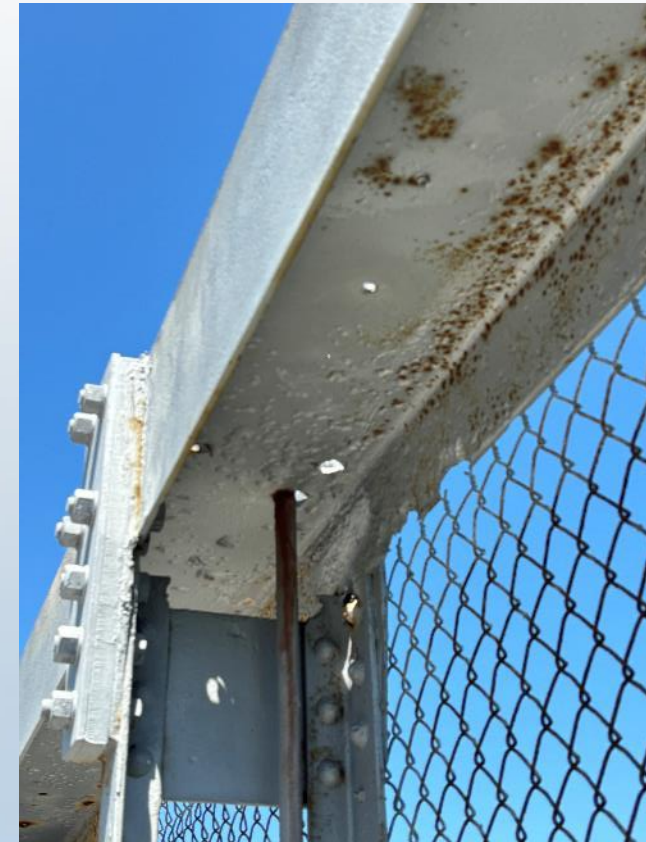
Photographs representative of existing conditions of the swing bridge's main upper truss members

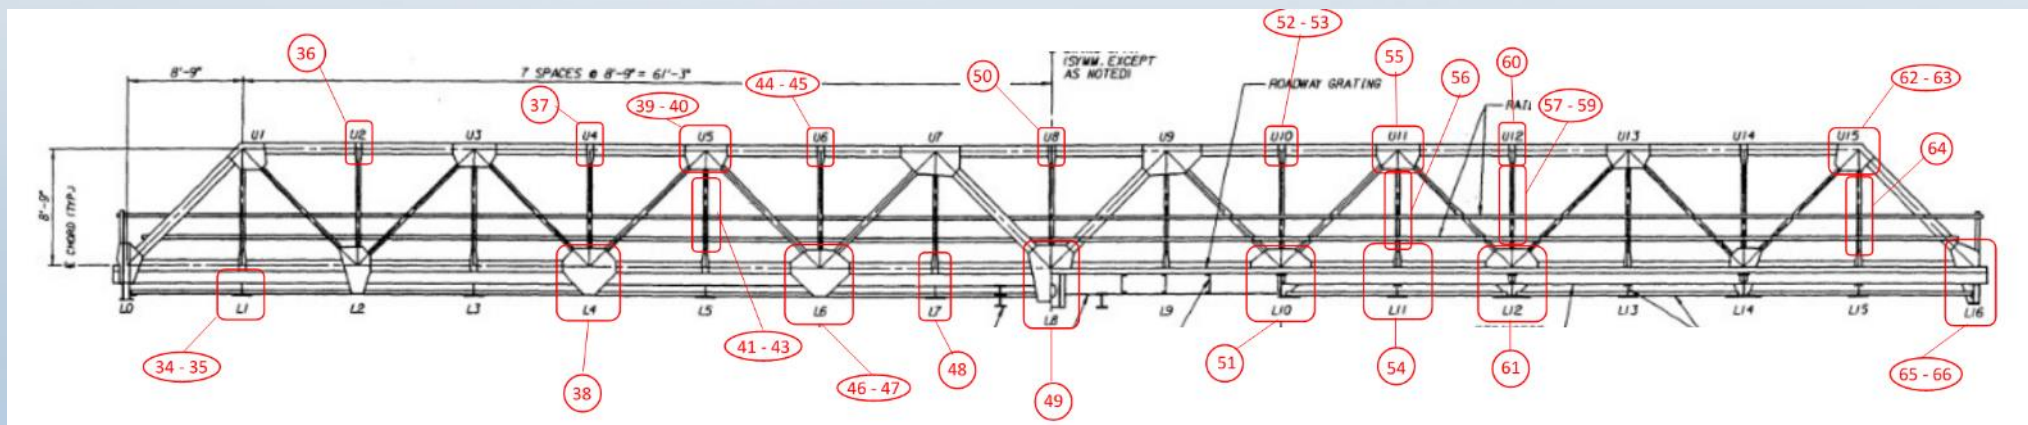
Recommended Truss Gusset Plate Repairs / Replacements (Prepared in 2021)

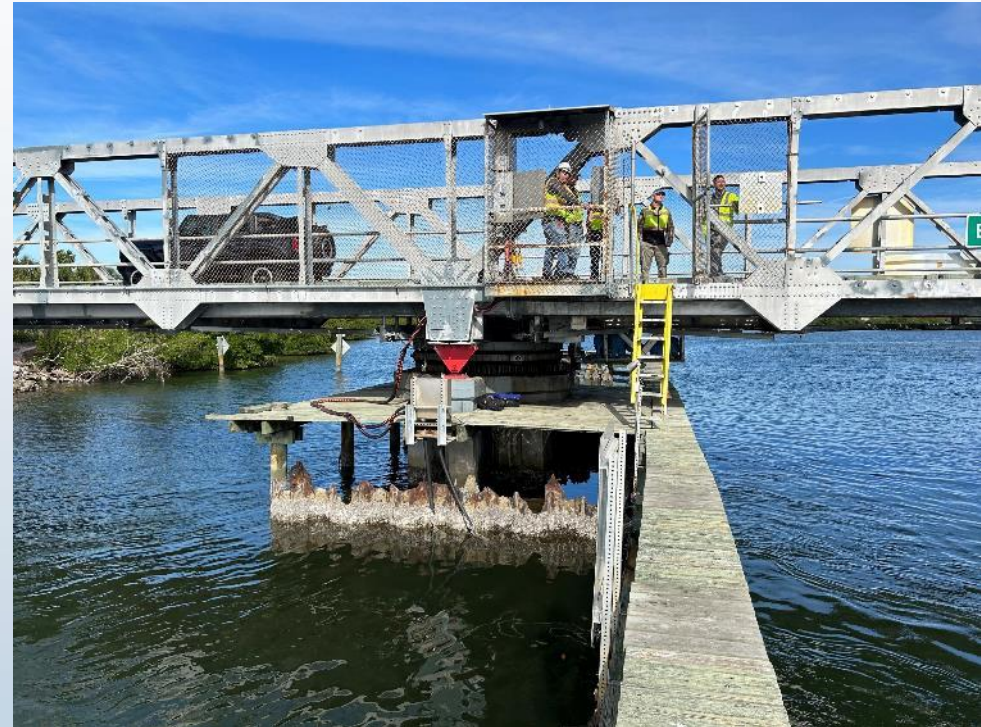
- Existing swing bridge and abutments are not capable of sustaining a direct vessel collision
- The existing bridge low members are within the splash zone, subject to accelerated corrosion due to saltwater and salt laden air

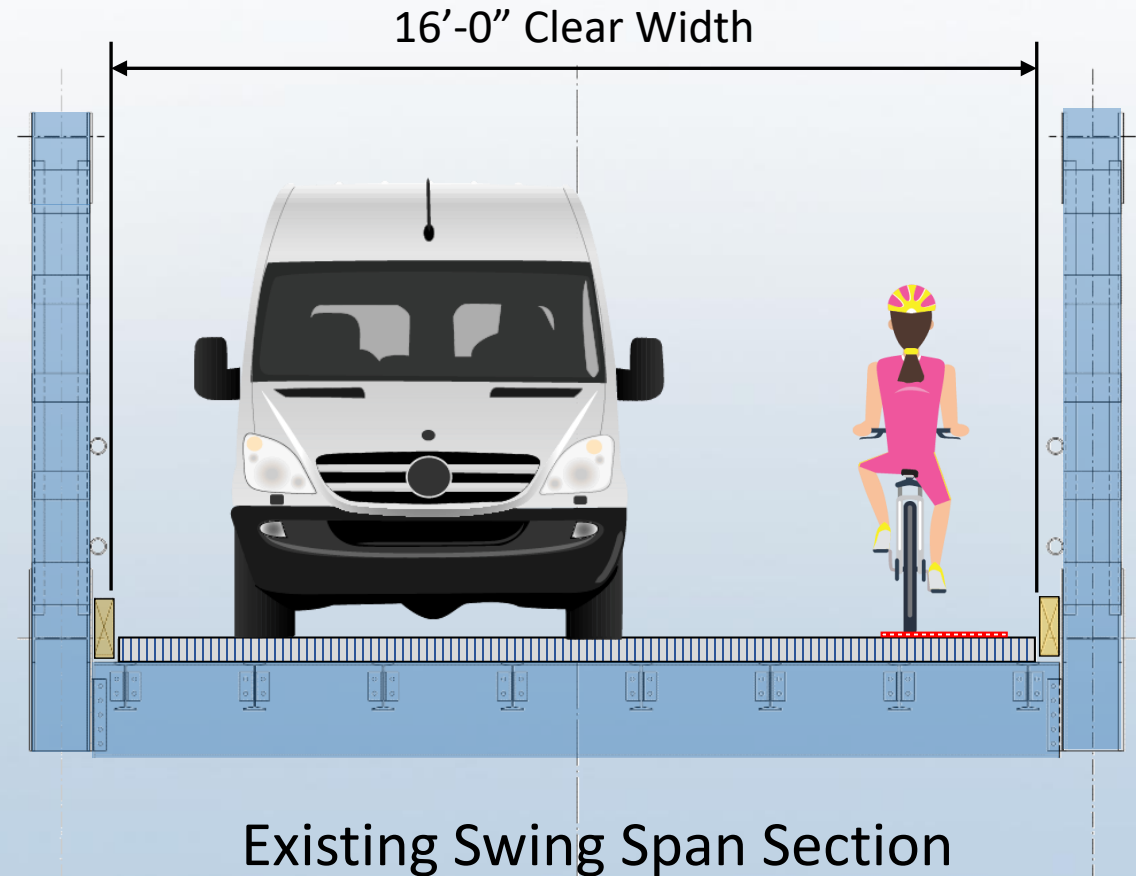
- Substandard clear roadway width of only one, 16-foot-wide travel lane
- Despite frequent daily pedestrian and bicycle use, the bridge does not feature shoulders, sidewalks or bicycle lanes
- Minimum required lane and shoulder widths prescribed by the American Association of State Highway and Transportation Officials (AASHTO) are not met.

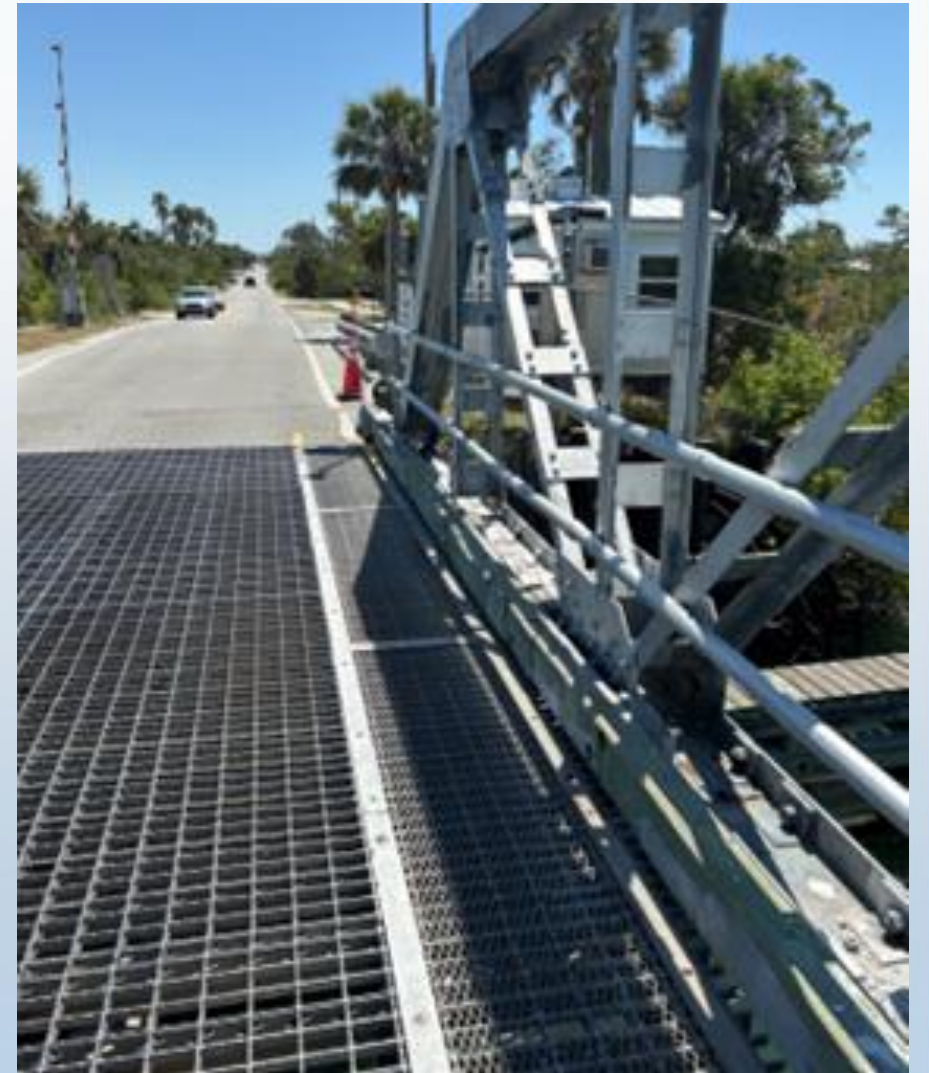
Existing bridge railings do not meet current standards for pedestrians or bicycles.

Existing bridge railings do not meet current geometric and crash testing safety standards for vehicles.

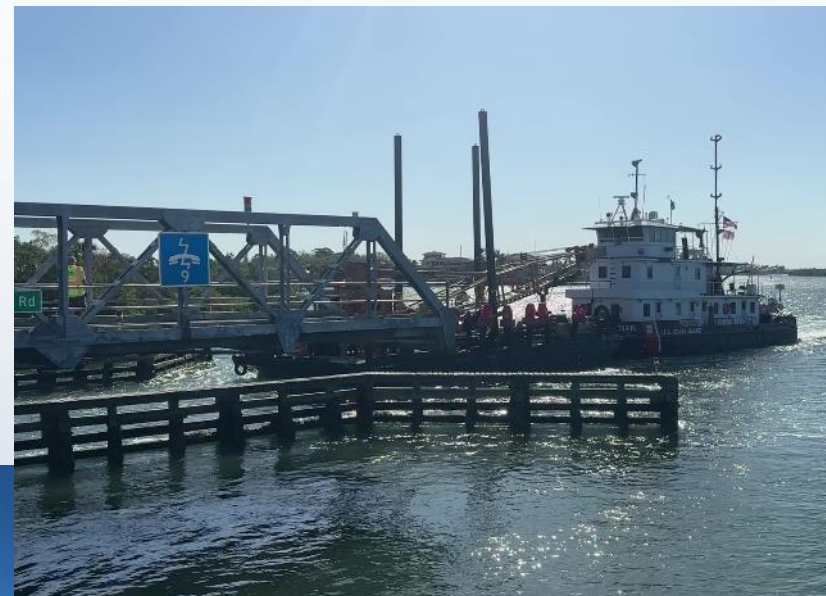
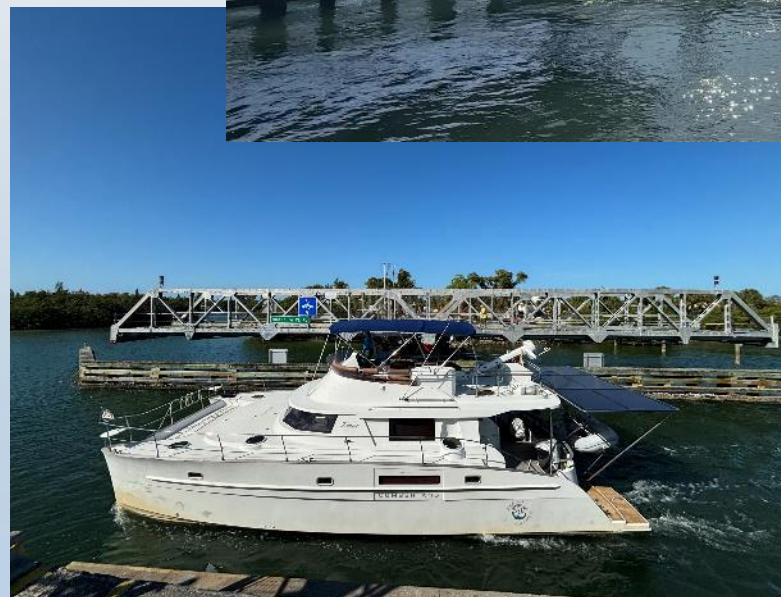
Existing Navigation Clearances (through the bridge fenders):

- Horizontal – 51 feet
- Vertical – 9.3 feet

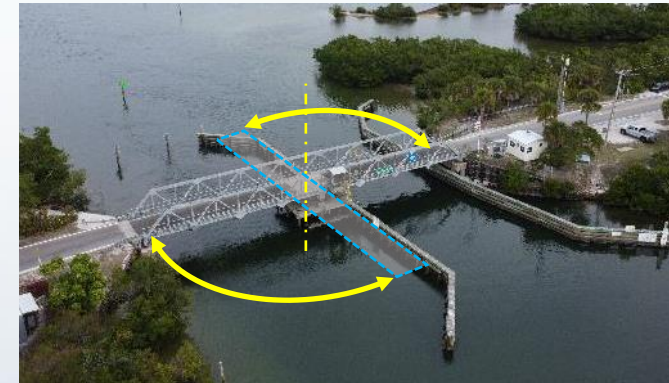
Swing Span

- No-Build:
  - Retain the existing single-lane bridge and repair as necessary to maintain operation and structural adequacy
- Replace with a new bridge:
  - Bridge types being considered:
    - Swing Span (bob-tailed, machinery on the east side of the channel)
    - Bascule Span (single-leaf, machinery on the east side of the channel)

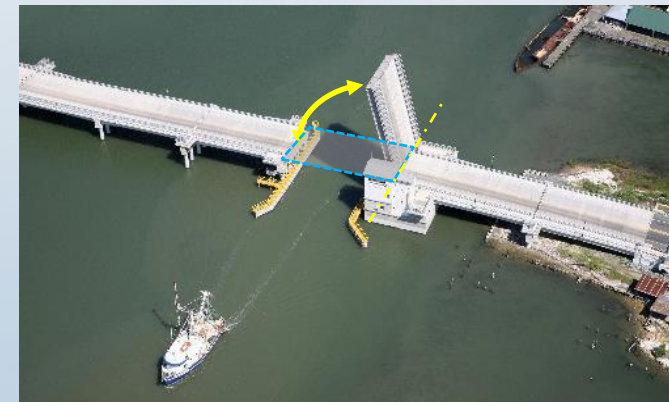
Bascule Span (single-leaf)

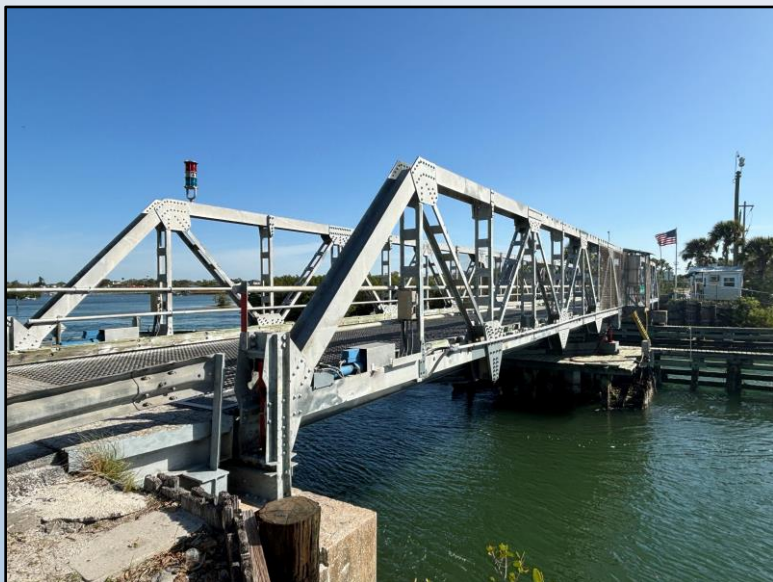
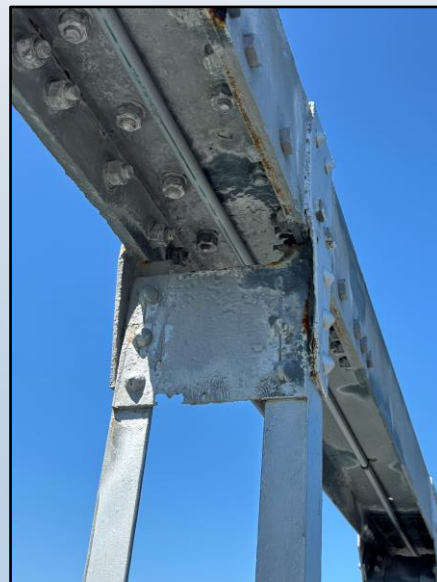
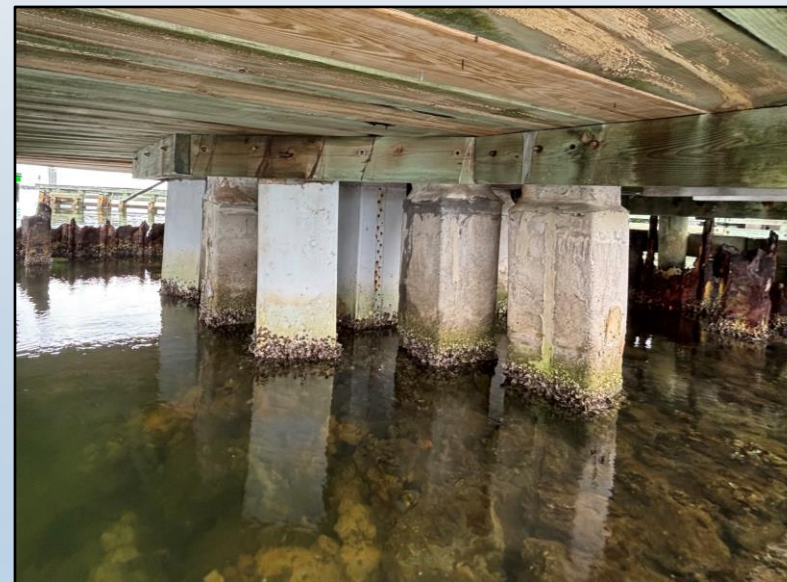
Continue repairs until the substructure (piles and pile caps) requires replacement or repairs that require USCG permits<sup>1</sup> – estimated at no more than 10 to 20 years given the current condition state - even with continued repairs and pile jackets

- Current Condition State = 3 – Serious
- Indicates that loss of section, deterioration, spalling, cracking, or other deficiencies have seriously affected primary structural components

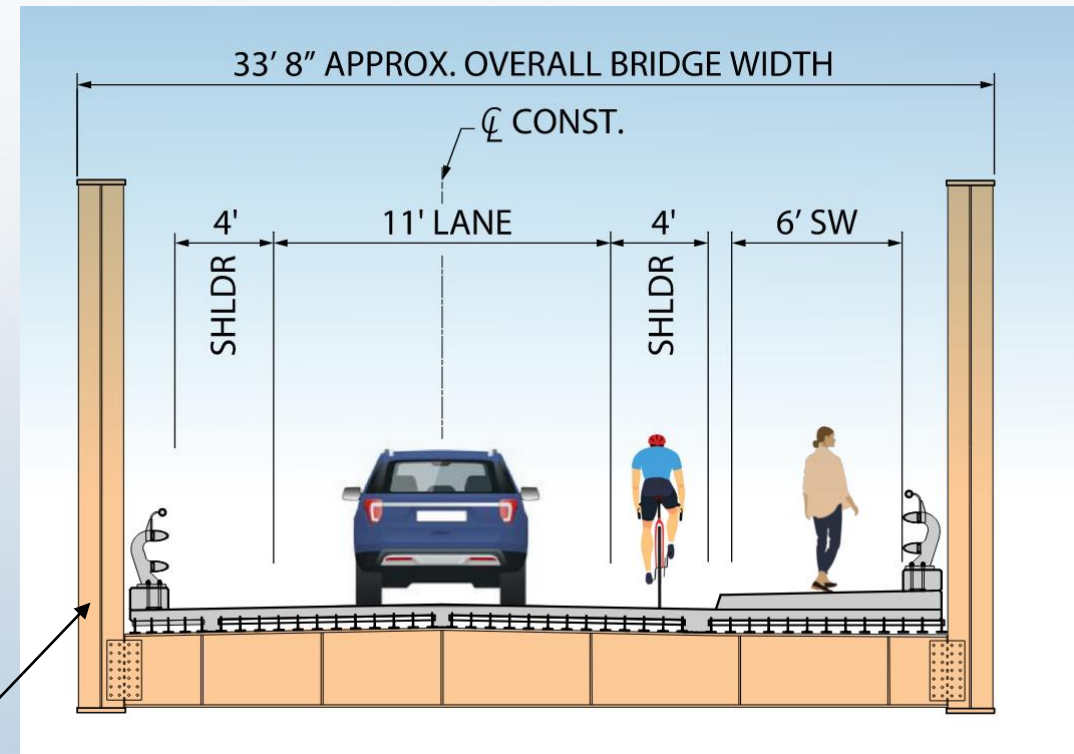
Single-Lane Bridge Option

- 11-foot-wide travel lane
- 4-foot-wide shoulders on either side of the lane
- 6-foot-wide sidewalk on the south side
- Safety barriers

Bridge Girder  
or Truss

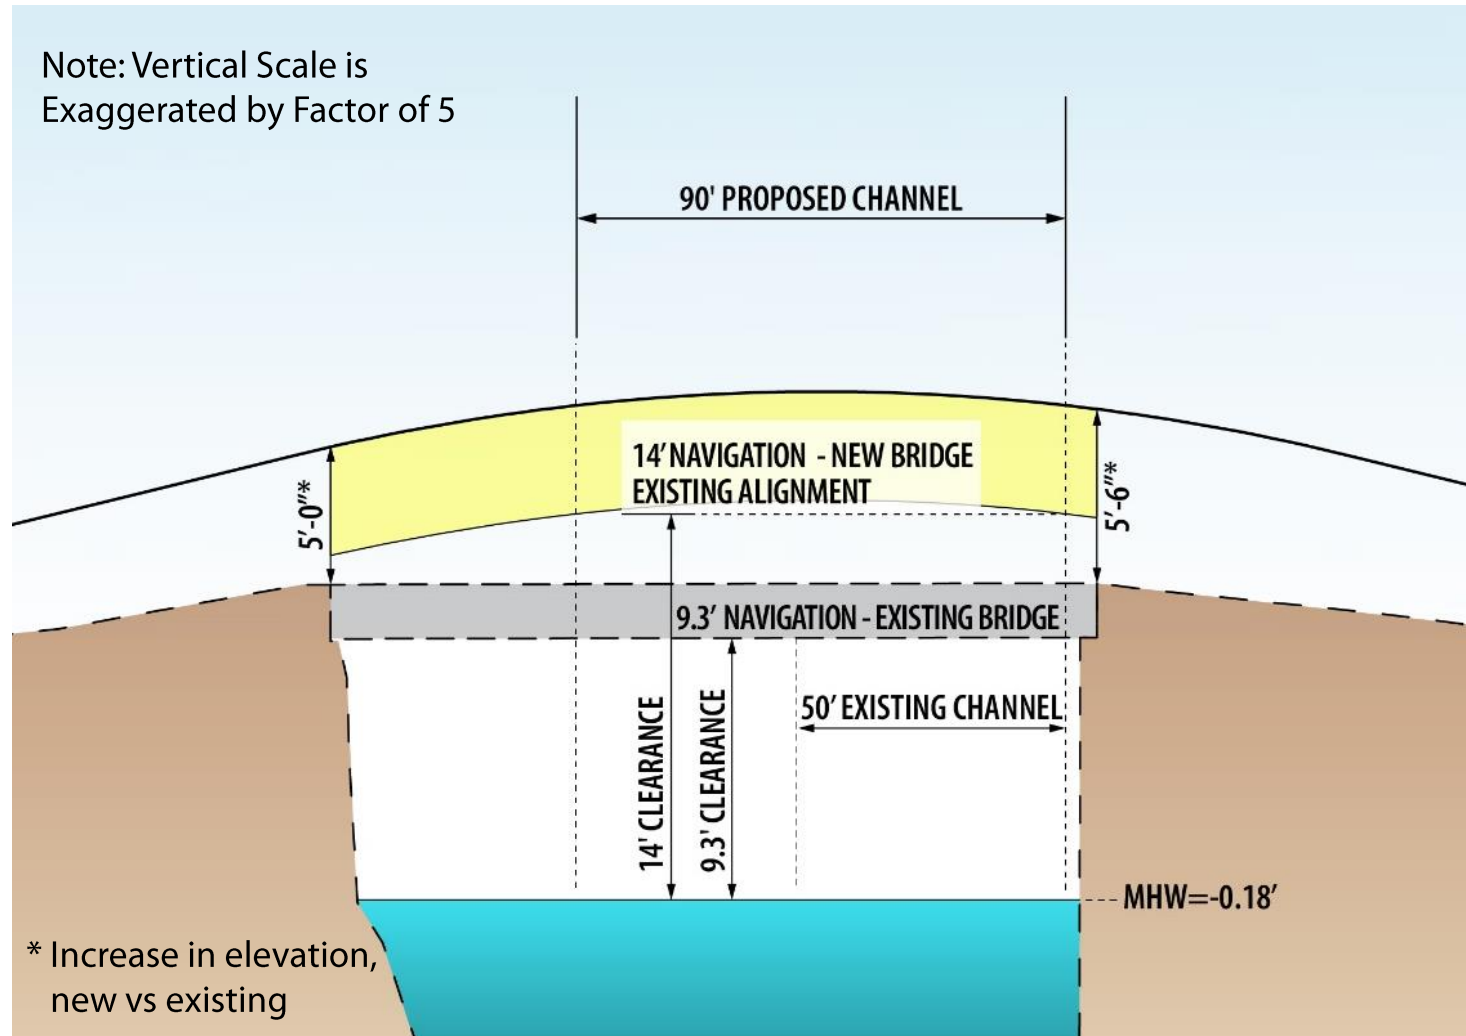
# VERTICAL ALIGNMENT

- Profile options are limited by adjacent driveways
- Potential Clearances:
  - 14 feet vertical clearance on Existing Alignment
  - The new roadway is approximately 5' - 5'6" higher than the existing at bridge ends

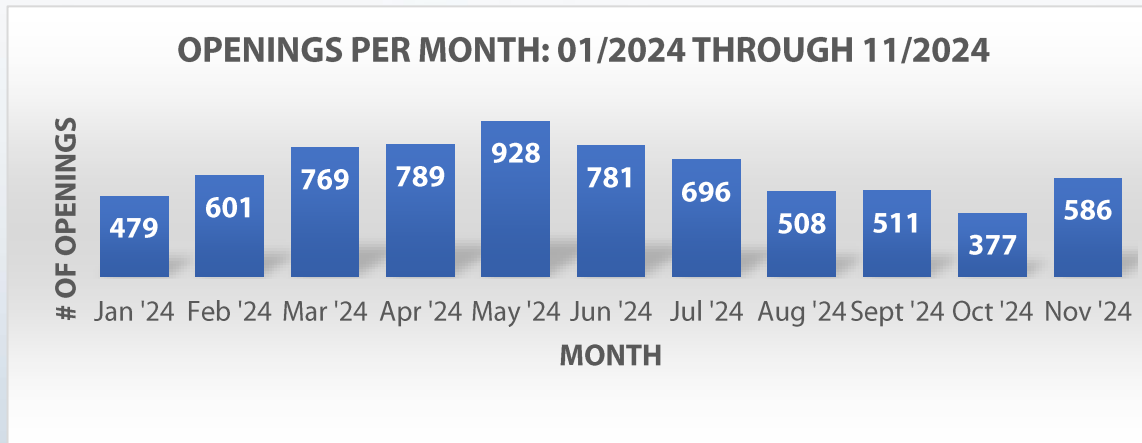
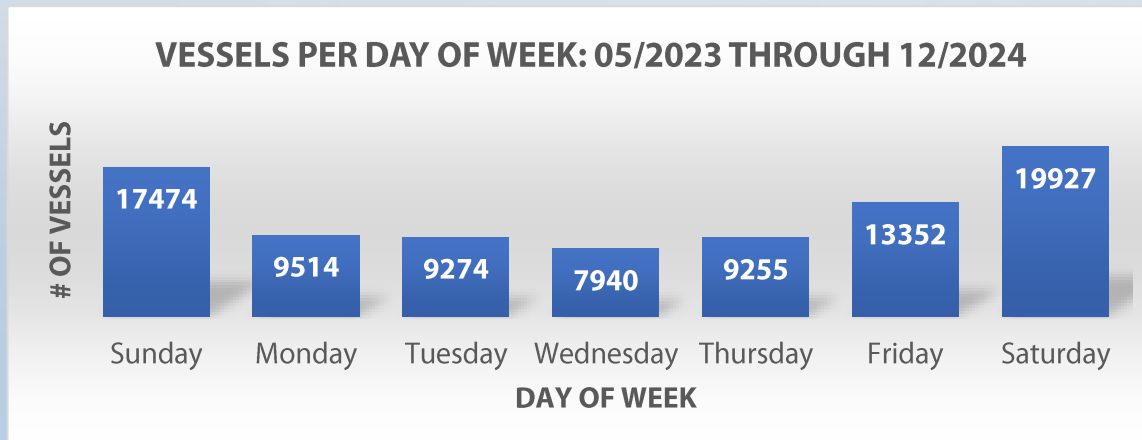
Effect of Increased Vertical Clearance on Bridge Openings

## Opportunity for Reduction in Bridge Openings with New Bridge

12 Feet	14 Feet	16 Feet	21 Feet
Bridge Clearance	12 Feet	14 Feet	16 Feet	21 Feet
% Reduction in Openings	31%	48%	62%	78%

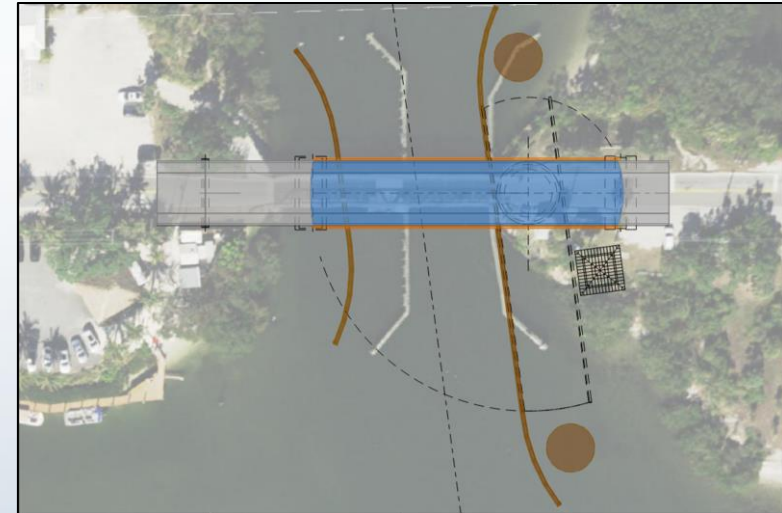
Pivot east of channel,  
existing alignment

Construction challenges:

- Requires a temporary bridge (of limited salvage value) to construct on the existing alignment

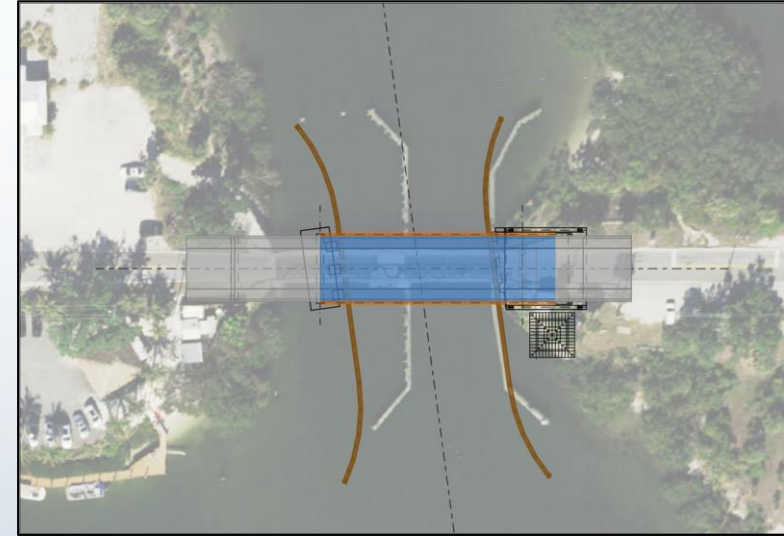
Existing alignment

Compared to the swing bridge options:

- Smallest movable span length
- Most resilient:
  - Maximum clearance above the water
  - Most durable with operating machinery located above the splash zone
  - Machinery is easily accessible without going below deck
  - Counterweight and machinery located on the east abutment
- Minimizes impacts to Blackburn Park
- Can be constructed to the north then slid to the existing alignment after existing bridge is removed – this avoids the cost of a separate temporary movable span

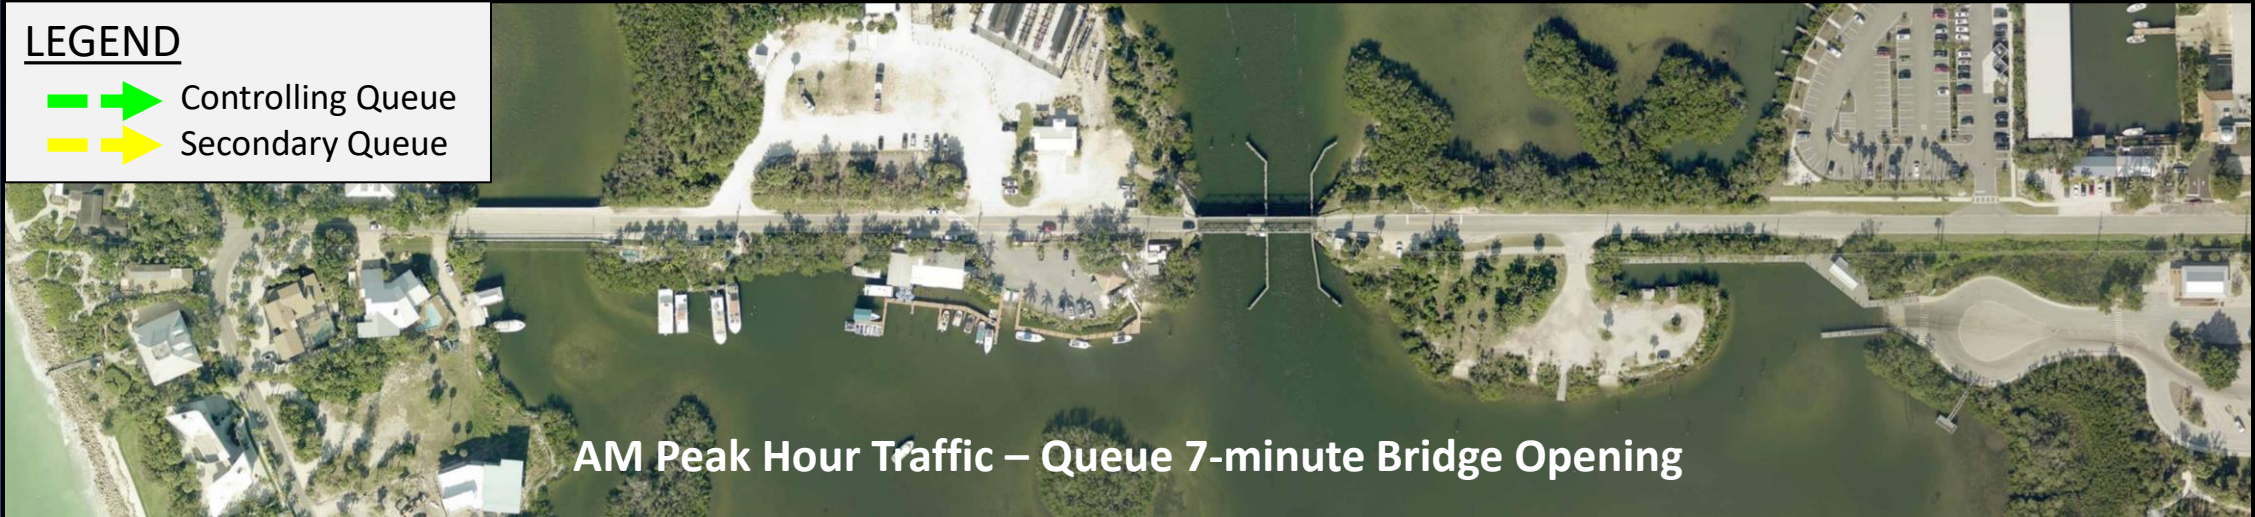
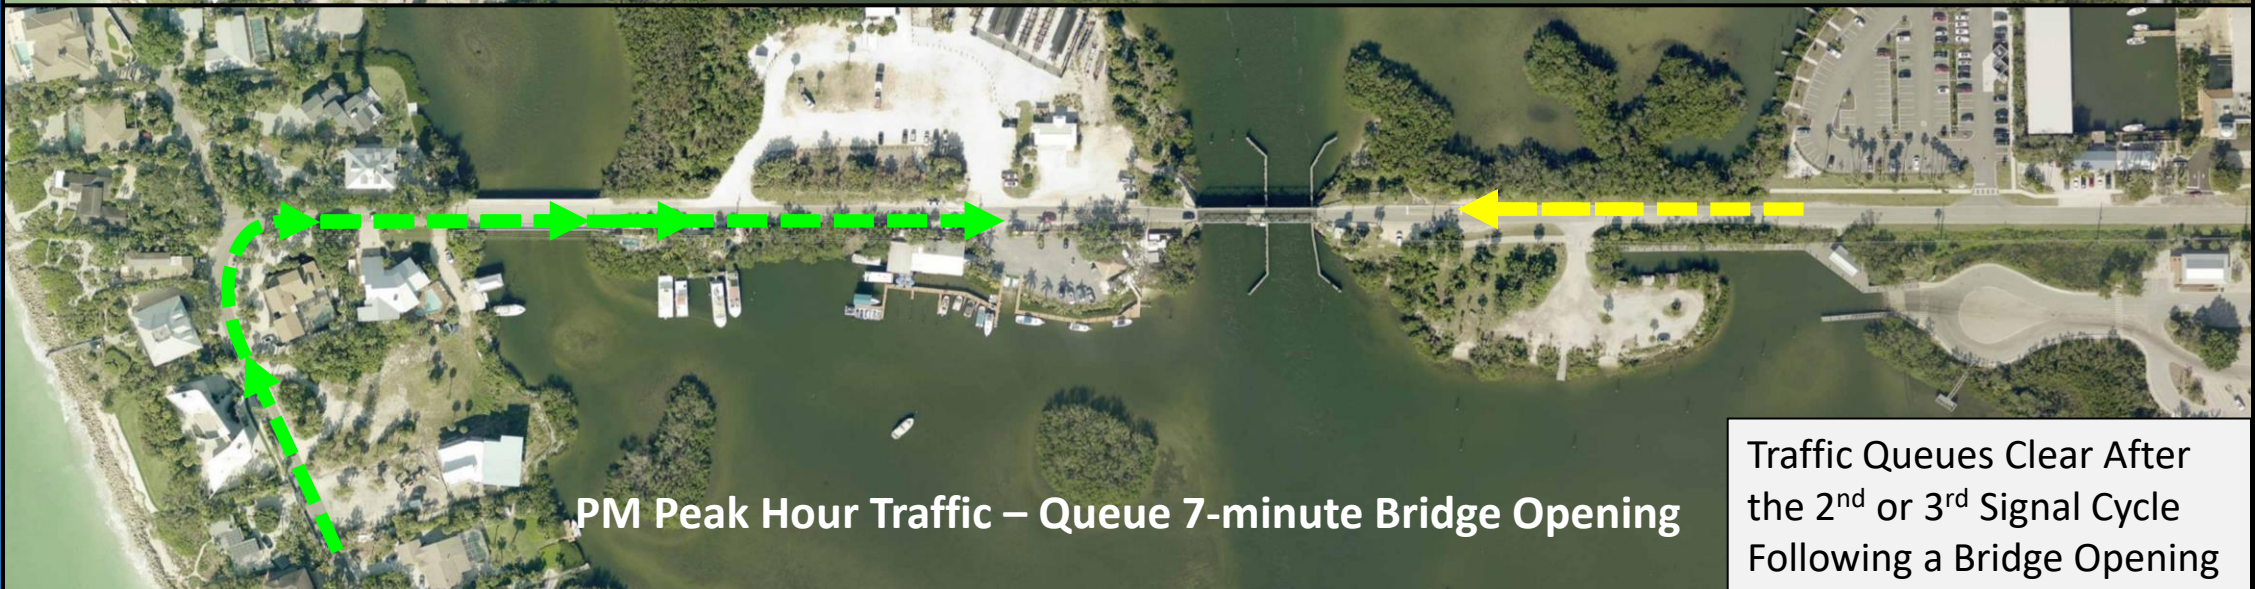
# SINGLE-LANE BRIDGE / TRAFFIC ANALYSIS / 2050 TRAFFIC VOLUME

Traffic Queues Clear After the 2<sup>nd</sup> or 3<sup>rd</sup> Signal Cycle Following a Bridge Opening

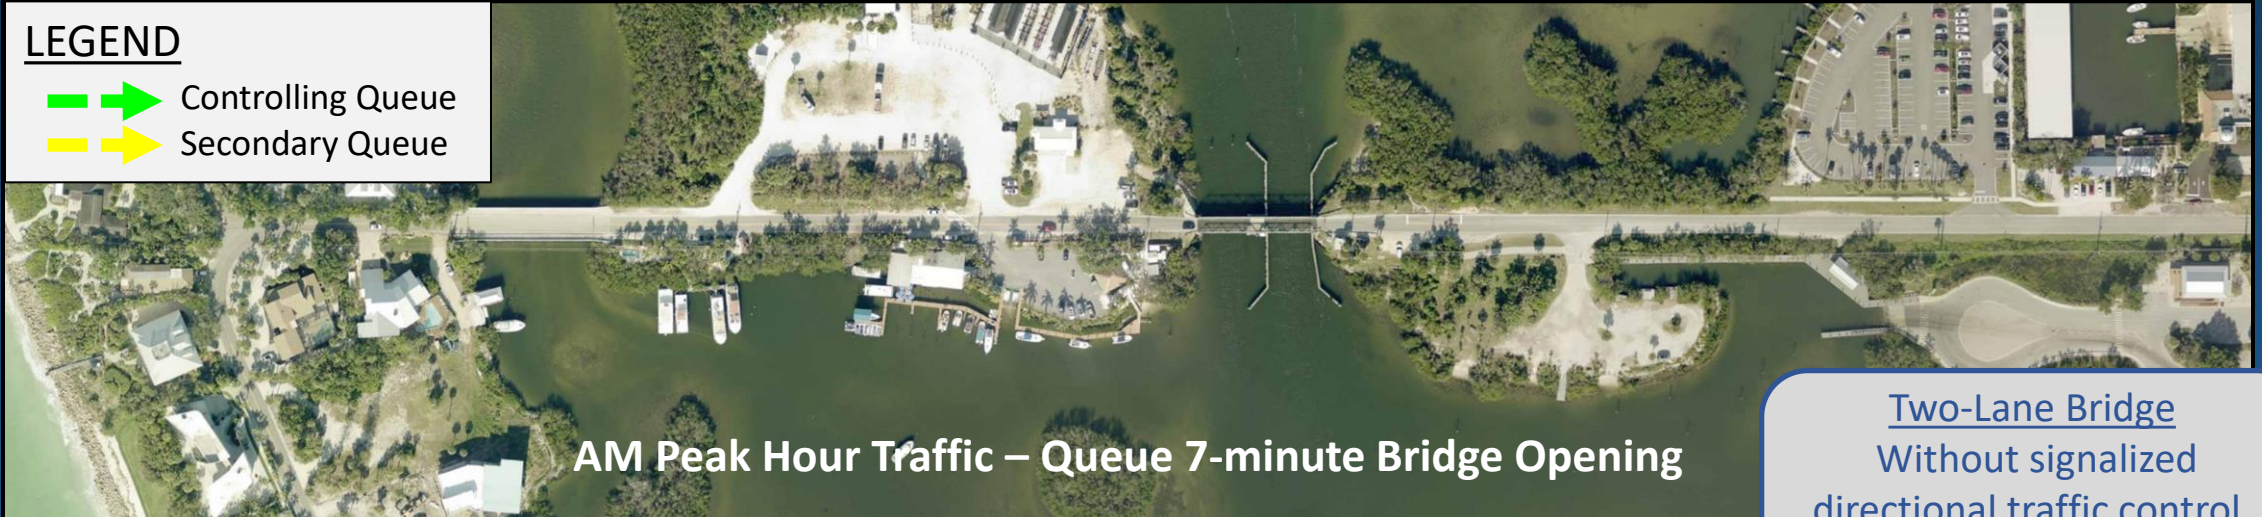
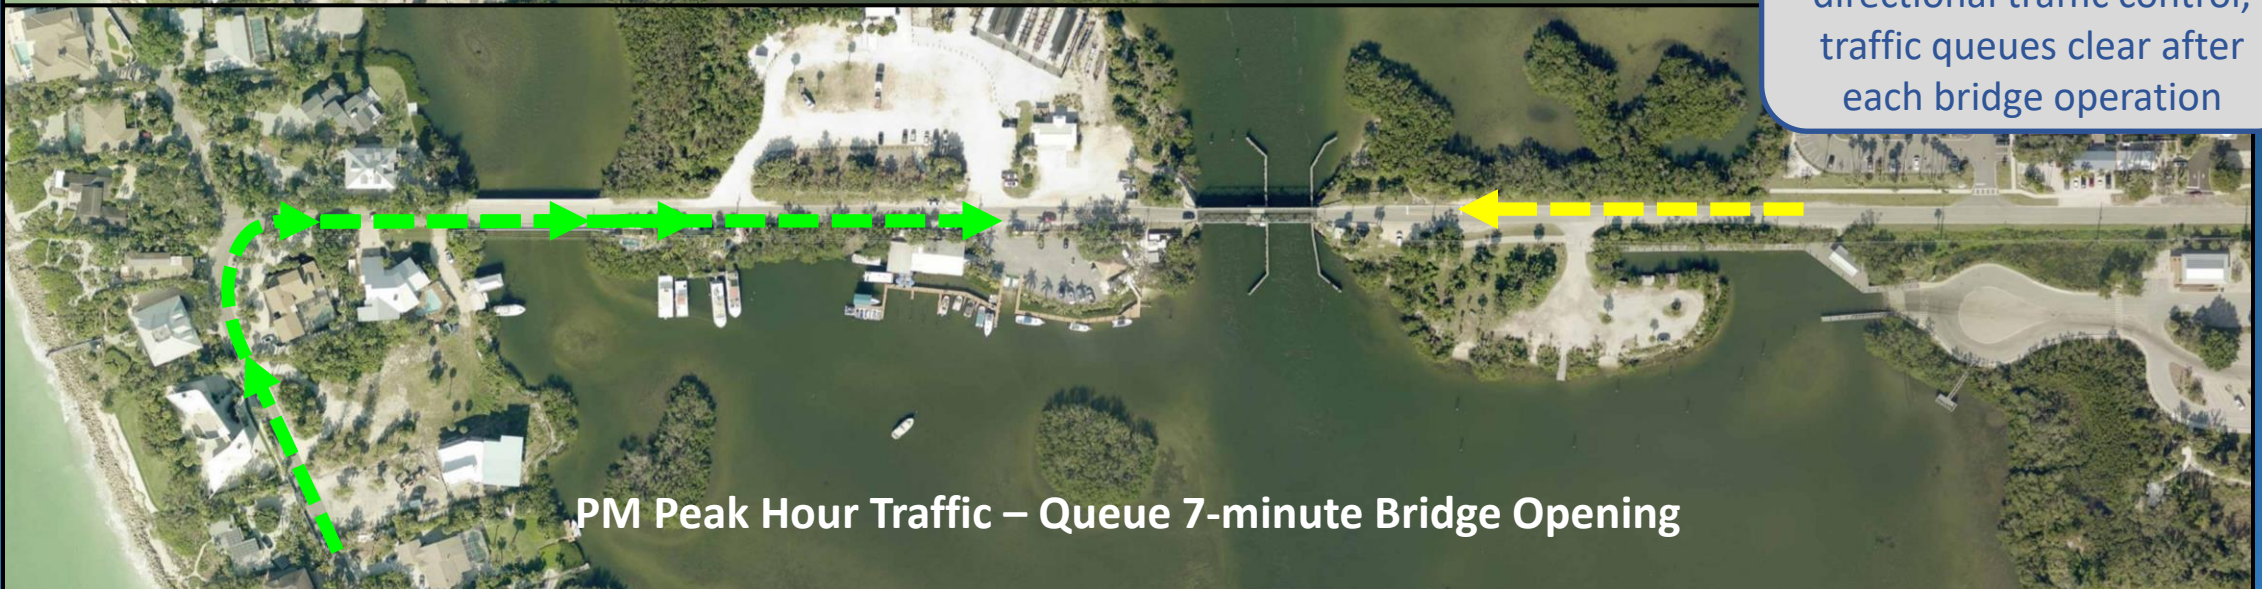
## TWO-LANE BRIDGE TRAFFIC ANALYSIS / 2050 TRAFFIC VOLUME

Two-Lane Bridge  
Without signaled  
directional traffic control,  
traffic queues clear after  
each bridge operation

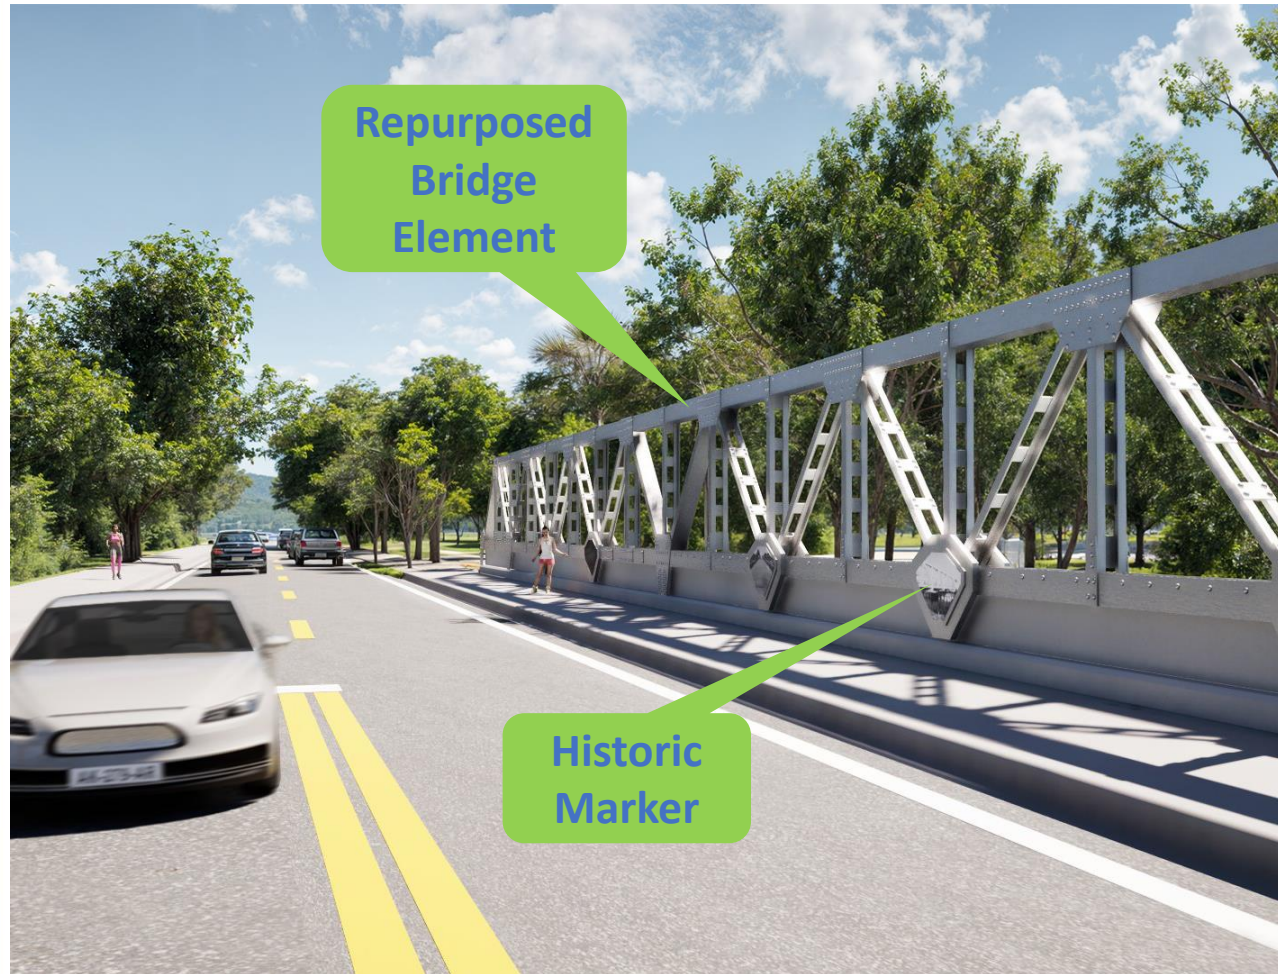
View from Blackburn Point Road

## Potential mitigation measures

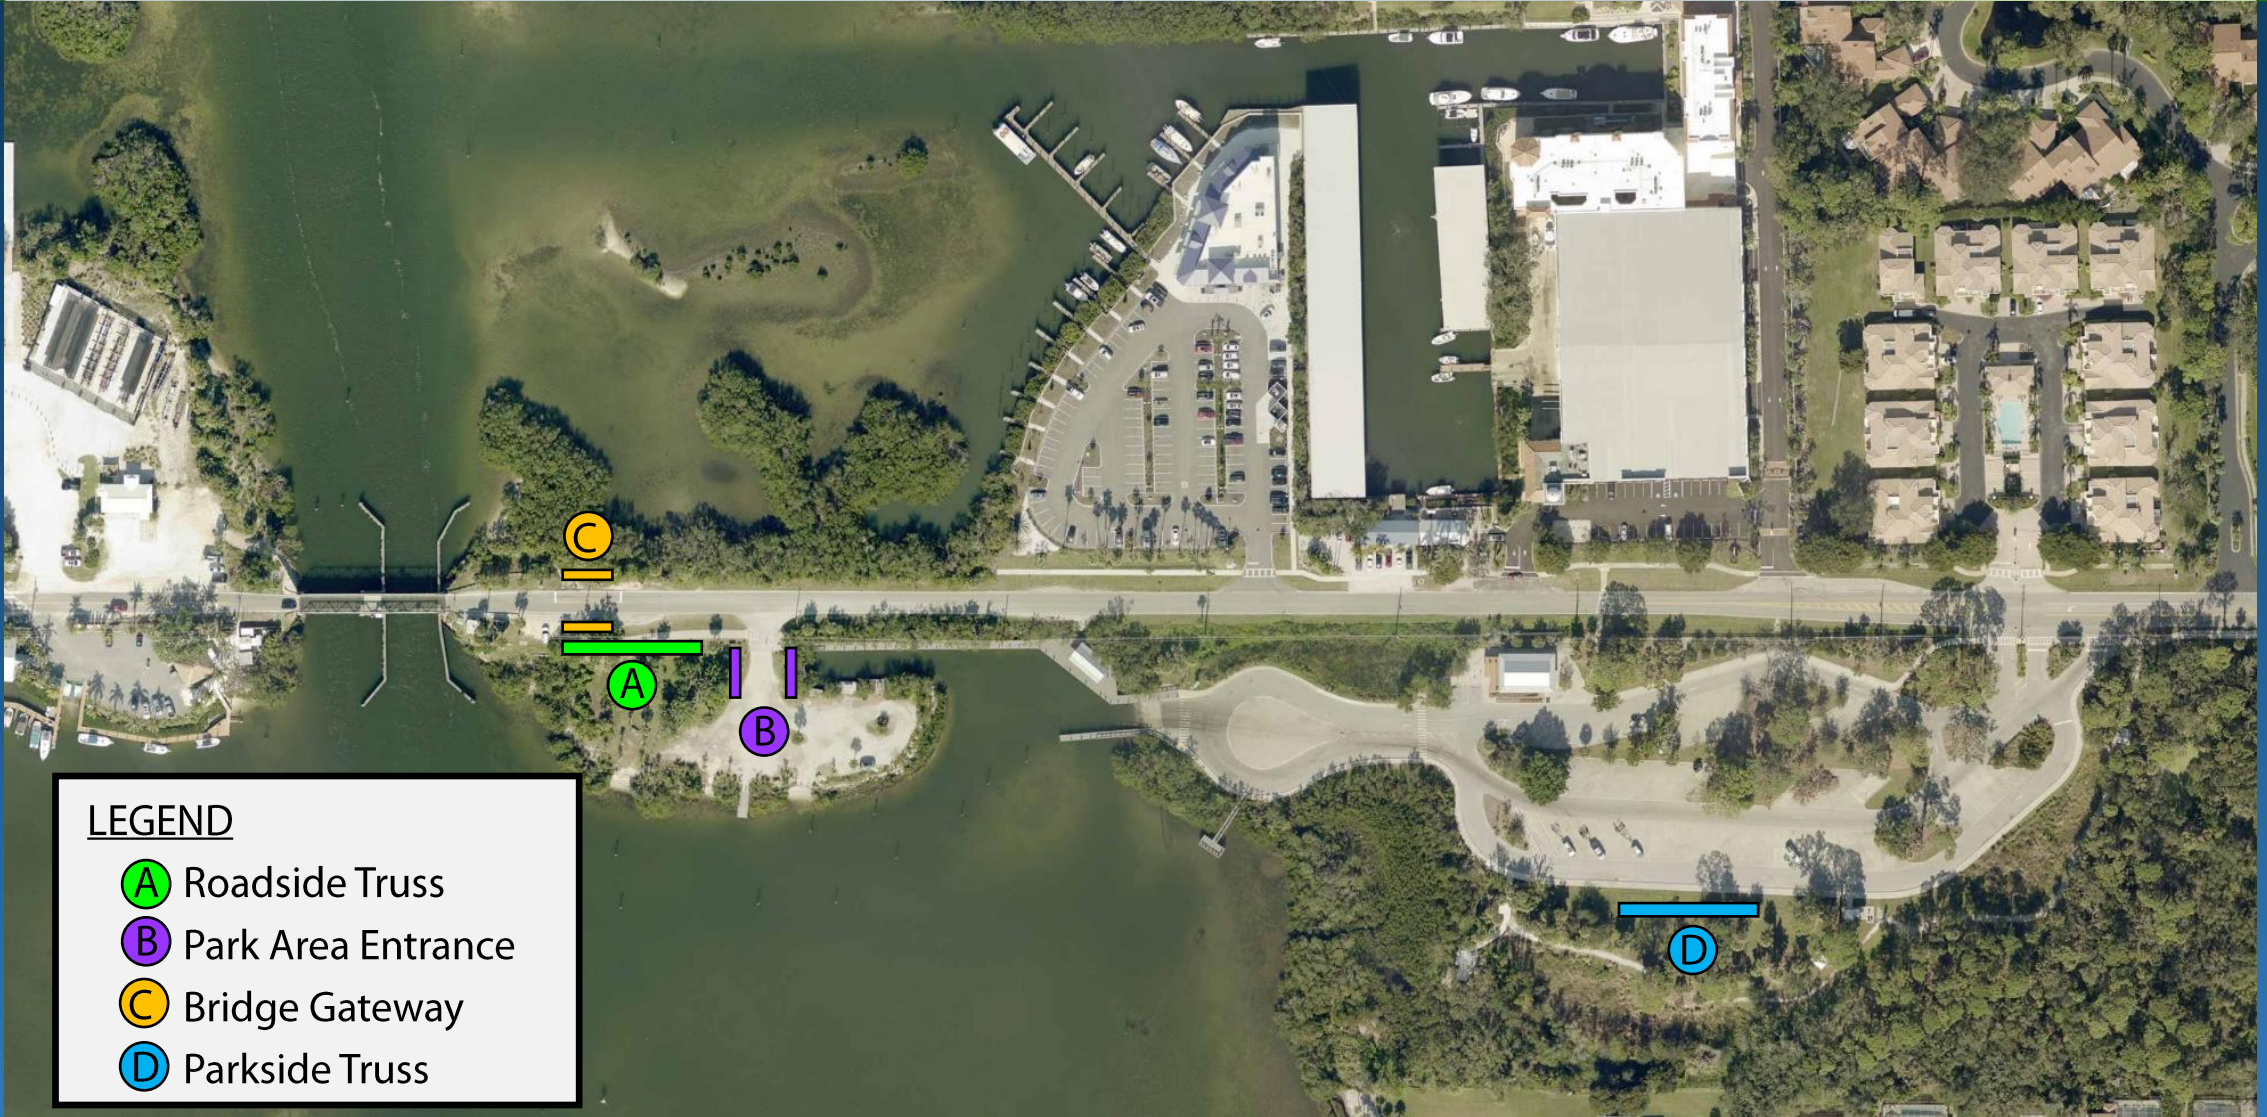
# POTENTIAL LOCATIONS FOR REPURPOSED EXISTING BRIDGE ELEMENTS / HISTORIC MARKER

- A** Roadside Truss
- B** Park Area Entrance
- C** Bridge Gateway
- D** Parkside Truss
